Evaluation of bleach plant piping materials

NICKEL DEVELOPMENT INSTITUTE
NiDI Reprint Series Nº 14 007

Arthur H. Tuthill and A. Garner

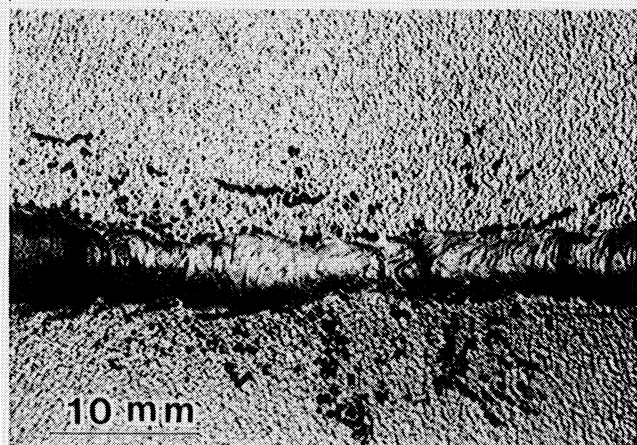
3. A cleaned circumferential weld of AL-6XN showing pitting. Pits initiated in unmixed zones of weld metal and spread under the corrosion products to nearby base metal.

The base metal and longitudinal (solution annealed) welds were unattacked. However, the circumferential butt-weld was pitted over about 60% of its length to depths up to 0.197 in. (5 mm) (Figs. 3 and 4). Metallography revealed that the manual TIG welding procedure had produced weld metal with substantial unmixed zones, i.e., zones in which remelted base metal was not mixed with the alloy 625 filler metal (Fig. 5).

As was found in previous field tests, the corrosion deposits themselves led to additional under-deposit pitting adjacent to the welds (Figs. 3, 4, 6, and 7). As will be discussed later, these ferric deposits create crevices under which active corrosion can occur readily at these temperatures.

In planning this work, we assumed that the procedures used to weld 304L and 316L pipe could be used, with minor alterations, to weld 6%-molybdenum stainless steels. However, we found that, even with fully qualified and experienced stainless steel pipe welders, these procedures can result in unsatisfactory welds for 6%-molybdenum stainless steels. Although unmixed zone corrosion had been noted in previous coupon test programs (10), its importance had been difficult to gauge without more careful replication of pipe weld procedures. This program was carried out to address this kind of shortcoming. It has shown that further work is needed to establish an inside root pass procedure which avoids the formation of unmixed zones. Possible options include automatic TIG, a greater root gap, or consumable inserts.

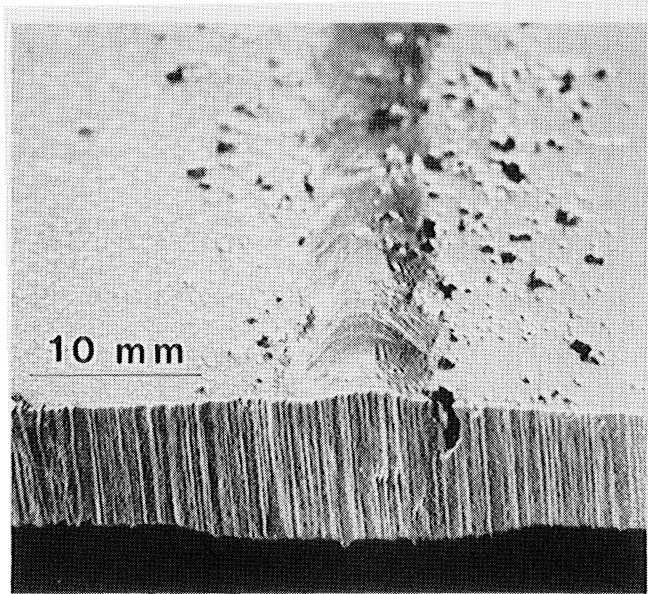
4. Cleaned and sectioned circumferential weld in AL-6XN. Deep pitting followed weld metal unmixed zone.

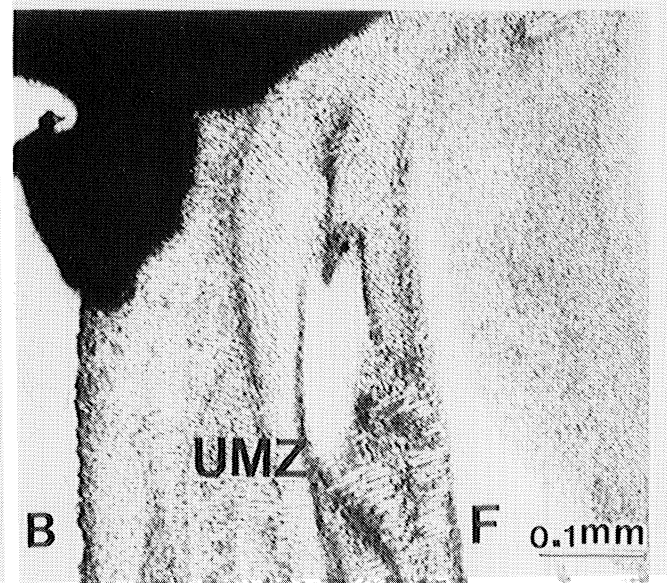
These observations were confirmed using energy dispersive X-ray analysis on a scanning electron microscope. Weld metal unmixed zones contained about 50% iron, as did the base metal; light-etching weld metal contained about 5% iron, i.e., as alloy 625 filler. In 6%-molybdenum austenitic stainless steels, such autogenous areas are well known to have pitting resistance much inferior to parent base-metal (9, 10). Dendrite coring or microsegregation leaves areas of microstructure depleted in molybdenum and chromium, areas through which pits can more easily propagate (Fig. 5).

5. Metallographic section of pit in the circumferential weld in AL-6XN. Dark etching unmixed zones (UMZ) are susceptible to pitting. Base metal (B) and light-etching undiluted Alloy 625 filler metal (F) resisted pitting in this aggressive bleach plant environment (Etch = 40 mL HCl + 10 mL H₂O + 10 mL HNO₃).

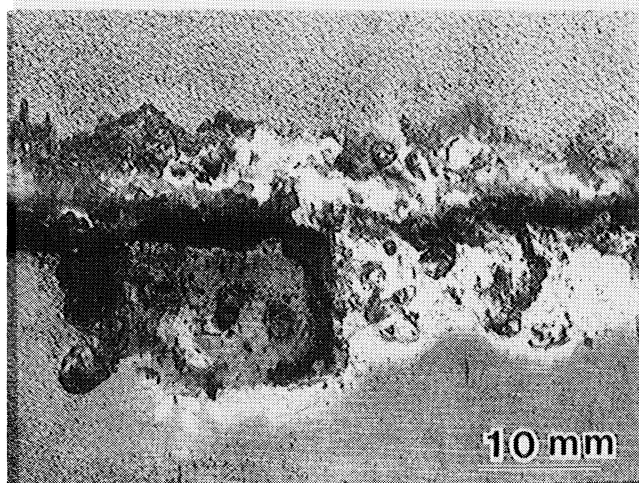
6. Secondary pitting and crevice corrosion occurs under ferric deposits formed near welds.

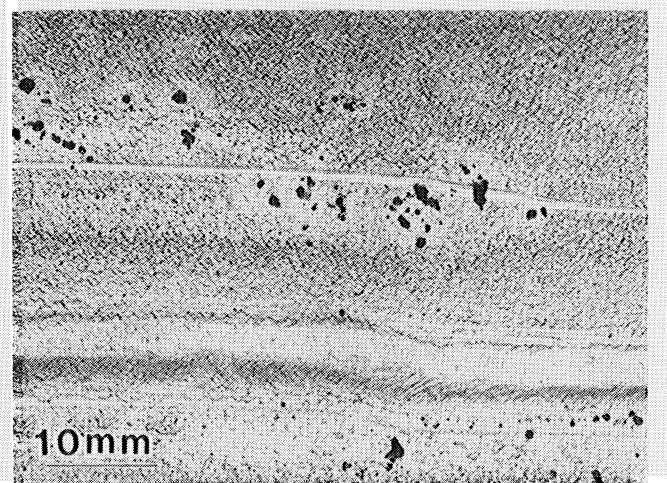
After superficial brown deposit was removed, substantial pitting was evident to a depth of 0.075 in. (1.91 mm) (Fig. 7). About 100 individual pits were visible to the naked eye on cleaned base metal, weld metal, heat-affected zones, and occasionally on a scratch, without any discernible pattern.

7. Pits in G-30 sometimes, but not always, are associated with a scratch or with welding.
