# Aspects Of Biofouling And Corrosion On Ship Hulls Clad With Copper-Nickel

*by Leslie H. Boulton, Carol A. Powell, and W. Bruce Hudson; Proceedings of Corrosion and Prevention-99. Nov 1999. Sydney.*

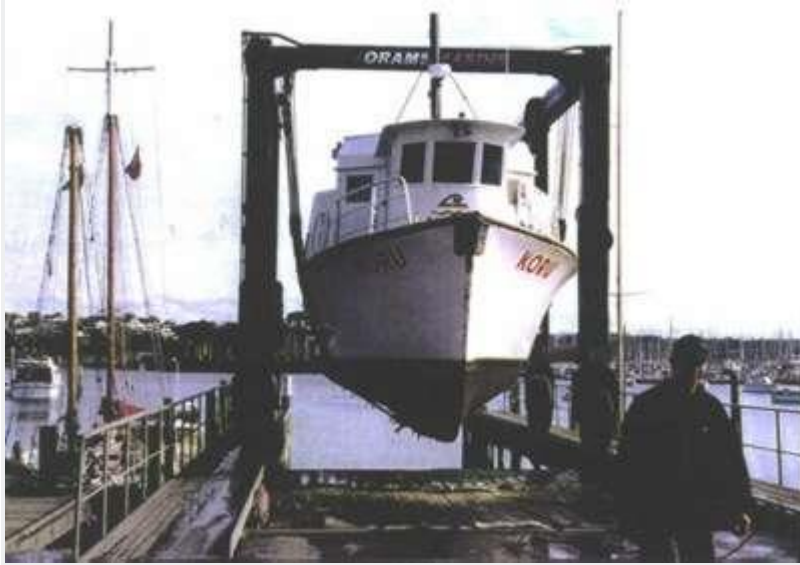
An old 48 tonne ferry, the *MV Koru* ([Figure 1](#)), had the FRP hull sheathed with Cu-Ni foil in 1993. *Koru* is a slow ferry, which travels at about 10 knots, and is held mostly in reserve for emergencies. The fouling and corrosion performance of the sheathed hull were monitored by inspection at dry-docking intervals, over the following years.

Fouling, in terms of slime formation, had occurred which was generally slight to medium. This tended to be heavier on sides exposed to sunlight when moored. Some patches of small barnacles had formed, which seemed to have occurred preferentially on the adhesive at the overlap of the panels. Barnacles on the Cu-Ni were easily removed by finger pressure.

**FIGURE 1.** The ferry *MV Koru*, being hauled out of the harbour in Auckland. The vessel had last been hauled out one year previously. Note the relatively clean condition of the Cu-Ni sheathing after one year in seawater without cleaning.

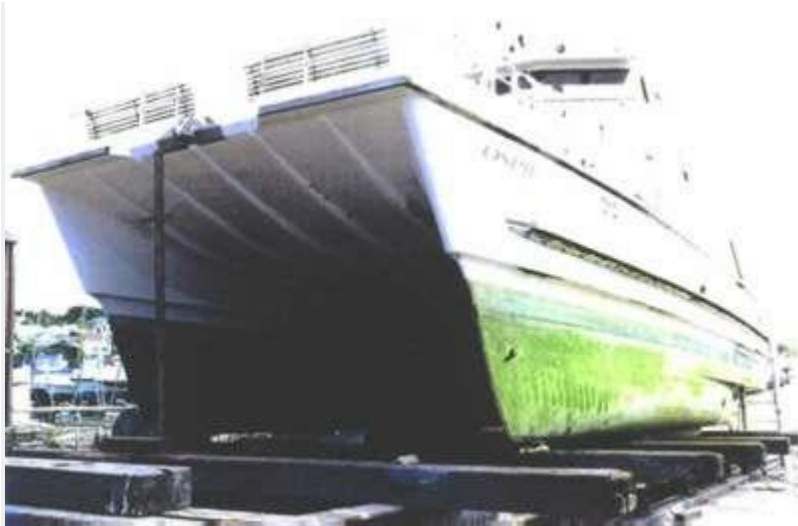
The 21-metre catamaran *MV Osprey* built as a fast passenger ferry, was launched in December 1994. The ferry has since been in passenger ferry service for about 30,000 nautical miles on the Waitemata Harbour in Auckland. Both FRP hull pontoons were sheathed from the waterline down with 90-10 Cu-Ni foil panels during construction ([Figure 2](#)).

Fouling again consisted of moderate algal growth. The growth was heavier on the exterior sides of the catamaran pontoons exposed to more sunlight. On the sheathed hull surfaces between the pontoons, where seawater velocity/turbulence are higher and sunlight exposure is less, the development of surface slime was minimal.

**FIGURE 2.** The catamaran ferry MV *Osprey*, being hauled out after one year's continuous service. Note that only slight microfouling (green algae) is visible where the hull is exposed to sunlight on the exterior surface of the nearest pontoon

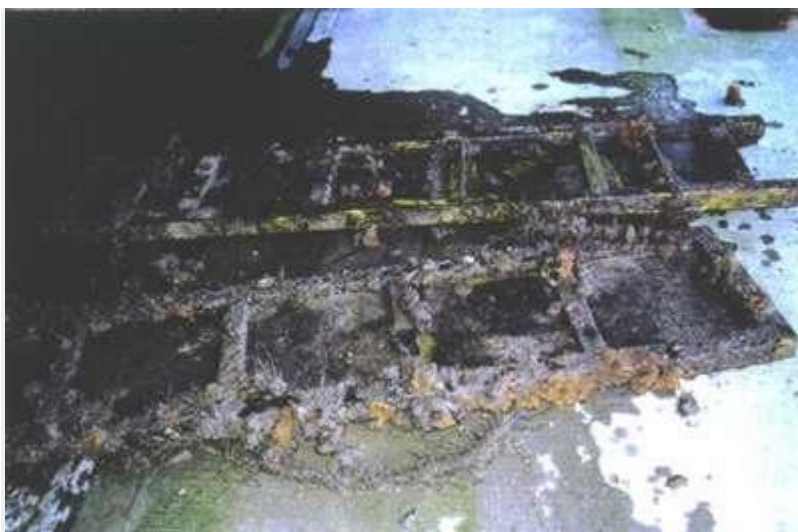
The panels and frames were recovered, water-blasted and inspected in early 1999 (Figure 3). There was no evidence on any test panels of surface corrosion of the Cu-Ni foil or detachment of the adhesive from the substrates or the foil. There was no evidence observed of degradation of the adhesive material in seawater. When the bare adhesive is exposed to seawater for long periods, it becomes fouled with marine growth at about the same rate as a non-antifouling paint.

**FIGURE 3.** Two test panel frames removed after five years' seawater immersion at the Maritime Museum site, Auckland harbour, NZ. The differing degrees of fouling on the wooden frames are visible. The nearer wooden frame (steel panels) is painted, whilst the farther frame (aluminium panels) is clad with 90-10 Cu-Ni foil.

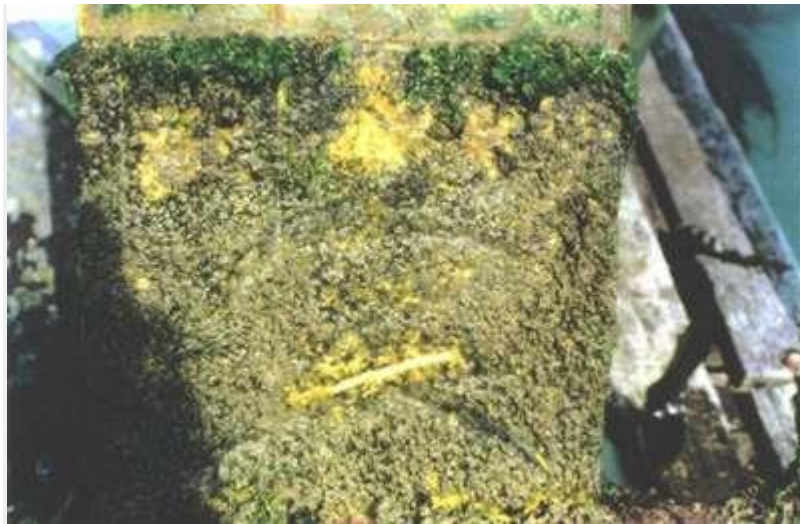
[Figure 4](#) shows a Cu-Ni sheathed FRP panel after 2.75 years' exposure in Langstone Harbour. This illustrates the low level of macrofouling on the Cu-Ni for this length of exposure time, and the ease with which the biofouling can be wiped off with finger pressure.

**FIGURE 4.** A Cu-Ni sheathed FRP test panel after nearly 3 years' exposure in Langstone Harbour (United Kingdom). Finger pressure was sufficient to remove biofouling off the panel surface revealing the original 90-10 Cu-Ni substrate.
