Long-term Exposure Trials Evaluating the Biofouling and Corrosion Resistance of Copper-nickel Alloy Sheathing Materials.

Dr Sheelagh Campbell¹ Dr Robert Fletcher² and Carol Powell³

³ Consultant Metallurgist to the Nickel Institute

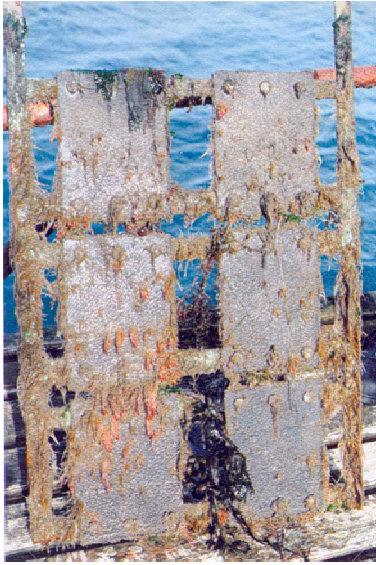
The 6 embedded granules panels were attached securely to a single steel frame using nylon screws, Figure 1. The frame itself was slotted into position on the raft and secured by ropes to prevent loss in heavy weather conditions. When in place, all of the samples were below the water level. Six expanded mesh samples were received and mounted on one frame initially as shown in Figure 6 with the single hot rolled sheet sample positioned towards the bottom

Fig 1. 12 month exposure
wipe

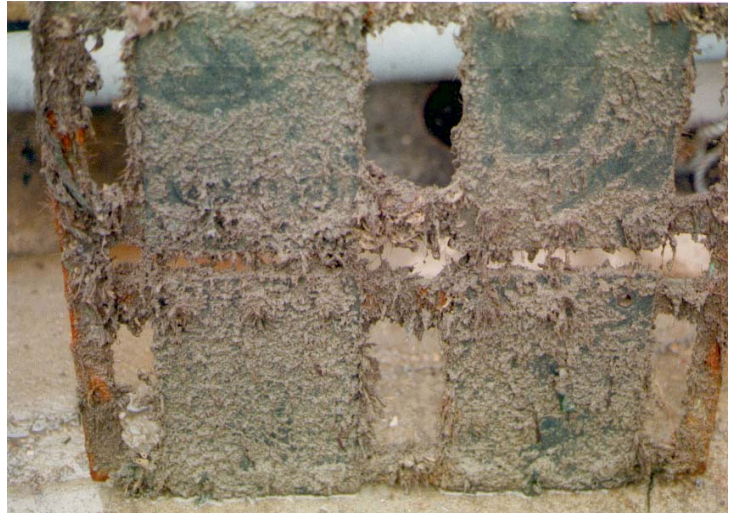
Figures 2 and 3 show the appearance of the panels after an immersion periods of 4 and 5 years. The brown layer could be removed manually. Although there were small barnacles and some red/green seaweed found attached to the copper-nickel loaded surface after 5 years, the heavier fouling was again located on the rear surfaces of the panels with a variety of organisms including seaweeds, barnacles and sea squirts.

Fig 2 4 year exposure showing areas of
brown slime removed after manual

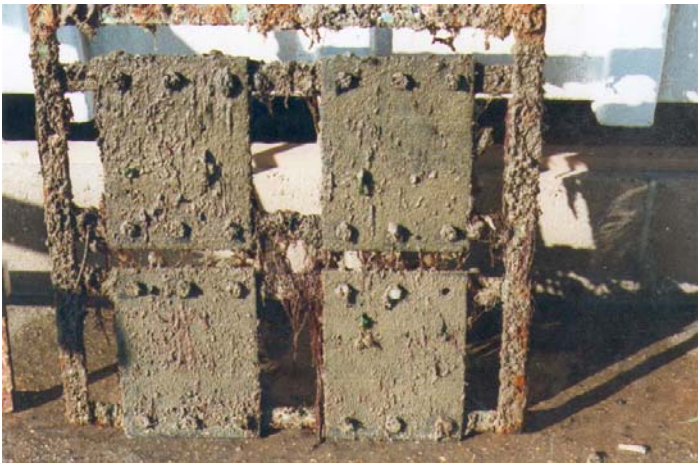
Fig 3 5 years exposure

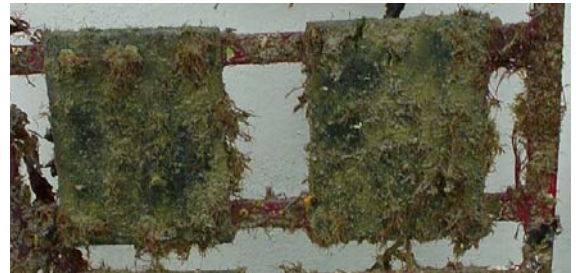
The samples were removed from the sea on 22 October 2002, after an exposure period of 8 years. The general appearance of the panels is shown in Figure 4. The main copper-nickel containing surfaces were covered with a brown slime layer but some macrofouling was also present in certain areas in the form of seaweeds and tiny barnacles. The slime layer could be removed by light wiping although the macrofouling required more pressure.

Fig 4. 8 years exposure

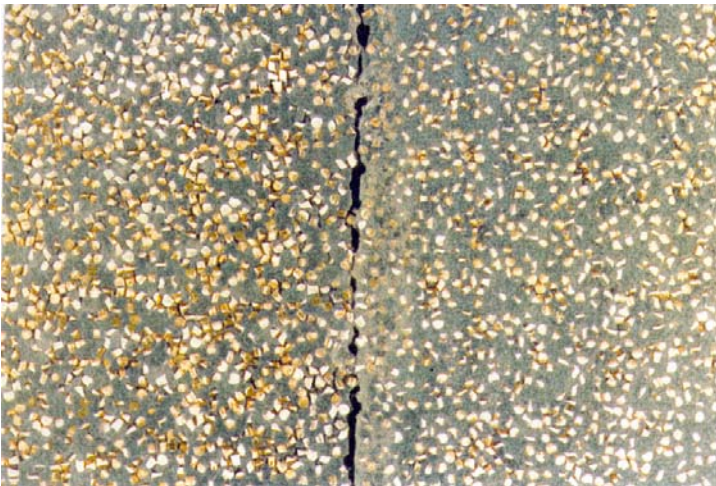
The general appearance of an “as received” embedded granule sample, mounted onto a GRP backing plate for the exposure testing experiments, is shown in Figure 5. The distribution of the rods showed a random arrangement with some lying parallel to the rubber whilst others were embedded at right angles to the surface.

Fig 5. Before exposure, showing
Copper-nickel rods

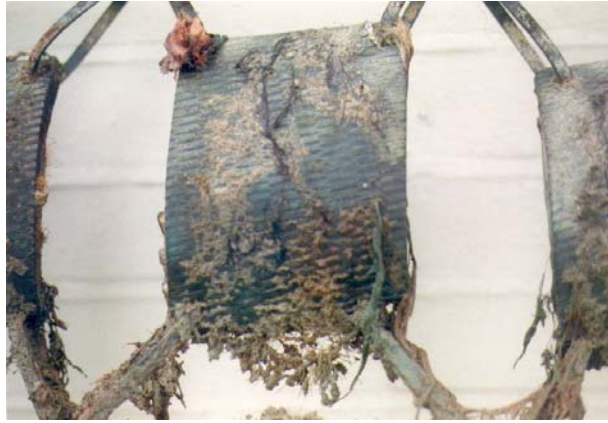
The appearances of the expanded mesh samples after an exposure period of 2.5 years is shown in Figures 7 and 8. The panels lying closest to the splash zone were less fouled than those lying lower in the water. The main fouling present was on the frames and ties supporting the samples and on the rear surfaces of the panels. As shown in Figure 8, the brown/grey slime deposit on the panels could easily be wiped away to reveal the underlying copper-nickel mesh.

Fig 7. 2.5 years exposure, top row

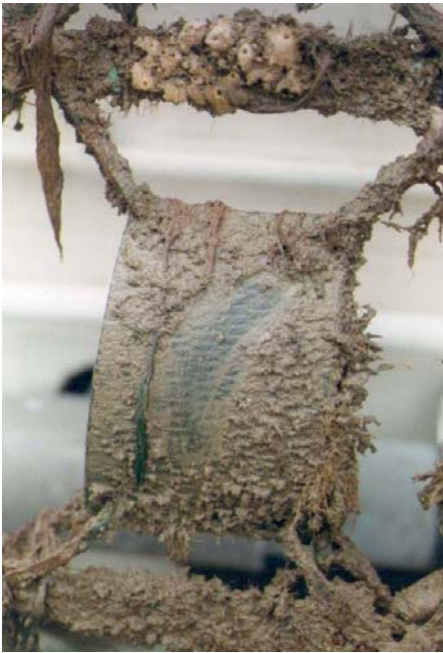
Fig 8. 2.5 years bottom row
Showing manual wipe

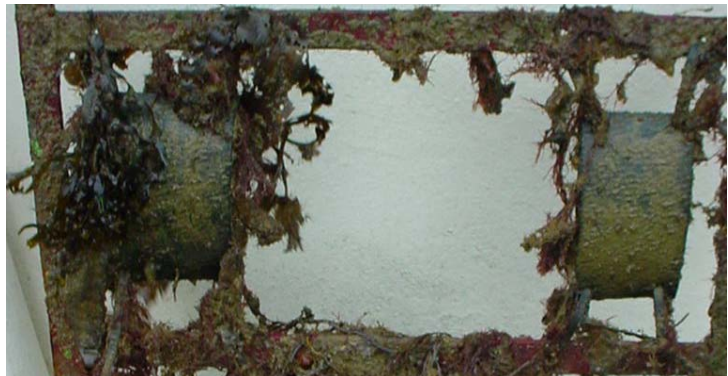
Figure 9 shows the appearances of the samples after removal from the exposure raft in October 2002 after 7 years. As noted previously, the main fouling was located on the frames themselves, and at the edges and rear surfaces of the panels. The panels were also covered with a brown slime layer, which was thicker on the lower section; much of this layer could be removed manually. After drying in the laboratory, the alloy-containing side of the panels could be seen to be coated with a green-grey deposit. These surfaces were largely free from macrofouling but did contain a few barnacles on the rubber and at the copper-nickel rubber interfaces. The attachment of the fouling material was seen to be predominantly in the regions of the EPDM rubber substrate.

Fig 9. 7 year exposure

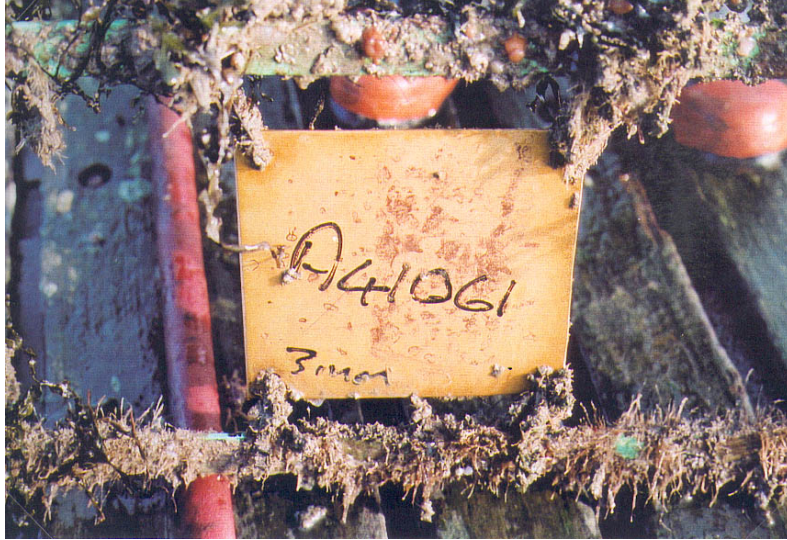
Fig 10

The appearance of the hot-rolled copper-nickel after a 13-month exposure period is shown in Figure 10. The panel remained very bright with no fouling on its surface. Throughout the exposure trials the panel remained relatively free of fouling. Figure 11 shows the appearance of the rolled sample after removal from the exposure raft in October 2002 after 7 years. The main fouling was located on the frame, with some on the ties securing the plate to the frame. A loose deposit present on the surface of the alloy could be manually dislodged.

13 month exposure

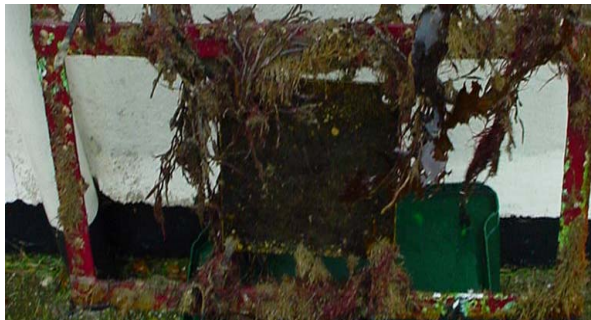
Fig 11

After 7 years, a section of the panel was sawn off and the surface examined. High magnifications showed the presence of surface roughening which had the appearance of a slight etching.

7 year exposure

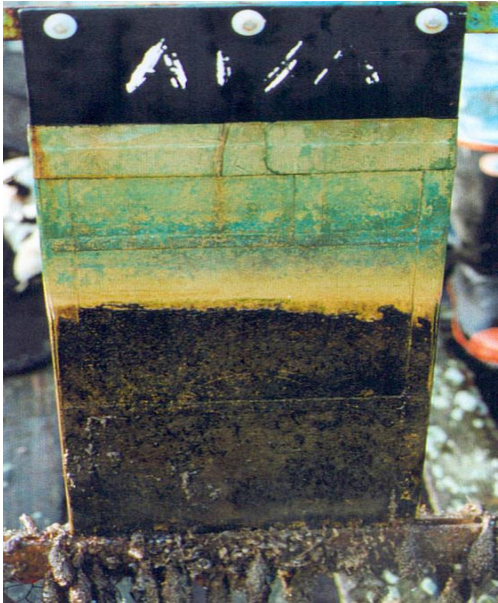
After 18 months, Figure 13, exposure, two regions were distinguishable on each panel; a green coloured area of copper-nickel above the water line and a lower region covered by brown slime. The latter deposit was easily removed on wiping. Little macrofouling was present on the panels.

By 18 months, scratching and pitting could be seen along the water line. The depths of these scratches and pits were 10 ± 3 and 50 ± 18 μm respectively. Although quantitative testing of the bond strength of the copper-nickel to the underlying surface had not been carried out at that time, there was no evidence of any deterioration in the adhesion of the metal to the panel. However, at the edges of the panels, considerable thinning of the copper-nickel was observed. This can be partly attributed to erosion corrosion as a result of the hydrodynamic conditions that would be experienced in these locations. Despite this reduction in alloy thickness, the underlying metal surfaces, even that of the aluminium panel, remained protected by the black primary coat layer.

Fig 13 18 month exposure

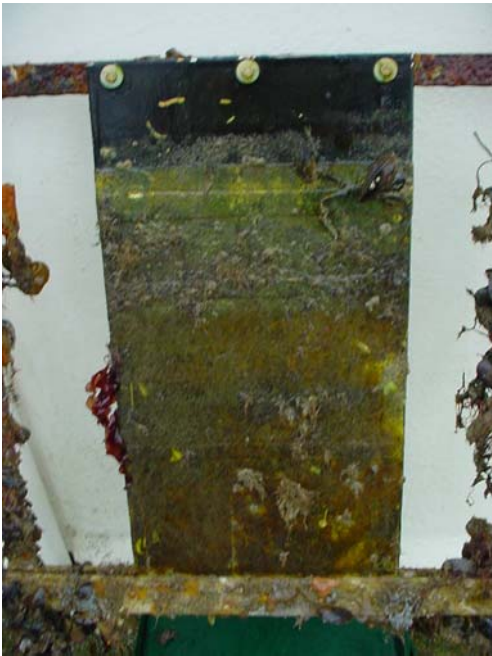
After the 7 year exposure period, the GRP based panels exhibited a similar fouling pattern to that observed for steel-based, Figure 14. The copper-nickel surfaces were again covered with the brown slime, which was easily removed in areas to display a clean metal surface. However, on one side of one panel there was more macrofouling on the lower section with barnacles and a moderate amount of fibrous material present. Thinning of the alloy was again noted at the panel edges and small organisms and plants could be seen settling in these locations. There was no evidence of any disbondment of the copper-nickel from the GRP base.

Fig 14 7 year exposure
