FABRICATION & METALLURGICAL EXPERIENCE IN STAINLESS STEEL PROCESS VESSELS EXPOSED TO CORROSIVE AQUEOUS ENVIRONMENTS

GEORGE E. MOLLER
AND RICHARD E. AVERY
N° 10026

Presented at Air Pollution Seminar,
Buffalo, NY, U.S.A., Oct 1987.

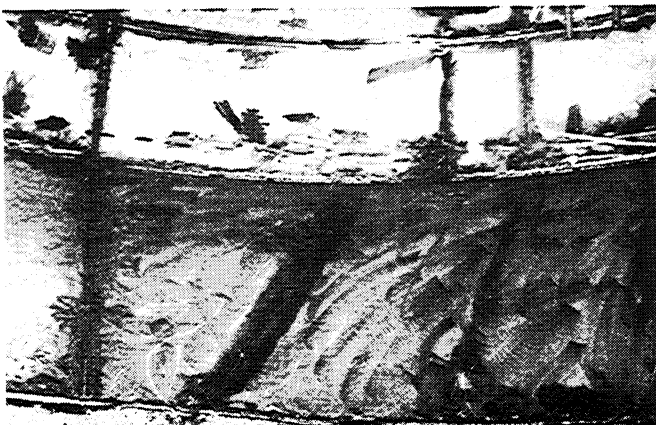
The vertical cylindrical tank portion below the liquid level of one installation is shown in Figure 1 after removal of the settled solids or

sludge. Vessels showing attack generally display geometrically arranged reddish-orange rust deposits associated with welds and prior locations of clips and gussets used in assembly where they were welded to the shell. Some of the rust deposits are found associated with random grinding marks.

A perspective view of a 316L vessel wall showing evidence of localized corrosion.

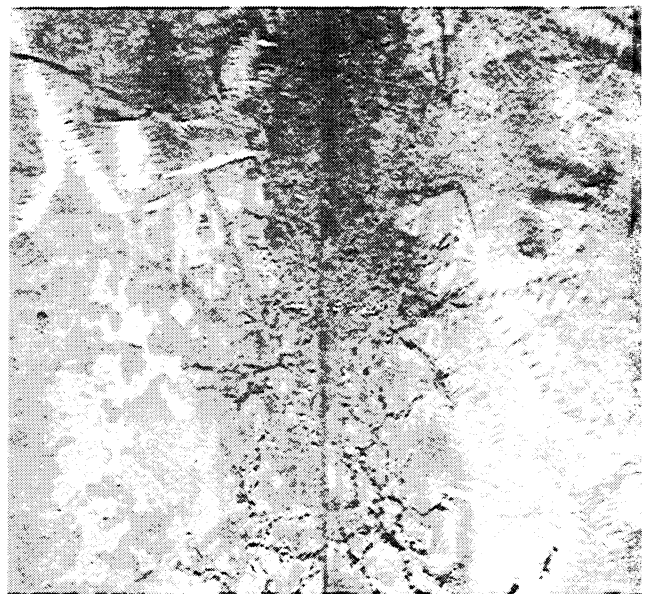
Figure 2 shows hairline cracking and crevice corrosion in and around a vertical weld as a band, several inches wide, spanning both sides of the weld. It is evident that the attack along the weld is in the zone of weld clean up by grinding. The clean up work introduced surface stresses and contamination by soils picked up from places with iron or carbon from carbon arc gouging.

Corrosion on both sides of a weld seam showing attack as a result of grinding or brushing.

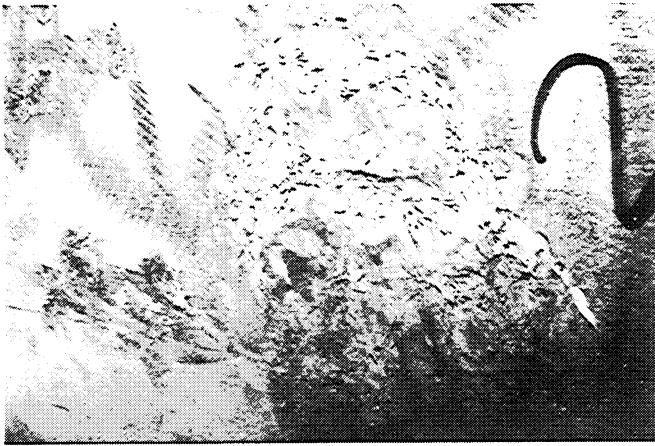
Figure 3

An area of severe localized attack is shown in Figure 3. In the center of this area, a 316L gusset used for alignment and rigging had been located. The gusset was removed by carbon arc gouging and the area dressed up with a disc grinder. The result is the smearing of the oxides, slag and carbon contaminated metal. These locations some of which could be seen in Figure 1 become active sites for pitting in the concentrated neutral chloride environment.

The location of a prior construction gusset cut off by carbon arc with irregular disc grinding.

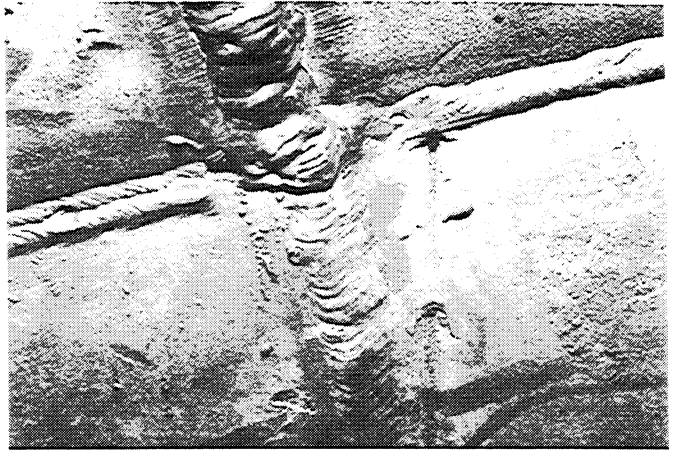
Figure 6

Initiation of attack in another evaporator from carbon arc spatter and field welding spatter on the sloping cone from the work on the cylinder above is shown in Figures 5 and 6. There was little apparent attempt of post weld clean up by grinding and pickling in this assembly. Attack shown here occurred within 3-6 months after commissioning.

Spatter alongside a vertical weld with the initiation of attack.

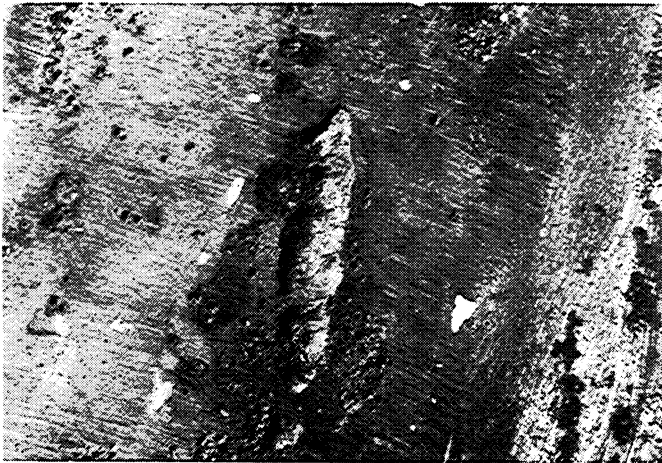
Figure 4

An elongated carbon arc gouge shown in close up appears in Figure 4. It was not cleaned up and overlaid with virgin weld metal but only ground. Pits have initiated under slag and spatter. In these vessels, no attack is found in the open areas untouched by welding, spatter or grinding.

A groove left after carbon arc gouging without proper final dressing.

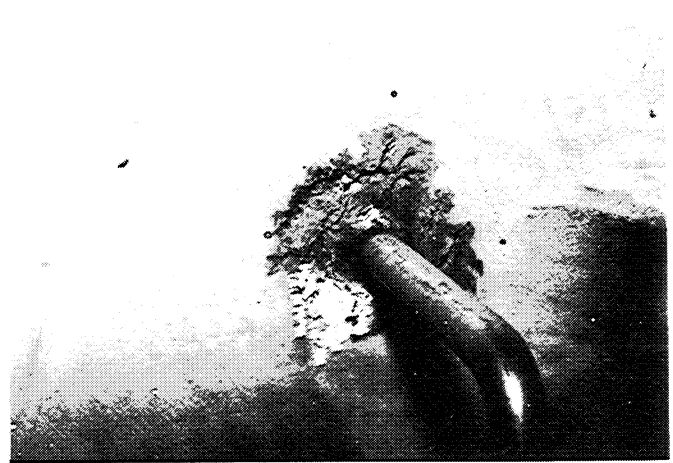
Figure 7

Localized crevice corrosion has developed in and around crows foot type SCC from the grinding of a fillet weld of a 316L ladder rung (Figure 7). Even though this is a weld executed in a competent fabrication shop known for handling stainless steels and reactive metals, the weld area has been contaminated. Acid cleaning (pickling) is recommended after grinding to dissolve deleterious oxides, iron and carbonaceous matter. A shop made 50mm (2") side branch connection in a 610mm (24") line again illustrates the same condition as found with the ladder rung (Figure 8).

Corrosion around the fillet weld of a ladder rung.

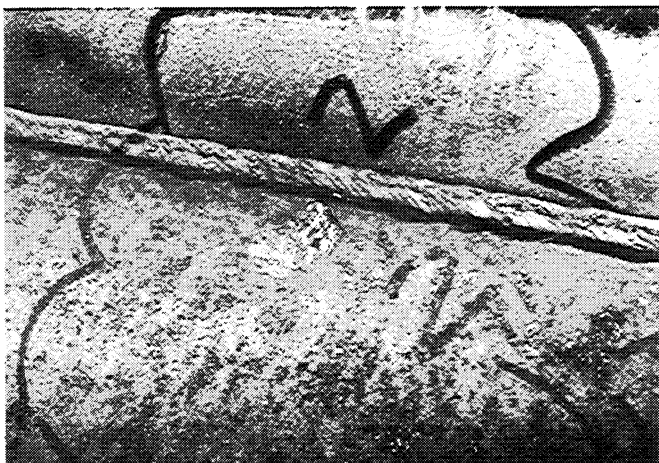
Figure 5

Corrosion initiated from carbon arc spatter from overhead construction work.

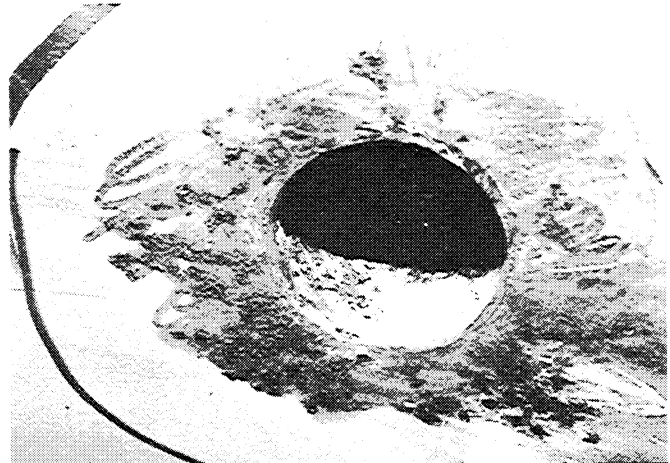
Figure 8

Corrosion around a side branch connection. Attack was initiated by clean-up grinding.

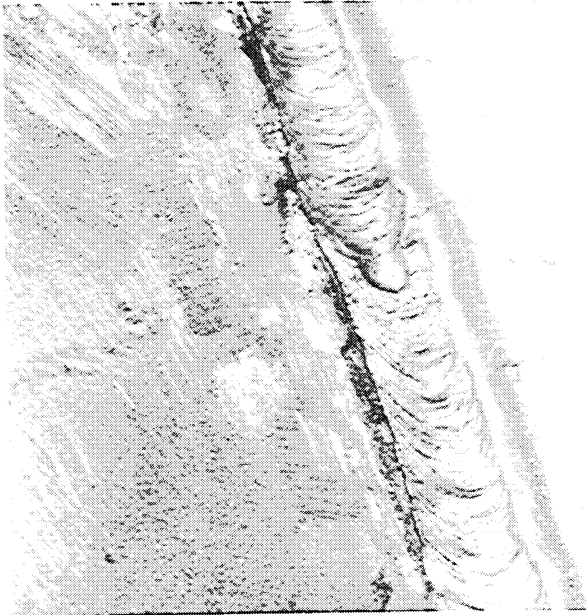
Figure 9
Corrosion at the toe of a vertical weld, probably from residual slag.

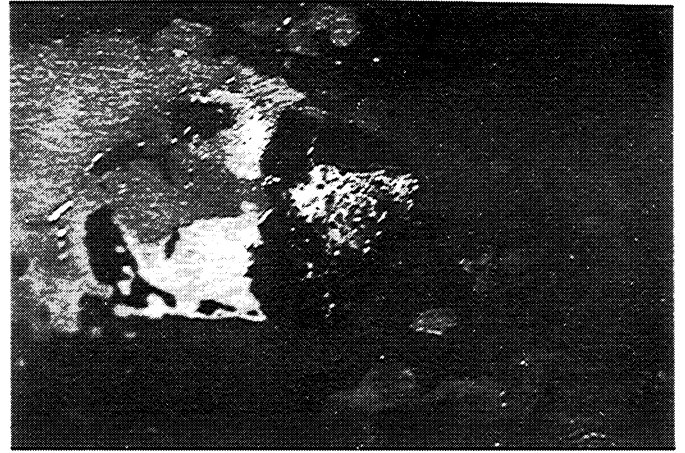
When inspecting surfaces covered in inorganic scale, found both in FGD modules and evaporator sumps, prior to scale or sludge removal, the active corrosion site could be found by a dark (brown or black) spot showing in the surface deposits (Figure 12).

Figure 12
Active corrosion of stainless steel can be identified by dark spots in the scale.

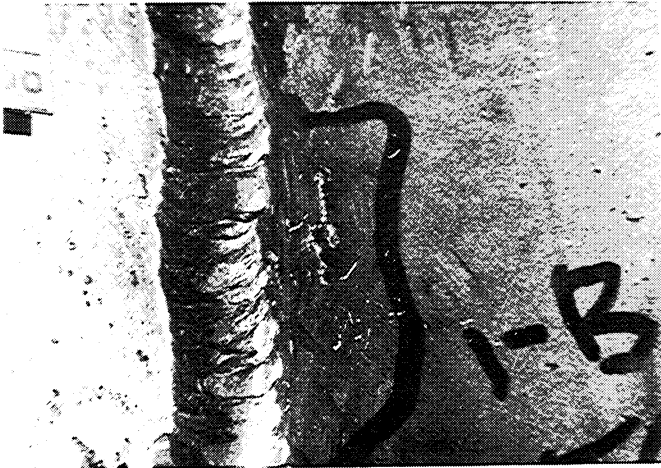
Figure 10
Corrosion along a vertical weld from either grinding or slag. The vertical nature of a pit may be from gravitational effects.

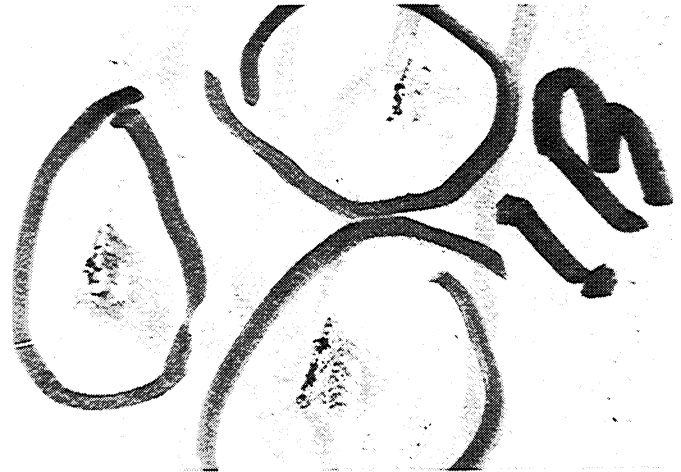
Active attack is frequently initiated by scratches, particularly scratching with ordinary carbon steel tools. Iron is embedded in the surface and reacts with chloride to initiate pitting (Figure 13).

Figure 13
Corrosion initiated by scratches.

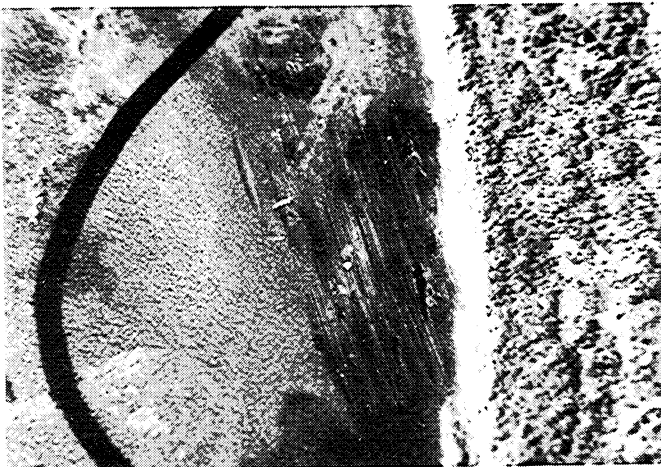
Localized corrosion and perforation of the 6.4 mm (0.25 inch) thick plate occurred in three months. The leaks in the tanks were found to be from attack immediately next to vertical welds at transitions from flat sides to curved corners, right at the toe of the weld pass (Figure 9) or next to it in the HAZ at locations of grinding (Figure 10). The longitudinal orientation of the corrosion pit is felt to be due to gravity and streaming ferrous chloride from the active pit. Just as with the evaporators, it was quite common in the FGD scrubber sumps to encounter attack brought about by grinding. Figure 11 is an illustration.

Figure 11
Corrosion as a result of clean up grinding.

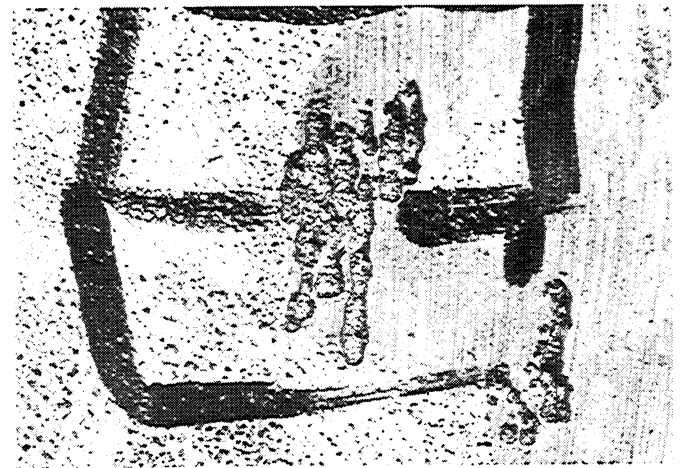
Figure 14 illustrates graphically activation of 904L by grinding in close contrast to the normal shot blasted and pickled mill finish of plate. In some instances, it was found microscopically that the groove type pitting from grinding activation would penetrate part way through the thickness of the plate at the active spot and spread out at an internal banded structure. This condition was found by a cross sectional microscopic examination of the corrosion.

Figure 14
Attack in a ground zone.

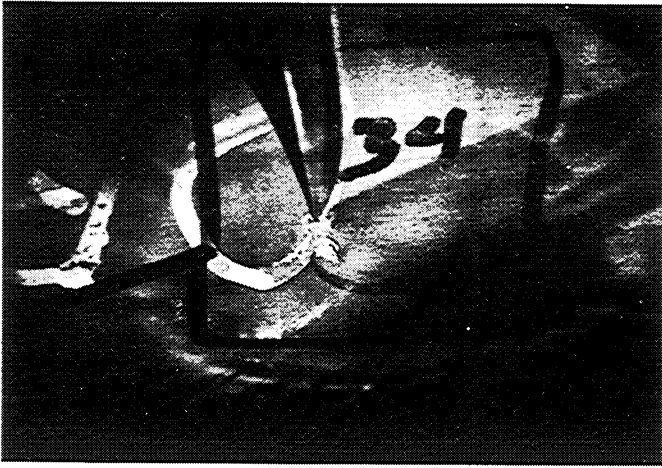
Paint films or identification marks lead to crevice corrosion. Figure 15 shows paint identifications on 904L piping which resulted in crevice corrosion.

Figure 15
Attack caused by paint markings.

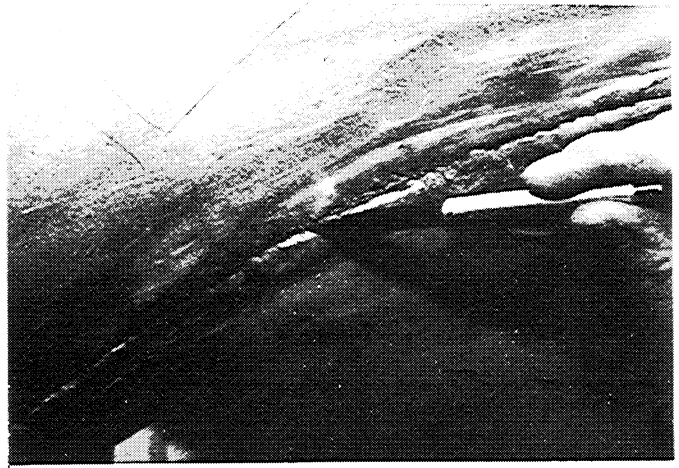
Figure 18
Attack of a shop weld.

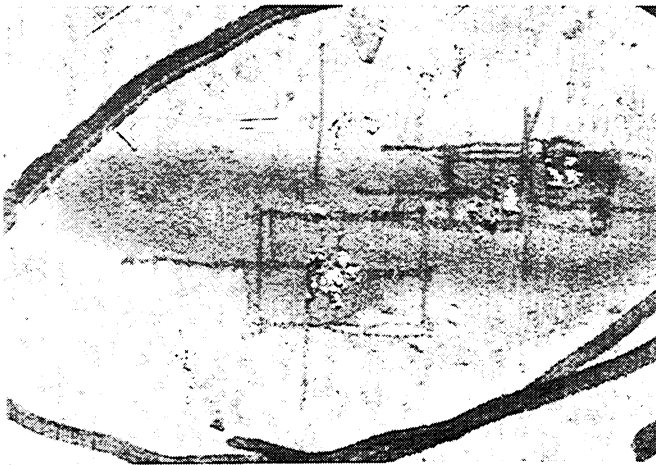
It was previously mentioned that the rectangular tanks, were supported externally by steel members to contain the hydraulic load. The members were tack welded with stainless welding filler to the 904L plate. The result was a countless number of heat tint spots on the inside. Some of these spots as shown in Figure 16 became active, under conditions of total immersion, but not above it, and showed localized attack. The reduced corrosion resistance from heat tint has been discussed by Wilson, et al (5), Kearns (6) and other investigators.

Figure 16
Pitting of 904L at a point of internal heat tint from external welding.

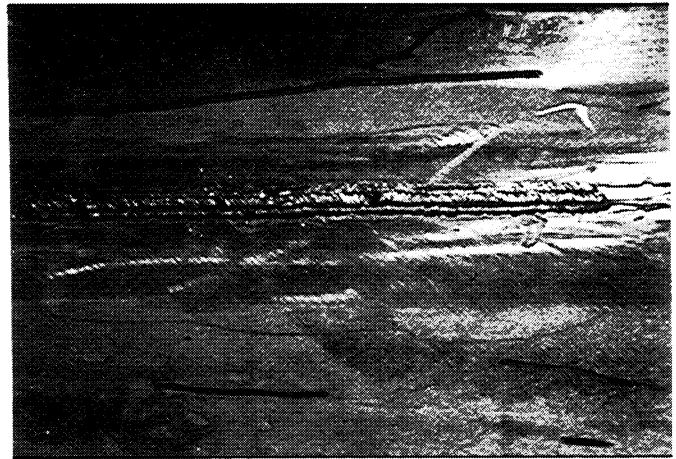
Figure 19
Repair of a pitted zone of an E 316L weld made with an ENiCrMo-3 electrode.

Repairs of pitted areas in welds and carbon arc gouges in both the evaporators and the FGD modules were made with ENiCrMo-3 (alloy 625 coated electrode) composition (7) after careful removal of corroded metal by grinding. A repaired weld is illustrated in Figure 19.

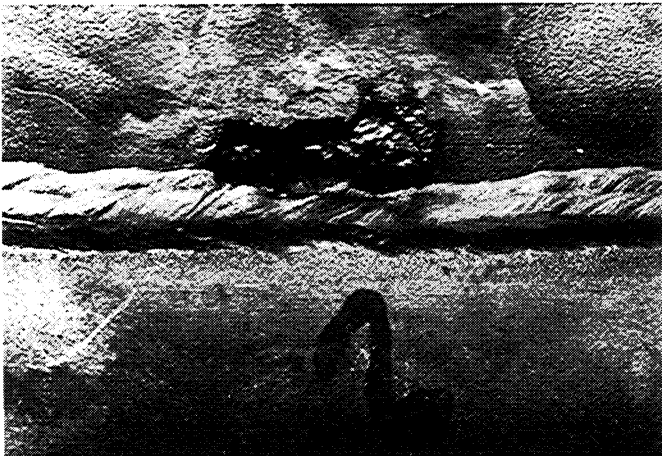
Figure 17 shows an example of localized attack where the weld bead and a place in the plate immediately above it has corroded. This example is from an evaporator but weld attack was prevalent in the matching filler weldments of the FGD units also. Figure 17 was a shop made weld. Garner (7) discusses the attack of matching welds in oxidizing acid chloride environments and discusses the advisability for the use of enriched filler metal. Figure 18 shows attack of shop executed circumferential butt weld in large diameter prefabricated pipe made under good shop conditions. This example is further evidence that matching welds generally have lower corrosion resistance than the parent metal, hence the need for enriched filler. Test work done by one of the authors in hydrometallurgical solvent extraction for copper and uranium production both operations of which are done in oxidizing chloride environments with a background of dilute sulfuric acid has shown similar results with matching welds.

Figure 17
Attack in a field seam and immediately above it.

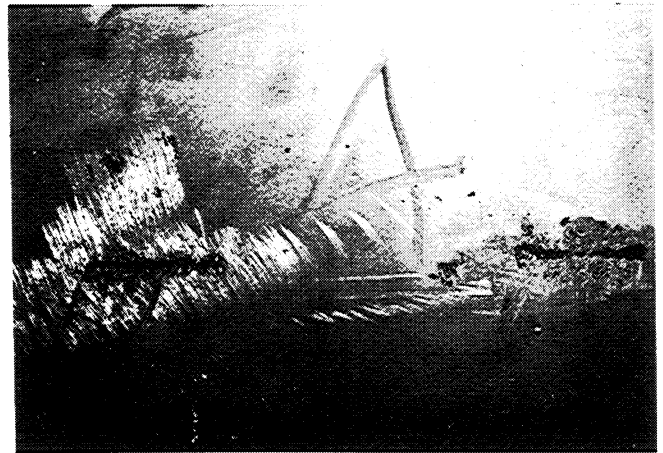
Figure 20
A passive surface as a result of treating with pickle paste. This area had been active.

Locations of active corrosion, as indicated by oxide stains and around repair welds, were scrubbed with a nitric-hydrofluoric pickle paste and then subsequently washed and neutralized with slaked lime. This treatment has been successful in arresting corrosion in three evaporators.

Although, it is not altogether clear in a black and white illustration, the area shown in Figure 20 had been treated with pickle paste with no recurrence of rusting or corrosion activity.

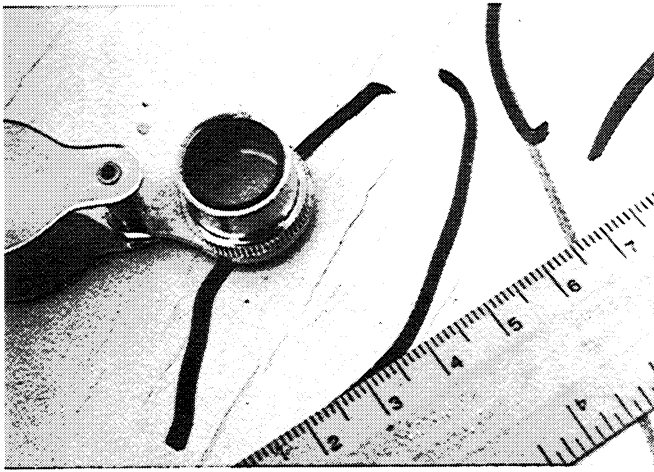
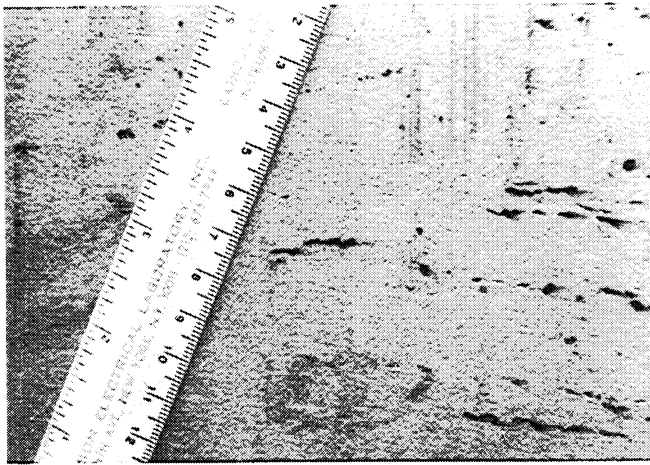
FGDscrubbers for one Western installation were specified and built from a special grade of 317L stainless steel with high nickel, high molybdenum and high nitrogen contents. The stainless plate was found to have surface blemishes called "seams" in the steel industry. They are in fact oxide filled crevices. Two examples are shown in Figures 21 and 22. This condition was found in plate produced by three rolling

Seams in a high Mo, high Ni, high N special grade of 317L created during hot working.

Oxide-filled seams and slivers which result in surface crevices.

mills. The condition is the result of a very narrow hot working or forging range. As the undesirable condition was found on one face only of each plate, it was decided to turn the good side to the corrosive environment, and seamed or blemished side to the atmosphere or outside.

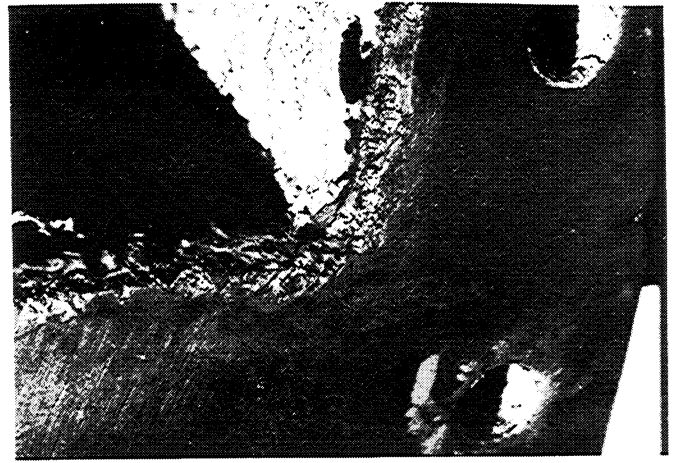
Figure 23

The manways of some FGD scrubbers and other equipment were found to be sealed with black rubber gaskets or graphite impregnated asbestos. The carbon black in the rubber and graphite in the fiber creates a galvanic couple with 904L or 316L resulting in pitting (Figure 23). Red rubber, white rubber or Teflon (R) has been substituted.

Pitting from the galvanic action of 904L by a black rubber gasket.

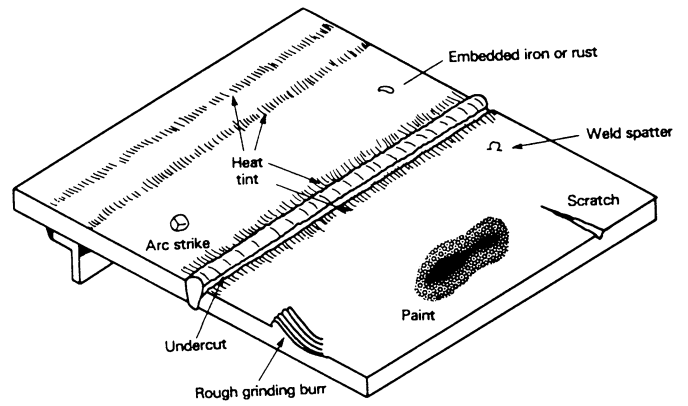
Figure 24

Typical fabrication defects or surface conditions commonly encountered.
