MICROBIOLOGICALLY INFLUENCED CORROSION OF STAINLESS STEELS BY WATER USED FOR COOLING AND HYDROSTATIC TESTING

G. KOBRIN ET AL.
N° 10085

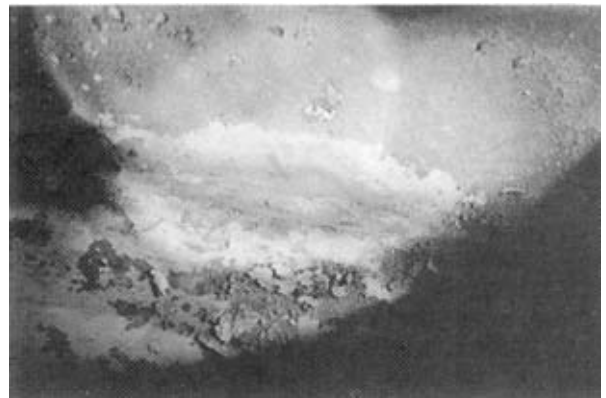
Closeup of a dry deposit.

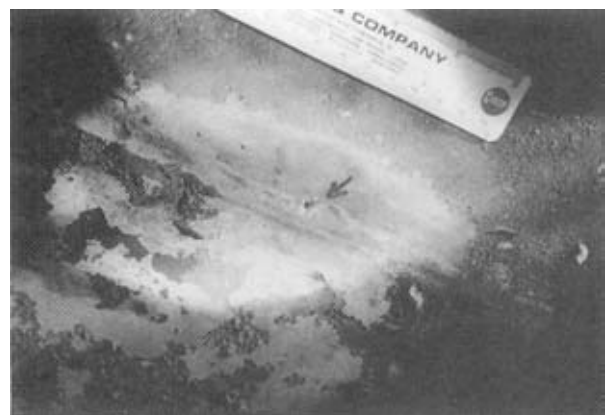
After removal of deposit, showing ring-shaped stain around the weld.

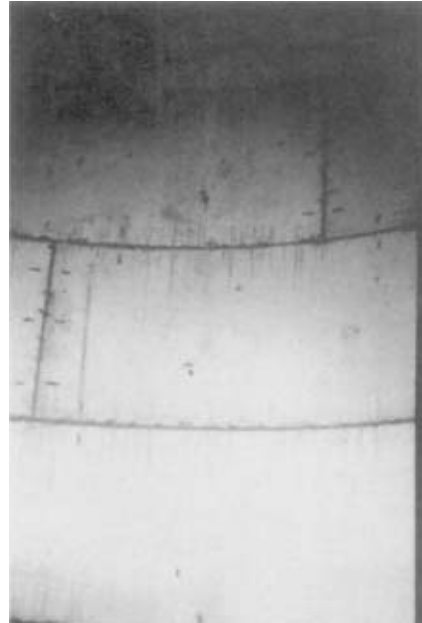
Figure No. 9
Rust-colored streaks normal to horizontal weld seams in sidewall of 316L tank.

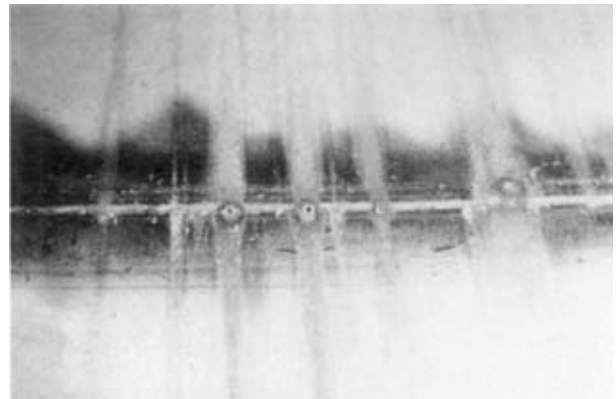
Figure No. 10
Closeup of streaks shown in Figure 9.

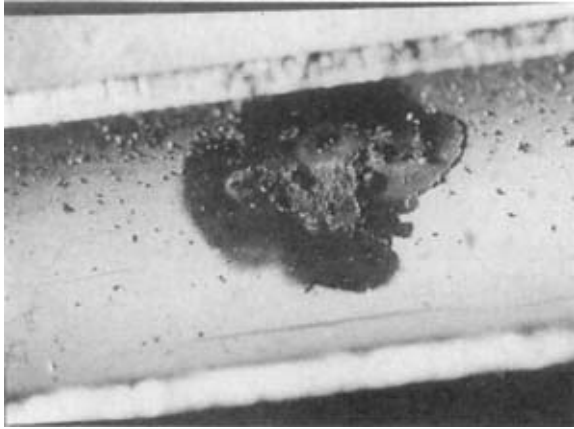
Figure No. 11
Reddish-brown deposit/stain and pits on internal surface

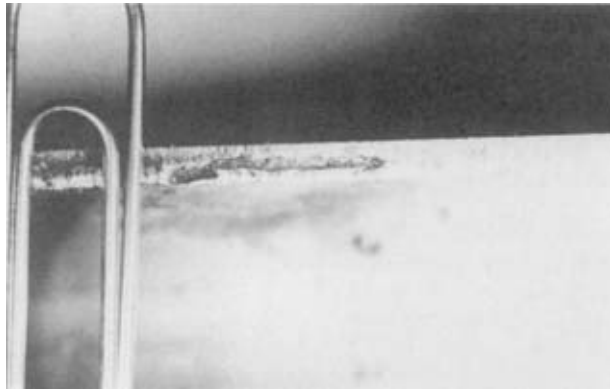
Figure No. 12
Cross-section through a pit in 304 SST tube showing sub-surface "tunnel".

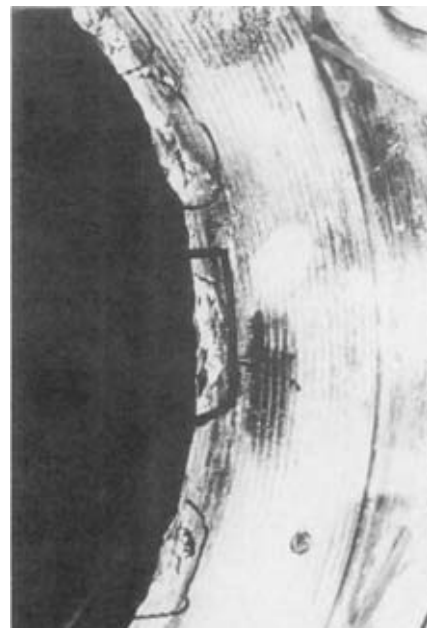
Figure No. 14
Closeup of flange in Figure 13 after cleaning. Shows open "gouging" corrosion that was directly under deposits.

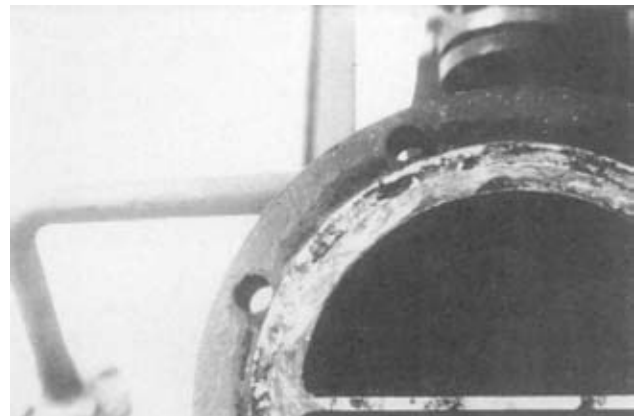
Figure No. 15
304 SST condenser head flange showing areas of crevice corrosion, some filled with black FeS, on gasket surface. Bacteria deposits covered the inside edge of the gasket in these areas.

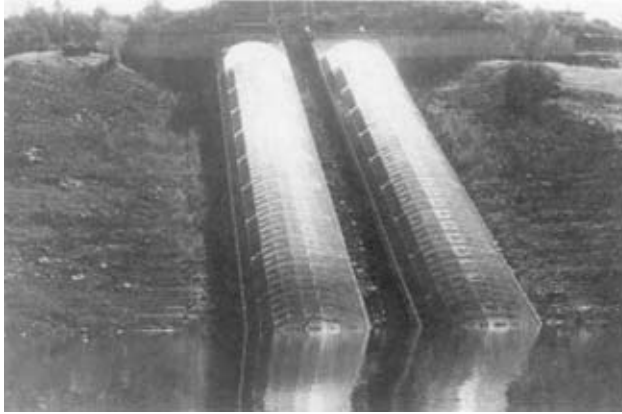
Figure No. 16
304 SST trash racks on a fresh water lake in California.

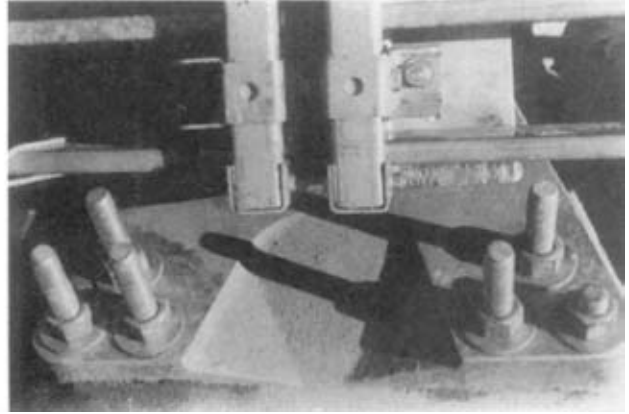
Figure No. 18
Trash rack weld; no evidence of corrosion.

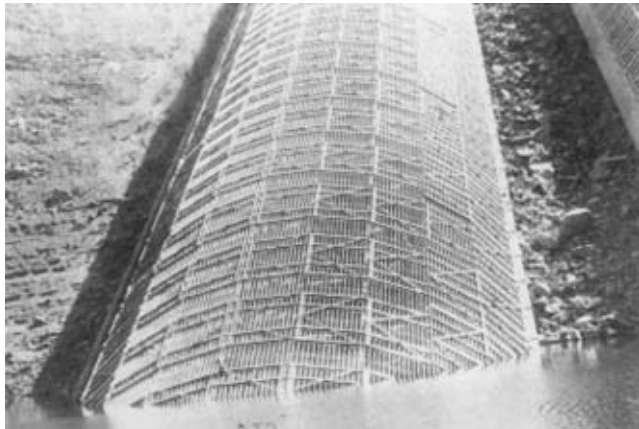
Figure No. 17
Closeup view of a trash rack showing half-hard 304 SST components.

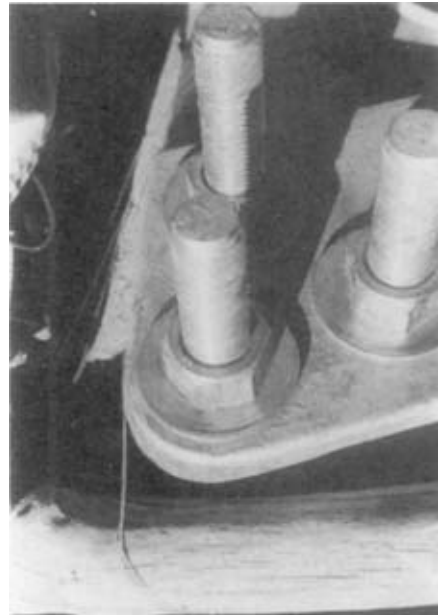
Figure No. 19
Trash rack fasteners; no evidence of corrosion.
