CORROSION OF METALLIC AND NONMETALLIC PIPING FOR BLEACH PLAN D STAGE FILTRATE

DAVID C. CROWE AND ARTHUR H. TUTHILL Nº 14013

Reprinted from Proceedings of the TAPPI Engineering Conference, Seattle, WA, Sep 25, 1990 Distributed by NICKEL INSTITUTE

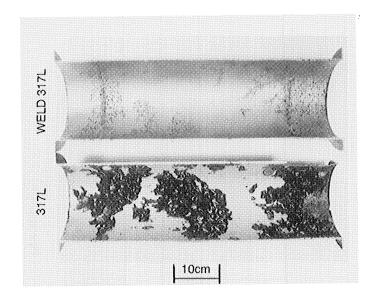
There were black, adherent corrosion deposits on the inside of the 317L pipe spools, as shown in Figure 2. The scale was dense, quite adherent and similar to the scale usually observed on stainless steel specimens exposed in D-stage. The scale contained primarily Fe, Cr and Mo, constituents of the alloy, with some Si, Cl and Ca. Garner (18) noted that in D-stage exposures, ferrous oxide deposits are insoluble above a pH of about 3.5, which is consistent with their presence here at pH 5.8. However, deposits were thought to be less likely above pH 5.5 since CIO2 becomes less corrosive toward steels and is transformed over time to chlorite, CIO₂-. The present results suggest that the deposits may form at pH as high as 5.8, or that they are formed during periods of lower pH, but not removed at pH 5.8.

Fig. 2. Black adherent corrosion deposits had formed over pits inside the 317L stainless steel spools.

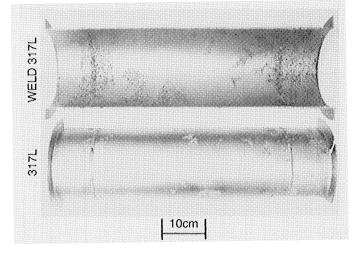
When the scale was removed, many pits were observed, as shown in Figure 3. On the outside, areas of through wall pit penetration were marked by dark patches of corrosion product. There was pitting on the outside surface of the pipe beneath the scale. Acidic corrosion products including FeCl₃ are believed responsible for spreading this underscale corrosion. Figure 3 illustrates how pitting was more prevalent near to welds but was not restricted to welds. Extensive pitting was found in the base metal, well away from the welds. Pitting at the welds may be related to the structure there such as Cr- and Mo-depleted austenitic dendrite centers. The pipe flange face suffered crevice corrosion, pitting and some stress corrosion cracking from the crevice sites, Figure 4. High stresses would be expected due to flaring of the flange material.

Fig. 3. Pitting of the 317L was more prevalent near the butt welds.

1. Type 317L stainless steel piping would provide marginal to poor service for D-stage filtrate service.

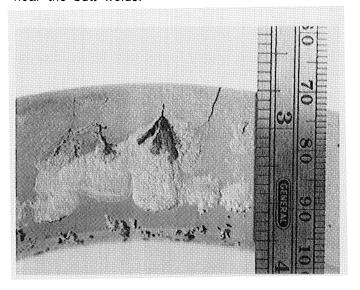
Fig. 4. The 317L flange face suffered crevice corrosion and cracking.

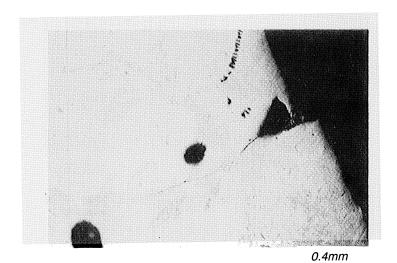
The longitudinal weld in the titanium was well made, but the butt weld was of poor quality. Penetration was incomplete and a fine crack was observed to run from the location of lack of penetration into the material as shown in Figure 7; this may have been an incompletely fused section of the original joint.

Hardness measurements made across the butt weld showed the weld to be 349 Hv, the heat affected zone 469 Hv and the bulk material 173 Hv. The increase of hardness at the weld is indicative of uptake of nitrogen and oxygen.

Fig. 7. At titanium butt welds showing incomplete fusion, a crack was observed.
