EVALUATION OF DECOMMISSIONED LNG STORAGE TANKS AT CHULA VISTA, CALIFORNIA

J.P. LEWIS,
AND T.A WILLIAMS
N° 10067

Presented at the American Gas Association
Distribution/Transmission Conference,
1991

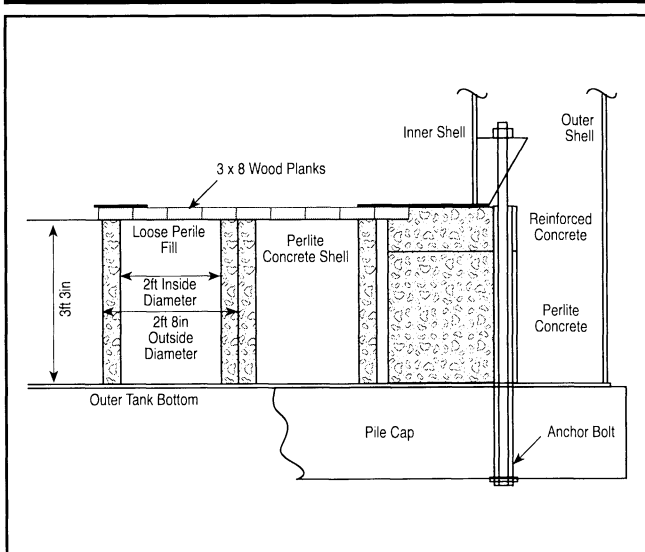
Figure 3 Tank T-1, Bottom Insulation System

The load bearing insulation used in T-1 was 32 in. (81 cm) diameter by 39 in. (99 cm) long, hollow concrete cylinders with the void spaces filled with loose perlite. This construction is shown in some detail in *Figure 3*. The cylinders were overlain with a floor of 3 x 8 in. (8 x 20 cm) Douglas fir planking. The inner 9% floor was placed directly on the wood floor with 12 in. (30 cm) wide asbestos strips located under the weld areas. From all appearances, this insulation system was exactly the same as when it was put into service 25 years before. The load bearing insulation used in T-80 was four layers of Foamglas, each layer being 5 in. (13 cm) thick. This construction is shown in additional detail in *Figure 4*. There were two unexpected observations relative to the Foamglas. When the inner bottom was removed, there was a very consistent 1.25-1.5 in. (3-4 cm) gap between the inner vertical surface of the bearing pad and the mass of Foamglas under the tank floor. This gap extended at constant width through the top two layers and then decreased or disappeared in the bottom two

layers. The width of the gap corresponds to slightly more than the expected contraction of the bearing pad and slightly less than the expected contraction of the inner tank. It is our opinion that this gap is a result of the bearing pad contracting during cool-down causing the Foamglas blocks to be compacted. When the tank warmed up, the bearing pad expanded away from the Foamglas leaving the gap. This hypothesis ignores the thermal contraction and expansion of the Foamglas, but it should be noted that the Foamglas has a vertical temperature profile from -260°F (-162°C) to near ambient.

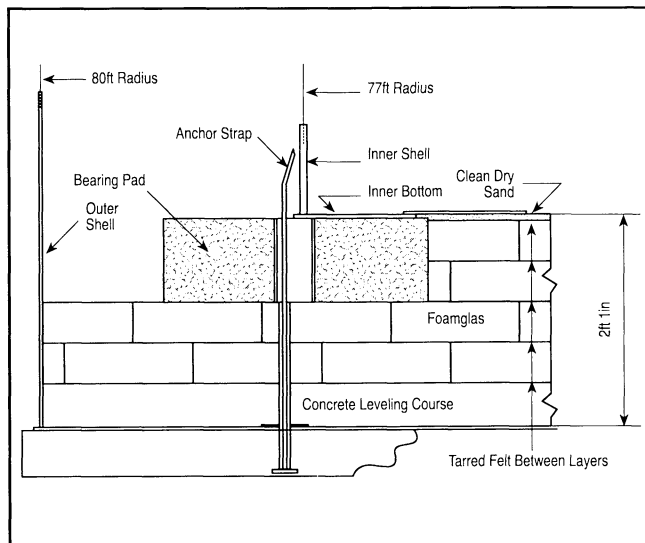
Figure 4 Tank T-80, Insulation Support

In the SDG&E T-80 tank, the Foamglas layers were separated by a tar impregnated felt layer. This apparently was generally effective in providing the load transfer between Foamglas layers, as this loss was found almost exclusively under the bearing pad. The drawings did not indicate that there should be tar impregnated felt under the bearing pad, although it was found in some places. A picture from the construction records taken before the bearing pad was poured shows the felt extending to the tie-down tubes, or about half way under the bearing pad. It is suggested that the direct contact of the concrete and possibly the radial relative motion of the bearing pad over the foam glass caused a combination of point loading and abrasion which resulted in crushing of the top of this layer of Foamglas. The loss of thickness in the Foamglas caused a slackening of the tie-down straps as manifested by gaps up to 1.25 in. (3 cm) between the locking bar on the upper end of the tie-down straps and the tie-down strap keepers.

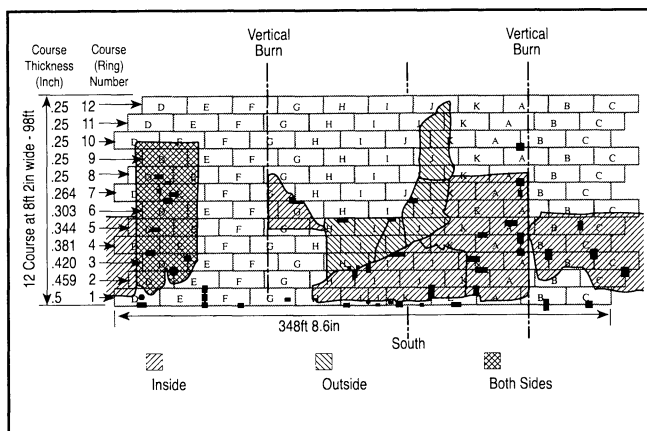
Figure 5 Tank T-1, Wall showing the individual plates from the floor to the knuckle. Cross-hatched sections show pieces removed from wall which were inspected by MRL.

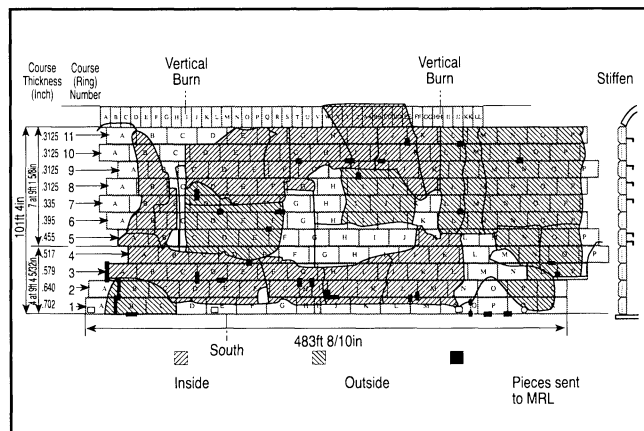
Figure 6 Tank T-80, Wall showing the individual plates from the floor to the knuckle. Cross-hatched sections show pieces removed from wall which were inspected by MRL.
