PROTECTING PUBLIC ART AGAINST CORROSION

L. H. Boulton¹ and E. Yuda²

¹Les Boulton & Associates Ltd, ²Artefacts Conservation Ltd

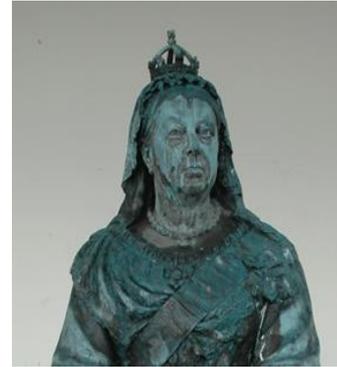
A description follows of the Queen Victoria bronze statue condition, after an assessment had been carried out by conservators (8). The sculpture showed severe corrosion of the bronze partially due to intricate detail and raised texture of the cast bronze surface. The bronze surface was covered with streaks, run-offs and disfiguring corrosion layers. Corrosion testing on the bronze confirmed the presence of localised chloride corrosion products, particularly *atacamite* $[\text{Cu}_2(\text{OH})_3\text{Cl}]$. The corrosion on the cast bronze was not uniform; there were heterogeneities present on the metal surfaces such as pores and boundaries between areas enriched with metallic inclusions (tin and zinc).

The imperfections on the bronze surfaces had become preferential sites for corrosion processes, e.g. pitting corrosion. From the exterior, it appeared that pitting and perforations had developed on the bronze particularly around the neck of the figure. Some years prior, the head of the figure had to be re-welded to the body along the neckline following an act of vandalism that decapitated the statue. If fragments of the iron casting armature or ferrous metal pins or bolts were still present in the interior of the cast bronze, there was the possibility of galvanic corrosion occurring. The granite pedestal and plinth on which the statue was displayed were in good condition, with some losses of the gold leaf inscription.

Figure 4. Queen Victoria statue showing extensive corrosion on the bronze surfaces.

1) *Remedial conservation treatment.* Once the statue had been removed to an indoor location (*Figures 3 and 4*) all of the bronze surfaces were closely inspected. It was necessary to assess the extent of remedial treatment and repairs required to address the disfiguring corrosion as well as any material losses and structural damage. Fortunately, inspection revealed that reconstruction of parts of the statue was not necessary other than minor brazing repairs around the neck area (*Figure 5*).

Conservation commenced with cleaning of the bronze surface to remove deposits and loose corrosion products. The initial treatment was followed by controlled mechanical and chemical removal of adherent corrosion products. The tools employed included abrasive pads, scalpels, peening with glass micro-beads, high pressure water washing, and chemical treatment using chelating agents and an acid. The objective during the remediation process was to achieve a cohesive surface layer of *cuprite* (Cu_2O) whilst preserving as much of the stable bronze patina as possible.

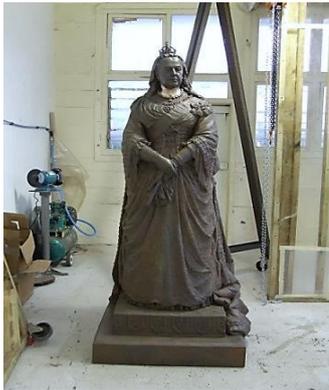
Figure 5. Bronze statue after treatment to remove corrosion. Repairs were made at the neck area.

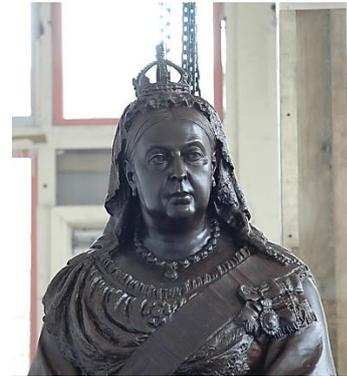
Figure 6. The bronze statue of Queen Victoria treated, patinated and waxed before re-installation.

2) *Repatination of the bronze.* Final repatination of the bronze statue was based upon documentation, aesthetic and functional aspects, in consultation with the conservators and public art and heritage personnel at Auckland Council.

3) *Application of a protective coating.* The final surface finish decided upon was hot application of microcrystalline wax comprising paraffin waxes. The temperature of the wax coating during application was kept in the range of 80°C to 100°C. Finally, a maintenance specification for the protective wax coating, particularly the ideal renewal time interval, was decided.

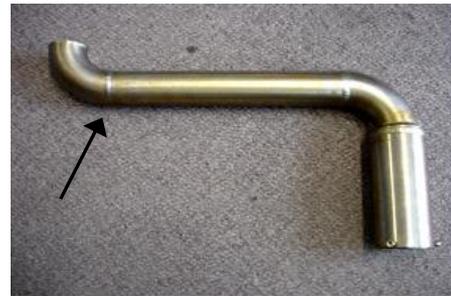
Not long after installation cracking occurred in a weld on the grade 316L stainless steel support arm for the pivoting wind sock on one of the kinetic sculptures. The sculptures were subjected to wind velocities of 100 km/hour or higher and vibrate vigorously in the wind. The stainless steel pipe cracked at a weld adjacent to a pipe elbow on the U-shape support arm. The weld at the other end of the elbow on the support arm also showed cracking (*Figure 8*).

The kinetic sculptures were also exposed to a severe marine environment as well as high wind loadings. Chlorides from windborne sea salt (i.e. marine aerosol) gained access inside the support arm pipe during service. The pipe weld showed some lack of penetration across the throat of the weld and there was heat tint present on the stainless steel around the internal root of the weld. Heat tinting on stainless steel welds is undesirable as it encourages corrosion to occur on welds exposed to a corrosive environment. The cracking in the pipe weld was found to be due to a mechanism called chloride-stress corrosion cracking (SCC). Residual tensile stresses from fit-up and welding had contributed to the SCC.

Figure 8. 316L stainless steel support pipe elbow on sculpture cone. Cracking occurred at pipe weld (arrowed).

Indications of fatigue were also observed on the stainless steel weld fracture face at high magnification in a scanning electron microscope (SEM). The cracking was likely assisted by fatigue due to cyclical loading on the sculpture support arm in wind. The cracking initiated at a notch at the root of the pipe weld where there was incomplete weld penetration. The notch and the presence of chlorides inside the stainless steel pipe arm supported an environmental cracking mechanism.

Designers generally know that grade 316L stainless steel is susceptible to stress corrosion cracking. Exposure of 316L stainless steel in a marine environment has to be managed through good design to ensure that cracking does not occur on vibrating parts. The lesson learned from this case was that when employing structural stainless steel components for modern outdoor sculptures an important feature prior to construction is to embrace good design including a welding procedure specification.

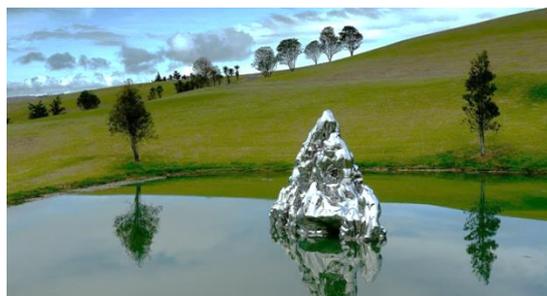
The floating sculpture was fabricated from an unknown grade of stainless steel. There had been historic corrosion issues on the chain that secured the floating artwork to the heavy cast steel mooring on the lake bed. The steel mooring chain had been replaced with stainless steel chain and a magnesium anode attached to the chain to halt the galvanic corrosion occurring. However, the connections of the chain to the submerged base of the sculpture continued to corrode.

Figure 9. Floating stainless steel sculpture moored in a fresh water lake at a sculpture park.

A sample of corrosion product from the submerged base component was submitted to X-ray analysis (EDS) in a scanning electron microscope, to identify the alloy employed for the connection. The analysis results indicated that the stainless steel component had undergone corrosion in the lake water. The grade of stainless steel employed appeared to be a free-machining ferritic stainless steel that contains a high sulphur addition. The grade of ferritic stainless steel employed for the base connection showed inadequate corrosion resistance submerged in the lake water. Free-machining grades of stainless steel have low corrosion resistance when exposed in a corrosive environment.

A higher grade stainless steel was required for the sculpture base component. The stainless steel employed for the sculpture base components and the mooring chain needed to be the same grade of stainless steel to avoid galvanic corrosion, that is, dissimilar metal corrosion between carbon steel and stainless steel. The use of an anode to provide cathodic protection to the steel mooring chain was unnecessary if the sculpture mooring connection components were all made from the same stainless steel alloy. Selection of grade 316L stainless steel was an appropriate choice for the component to attach the floating stainless steel sculpture base to the heavy cast steel mooring on the lake bed.

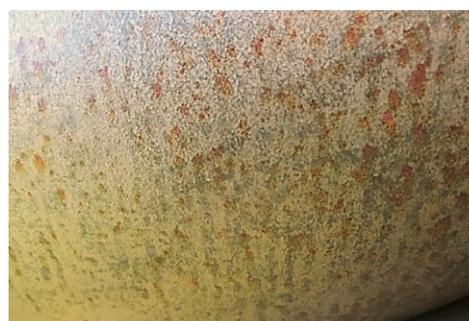
Figure 10 shows the honey-gold colour on a cast test piece of the silicon bronze. For a various reasons, the polished surface of the bronze sculpture had not been cleaned and coated with wax annually, as part of a maintenance plan. Wax is applied onto the bronze surfaces to stop the metal from coming into contact with an aggressive *marine aerosol* that prevails over the Auckland isthmus.

Examination of the red-brown spots and streaks on the polished bronze surfaces confirmed that the deterioration of the bronze surface was likely due to contamination by minute particles of iron embedded in the bronze surface during the casting process. Alternatively, the surface contamination occurred when the castings were cleaned by shot-blasting at the foundry. The embedded iron particles had undergone galvanic corrosion in contact with the bronze on the sculpture surface. Iron oxide (red rust) was produced and the corrosion products weeped under gravity from spots on the bronze surface producing streaks that were aesthetically unpleasant.

Figure 11. Rust spots and streaks that developed on the polished surfaces of the silicon bronze sculpture.

Initially the bronze sculpture should be cleaned and mildly blasted (walnut shell) to remove any surface residues and corrosion products. After blasting the sculpture should be cleaned immediately with non-ionic detergent solution and rinsed with clean water to remove the detergent residues. Following water rinsing the sculpture surfaces should be cleaned with a solvent (e.g. white spirits) to remove the last traces of any surface residues off the bronze surfaces.

A full even coat of *Incralac* should be sprayed onto the cleaned sculpture surfaces. The applicator should follow the recommendations of the manufacturer for the application and drying time of the *Incralac* coating. Once the *Incralac* coating has fully cured, apply two cold coats of microcrystalline wax. The first wax coating should be lightly buffed with soft cotton pads before the second wax coating is applied. The second wax coating should be gently buffed after application.

The application of a new wax coating should be undertaken annually as a protective coating on *Incralac*. The waxing is necessary to ensure that the prevailing marine atmosphere does not cause deterioration of the acrylic coating on the bronze. During maintenance and re-waxing of the sculpture it is important to ensure that the wax coating on the sculpture is not cleaned with a solvent. Solvents can have a deleterious effect on an *Incralac* coating. The wax-coated bronze sculpture surface should be periodically washed with clean water to remove any surface contaminants.

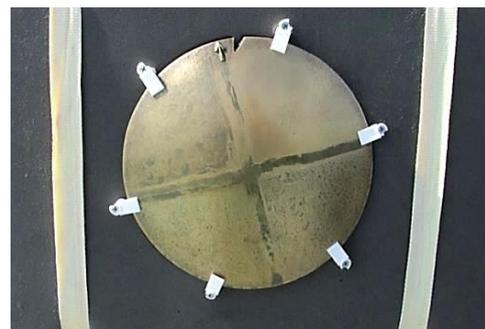
Figure 15. The bronze disc after exposure to a severe marine environment for 3 months.

After the examination, the segment on the bronze disc that performed best with least surface corrosion on the polished bronze surface was Sample B, the *Incralac* coating with two additional coats of wax. The second best surface treatment, with slight corrosion occurring on the bronze surface, was Sample C, *Fishoilene*. The remaining two treatments had the highest surface corrosion on the polished bronze, and corrosion performance results about the same, namely Samples A and D coated with microcrystalline wax plus BTA.
