GUIDELINES FOR THE USE OF COPPER ALLOYS IN SEAWATER

NiDI
NICKEL
DEVELOPMENT
INSTITUTE

COPPER
DEVELOPMENT
ASSOCIATION

ARTHUR H. TUTHILL

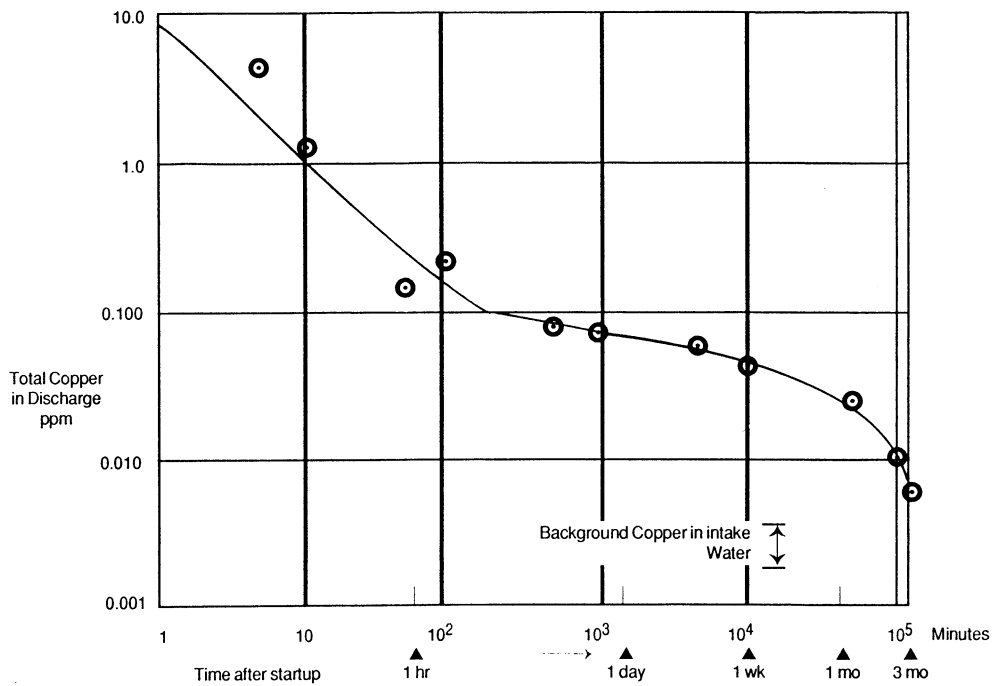
rate of film formation is indicated as the rate of copper reduction in the effluent (Figure 1). Total copper decreases tenfold within 10 min and 100-fold in the first hour. In three months, copper in the effluent is seen to be virtually at the level of the copper in the intake water.

FIGURE 1—Formation rate of corrosion product film on Alloy C70600 in seawater.

1. The initial unfiled corrosion rate of copper alloys in seawater decreases ~100 times in the first hour of exposure at 60 F (16 C) and continues to decrease during the first several years of exposure.

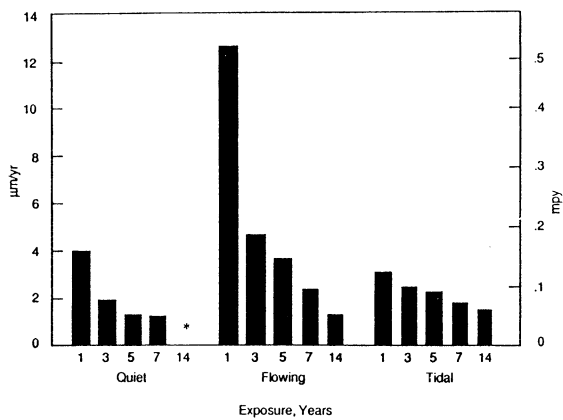
Weight loss corrosion studies show that the protective film continues to improve, with the corrosion rate dropping to 0.5 mpy (0.012 mm/y) in ~1 y, and a long-term, steady-state rate of ~0.05 mpy (0.001 mm/y) in 3 to 7 y in quiet, tidal, and flowing seawater (Figure 2).² Alloy C71500 (70:30 copper-nickel) exhibits the same pattern of decreasing corrosion rate with time.

FIGURE 2—Corrosion rates for Alloy C70600 for long-term seawater exposures.

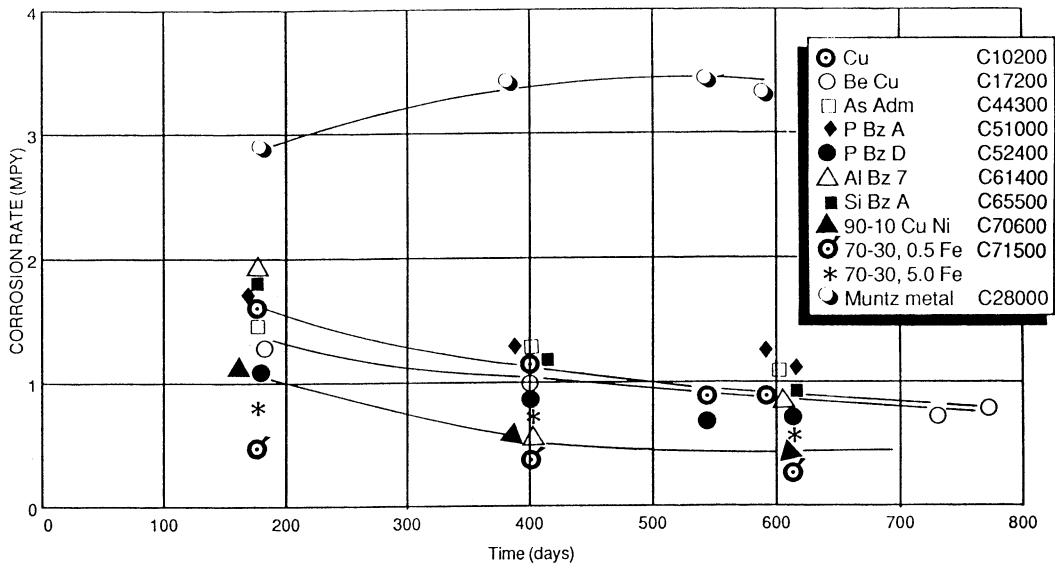
Reinhart found that copper and its alloys of aluminum, silicon, tin, beryllium, and nickel had significantly lower long-term corrosion rates after 18 months compared to those specimens measured after only 6 months of exposure to seawater (Figure 3).³ The only exception was Alloy C28000, Muntz metal, which exhibited a slightly higher corrosion rate after 18 months as compared to 6 months. Alloy C44300, Admiralty, was in the group characterized by a decreasing corrosion rate with time. The long-term, steady-state corrosion rate for copper and copper alloys, except for Muntz metal, is on the order of 1 mpy (0.025 mm/y) or less, and for the copper-nickel alloys on the order of 0.05 mpy (0.001 mm/y), within those velocities that each alloy can tolerate without damage to the protective corrosion product film.

FIGURE 3—Corrosion rates for copper alloys for up to 800-day seawater exposures.

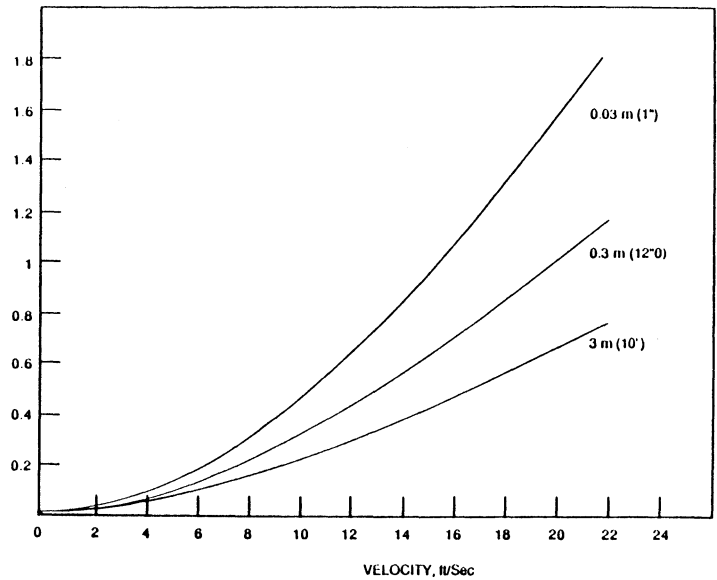
Efird studied and estimated the critical shear stress for C12200, C68700, C70600, C71500, and C72200 (Table 2).⁴ Figure 4 shows how the critical shear stress varies with velocity and pipe (or tube) diameter. The shear stress in 1-in. (25-mm) diameter pipe at 10 fps (3 m/s) is no greater than that in 12-in. (305-mm) diameter pipe at 12 fps (3.7 m/s) or that in 10-ft (3-m) diameter pipe at 16 fps (4.9 m/s). As the diameter increases, copper-base alloys will tolerate higher nominal velocities in the piping system.

FIGURE 4—Variation in shear stress between the flowing seawater and metal wall with the nominal velocity in the pipe and diameter of the pipe.

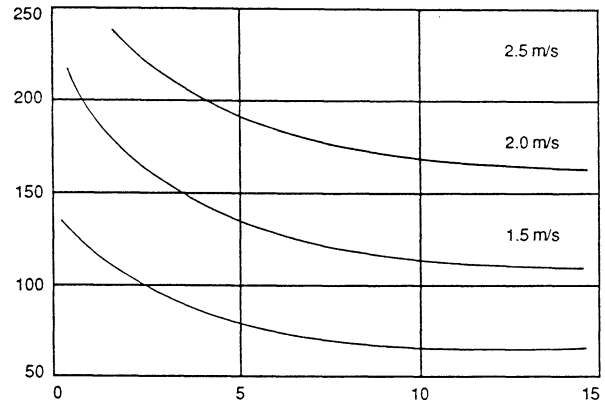
Sato and Nagata showed that the shear stress at the inlet end of a condenser tube is about double that further down the tube (Figure

5).⁵ These data explain why inlet-end erosion/corrosion is such a common occurrence and also explain the preference for the copper-nickel that have been developed because of their greater velocity tolerance. Sato and Nagata also showed that water velocity passing a partial obstruction in the bore of a condenser tube can reach 26 fps (8 m/s), even though the overall velocity remains in the normal 6.6 fps (2 m/s) range. This explains the occurrence of tube failures downstream of lodgements in condenser tubes when using debris-laden water.

FIGURE 5—Variation of shear stress between the flowing seawater and metal wall with the distance from the inlet end.

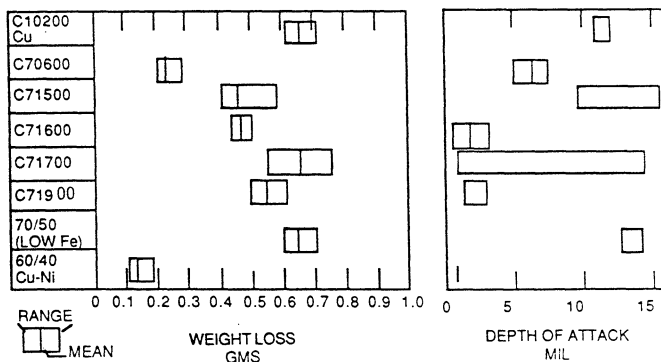
FIGURE 6—Weight loss and depth of attack on copper alloys in BNMRA jet impingement tests.

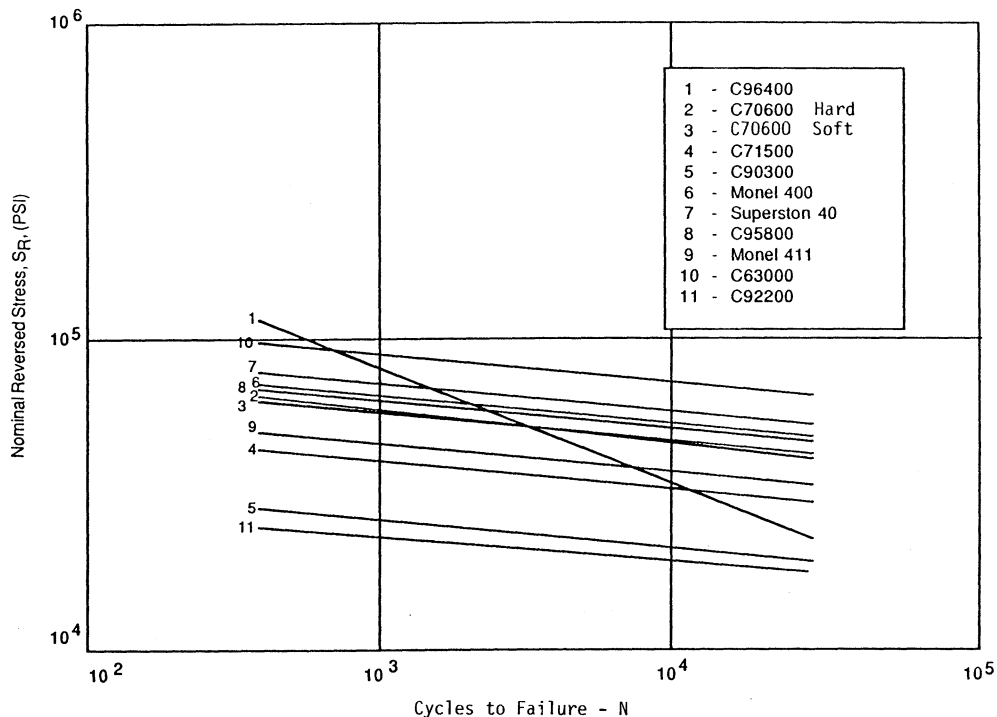
FIGURE 7—Low-cycle fatigue of nonferrous alloys.

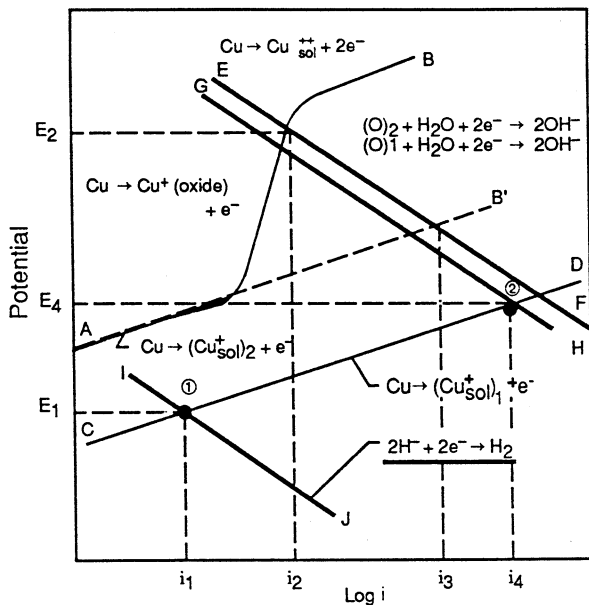
Syrett noted that sulfides in saline waters are not particularly detrimental to copper alloys unless dissolved oxygen is also present or unless exposure to oxygen-free, sulfide-polluted waters is followed by exposure to aerated, unpolluted waters. The author found that in the complete absence of oxygen, corrosion rates remained low up to sulfide concentrations as high as 55 g/m³ and at flow velocities up to 5 m/s. The corrosion rate remains low in the absence of oxygen, despite the more active potential, since the only cathodic reaction is hydrogen reduction (Point 1, Figure 8). In polluted waters with both oxygen and sulfide present, the cathodic reaction reverts to oxygen reduction with a much higher corrosion rate, as indicated by the large increase in current despite the more noble potential (Point 2, Figure 8). The potential at Point 2 is somewhat below that at which a stable cuprous oxide film can form, thus permitting the high corrosion rate to persist until either the oxygen or sulfide is consumed in the corrosion process.

FIGURE 8—Influence of sulfide and oxygen on the corrosion current in a copper-nickel alloy exposed to flowing seawater.

Syrett also showed that the typical black sulfide film that forms during exposure to sulfide-polluted seawater will eventually be replaced by a normal oxide film when the sulfide-polluted seawater is replaced by clean, aerated seawater. However, substantially higher corrosion rates persist for some time during the transition period. These conditions commonly arise when vessels are fitted out in polluted harbors and later operate in the open sea. Experience indicates that once the vessel begins regular operation, the normal

protective film forms and persists during subsequent harbor visits. Syrett found that the normal protective film replaced the sulfide film in ~9 days.

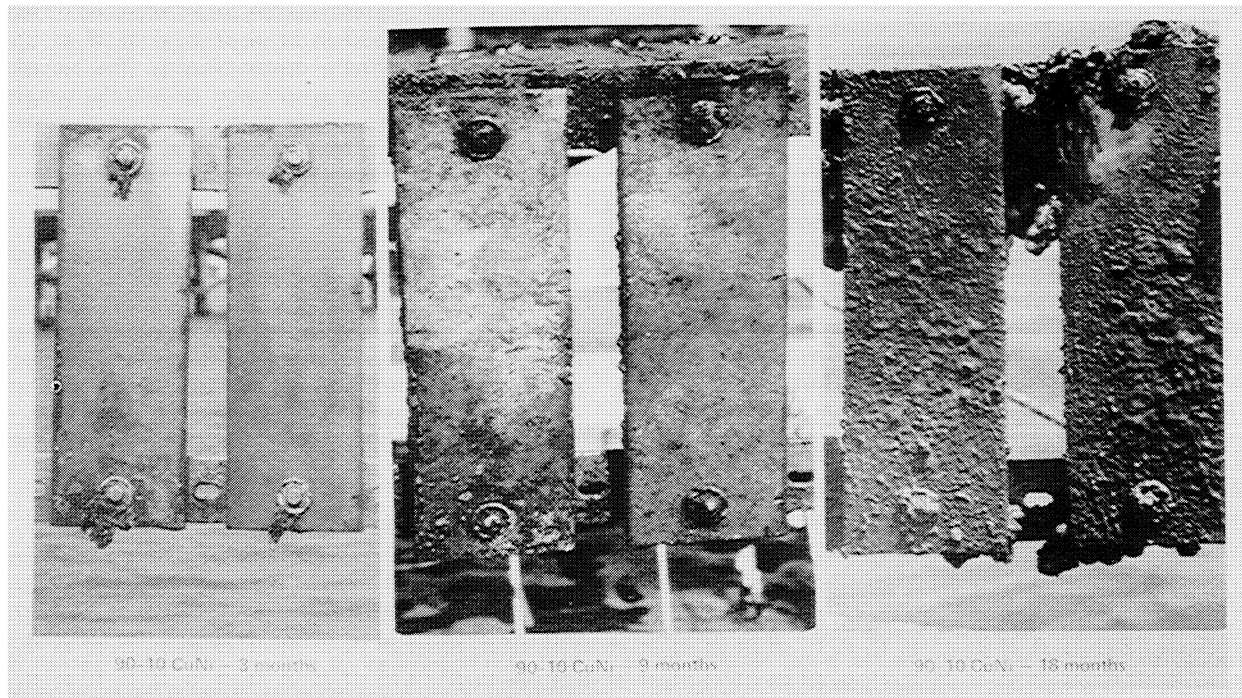
FIGURE 9—Progression of biofouling from 3 to 18 months on Alloy C70600 in seawater.

The normal condition of copper alloy surfaces in seawater is illustrated by the clean condition of the C70600 hull of the copper mariner after 52 months of sea time, as shown in Figure 10. A few pin head-size barnacles have been able to attach, but most have been removed by wave action underway. Those remaining could be removed easily by finger pressure. Operation had kept the hull almost as clean and smooth as it was originally. It is both the inherent resistance to biofouler attachment and the poor adherence of the occasional biofouler able to attach that made copper so useful as hull sheathing for sailing vessels and copper-nickel so useful for the piping, water boxes, and other components of marine cooling water systems.

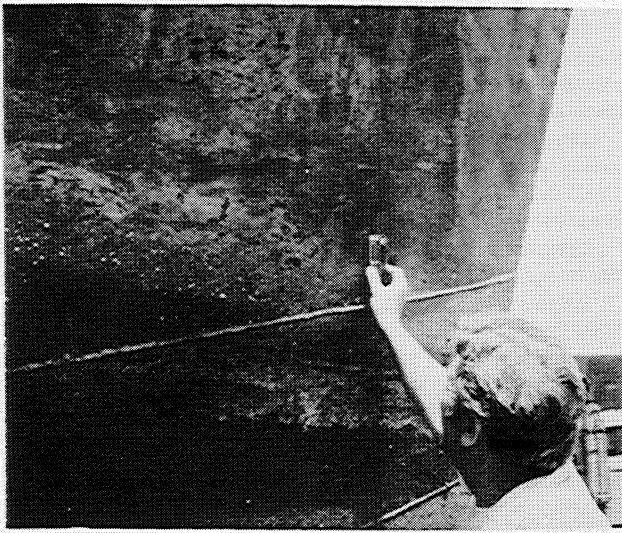
FIGURE 10—Small barnacles at the waterline on the bow area of Copper Mariner after 52 months of sea time.

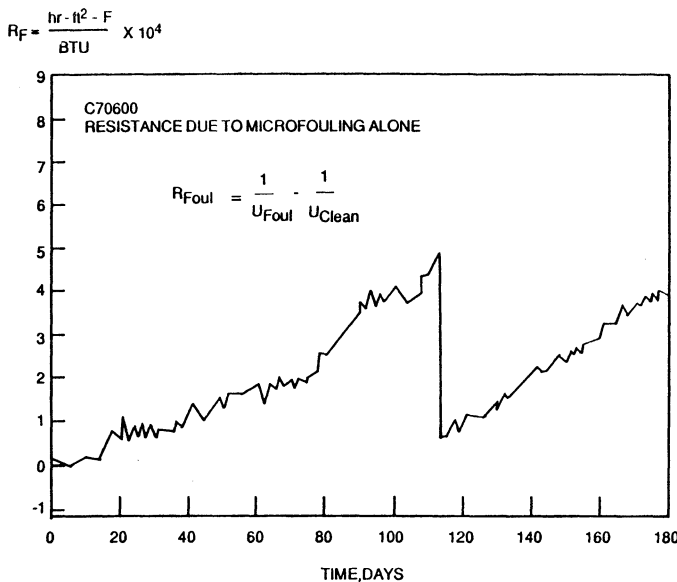
FIGURE 11—Resistance of Alloy C70600 to heat transfer resulting from the growth of a microfouling film on the inside wall of tube in clean seawater.

Copper alloys are also resistant to the microfouling that occurs within condenser and heat exchanger tubing. Lewis measured the time required for microfouling to significantly reduce the heat transfer of C70600 tubing in clean seawater at 6 to 8 fps (1.8 to 2.4 m/s) over a 180-day period (Figure 11).¹⁴ While not immune to microfouling, the indicated 90- to 110-day interval between cleaning for C70600 is an order of magnitude greater than the 10-day cleaning interval found necessary for other than copper alloy condenser tubing in this study.

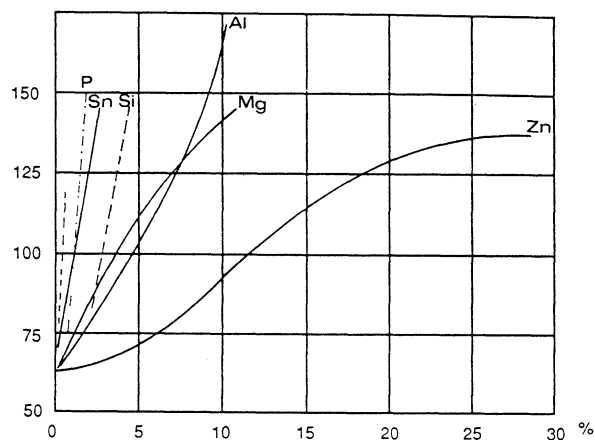
FIGURE 12—Resistance to seizing at 150 C as a function of alloying elements.

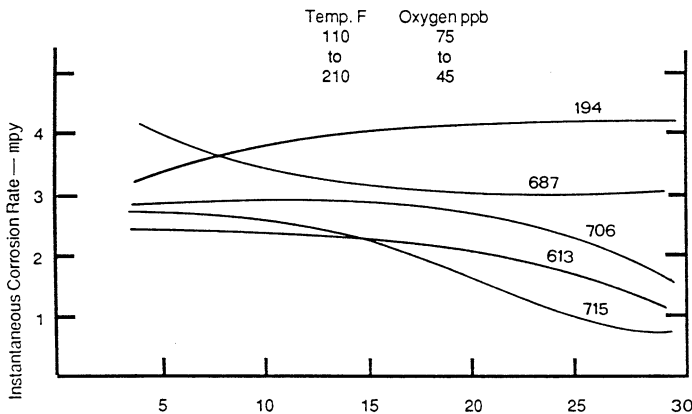
FIGURE 13—Variation in corrosion rate for copper alloys from 5 to 30 months in the heat recovery section of an experimental desalination plant.

After deaeration, the seawater is fed through tubing in the heat recovery section, where it is gradually heated in a series of stages to either 180 F (82 C) in the plants using polyphosphates or 220 to 230 F (104 to 110 C) in the plants using acid or chemical additives. This section of the plant requires ~87% of the total tubing. Oxygen contents range from 20 to 100 ppb, and corrosion rates are low. Alloys C68700 and C70600 are used in the heat recovery section of the plant with outstanding success. Figure 13 illustrates the continuing downward trend of the corrosion rate of Alloy C70600 with time as compared to the more constant corrosion rate of C68700.²⁰ The tendency for the corrosion rate of Alloy C70600 to decrease with time as it does in seawater partly accounts for its increasing preference for use in the heat recovery section.

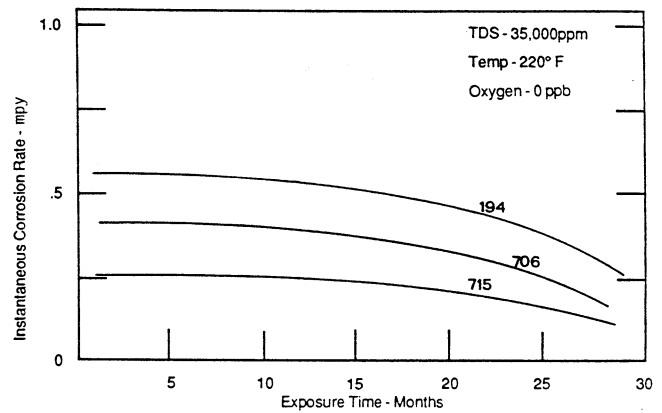
FIGURE 14—Variation in corrosion rate for copper alloys from 5 to 30 months in the brine heater section of an experimental desalination plant.

protective film and possibly some metal are lost. For this reason, somewhat heavier-wall 16-gage tubing is preferred in the brine heater. Figure 14 shows the same decreasing corrosion rate with time for C19400, C70600, and C71500 under brine heater service conditions that characterized C70600, C71500, and C61300 under heat recovery service conditions.²⁰ Although both C70600 and C71500 are used in brine heater service successfully, Alloy C71500 seems to be preferred.

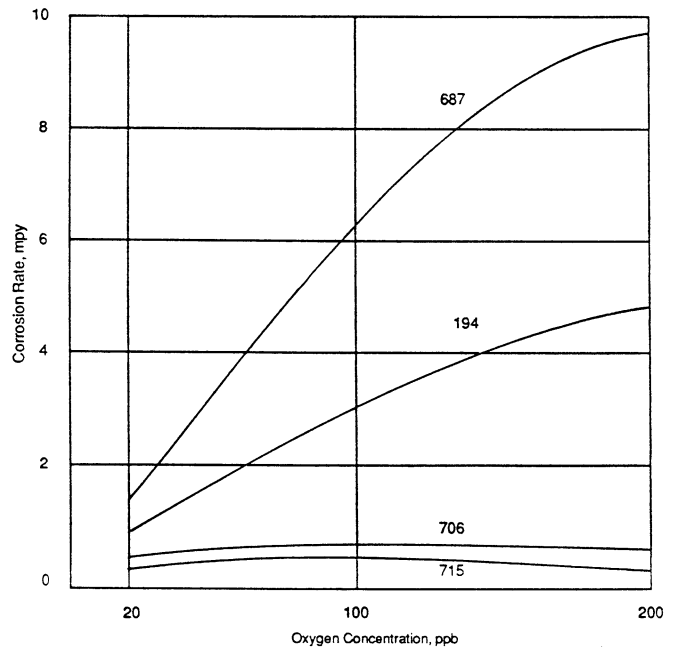
FIGURE 15—Corrosion rate as a function of low oxygen concentrations at 220 F (104 C) in an experimental desalination plant.

Oxygen content affects copper alloys differently, as shown in Figure 15.²⁰ The corrosion rates of C70600 and C71500 remain low in the 20 to 200 ppb oxygen range, whereas those of C68700 and C19400 increase significantly as oxygen content increases. The lower rates maintained by C70600 and C71500 account for the preference of these alloys in desalination applications.
