Successful Stainless Swimming Pool Design

by Catherine Houska, CSI and James Fritz, Ph.D
(Extracted from Construction Specifier Magazine, December 2005)

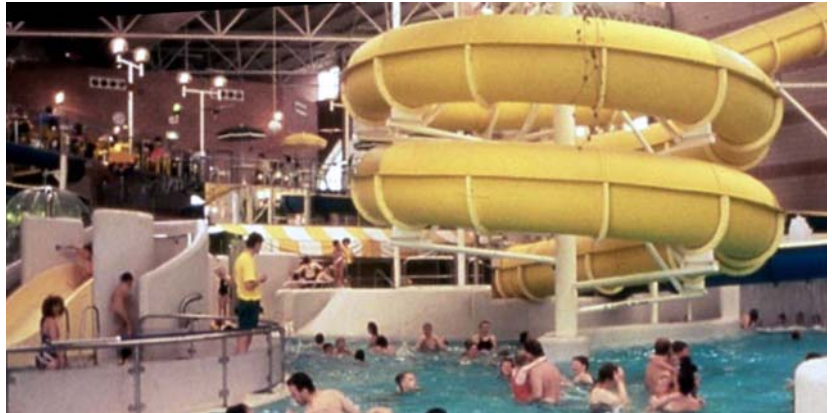
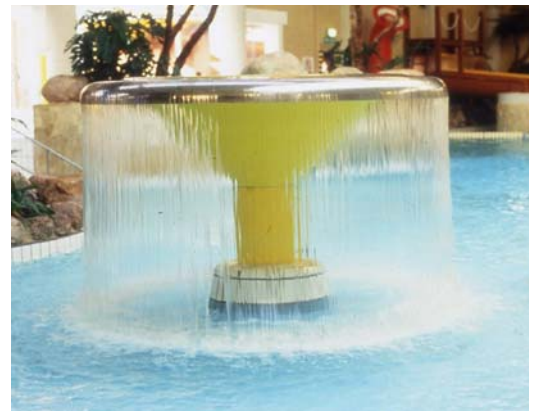
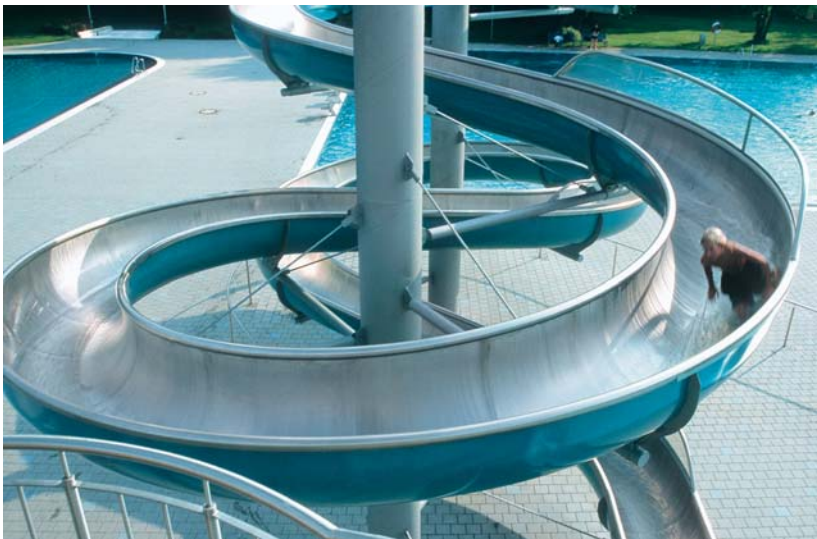
Figure 1

Figures 1, 2 and 3: Stainless steel swimming pool slide and water feature.

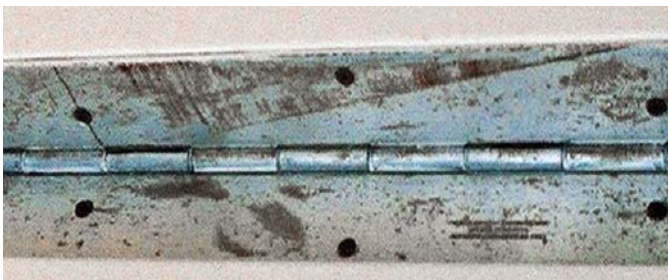
Figure 5: Carbon steel brushes were used by a cleaning contractor on this stainless steel door hinge that was installed beside an indoor swimming pool. The areas with carbon steel contamination are rusting. Photo courtesy of TMR Consulting

Poor maintenance and the use of inappropriate cleaning compounds can be another factor in corrosion performance. Carbon steel wool and wire brushes should never be used for cleaning or 'refinishing' stainless steel since particles can become embedded in the surface. These carbon steel particles corrode at the same rate as unprotected carbon steel and cause unsightly surface damage.

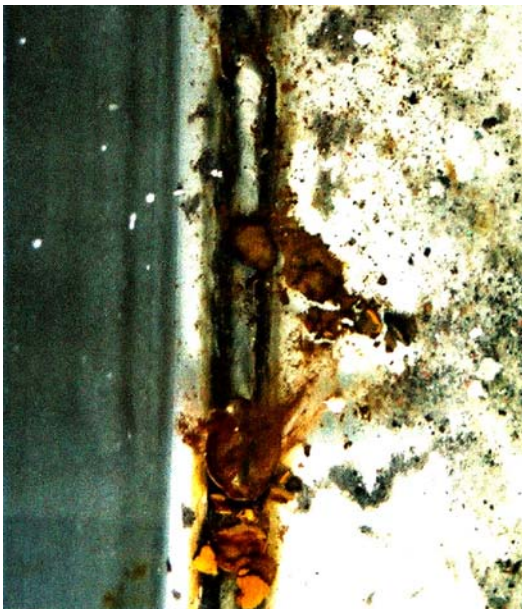
Figure 6: This weld within a swimming pool gutter was not cleaned properly and pitting corrosion is occurring along the weld seam. Photo courtesy of TMR Consulting

In cases where stainless steel components have welded joints, the welds should provide the same level of corrosion performance as the surrounding metal. Therefore, corrosion on and around welded stainless steel joints is unacceptable. Grinding and pickling joints is the best means of restoring a weld's corrosion resistance.

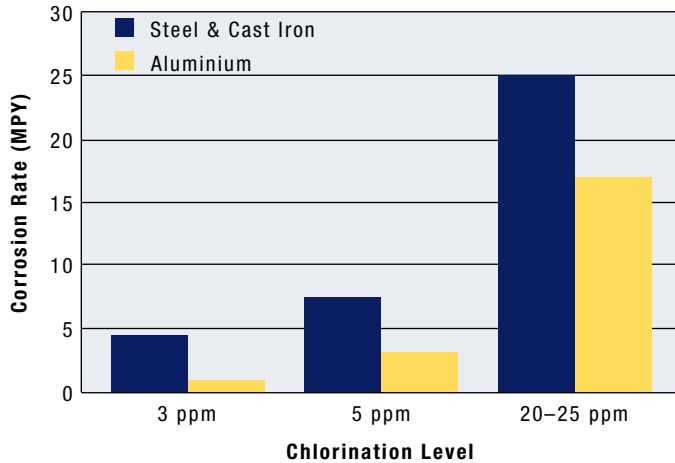
Figure 7: Carbon steel, cast iron, aluminum and stainless steel alloys were tested at three different chlorination levels and the average rate of metal loss determined in mils per year (mpy). The general corrosion rate of type 304 and 316 stainless steel was so low (<0.1 mpy) at all chlorination levels that it could not be graphed.

Various aluminum (e.g. 1100, 3003, and 6061), cast iron, carbon steel, and stainless steel alloys were exposed to 3- and to 5-ppm chlorinated water for 250 days and to 20- to 25-ppm chlorinated water for 32 days. Aluminum had low corrosion rates up to 2 ppm of chloride, but, above this level, corrosion increased with rising chloride levels. The relatively linear, rapid increase in aluminum, carbon steel, and cast iron corrosion rates with increasing chlorination levels is shown in Figure 6. The stainless steels (Types 304, 316) that were tested had insignificant general corrosion rates (<0.1 mpy) at all chlorination levels and are therefore not shown on the graph. Even during the 32-day exposure at 20 to 25 ppm chlorine, there was no general or pitting corrosion of either Type 304 or 316 stainless steel.²

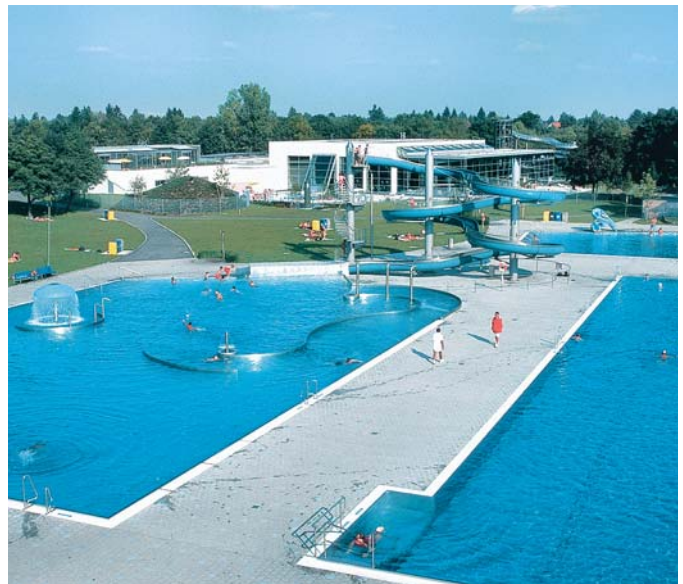
Figure 8: This swimming pool in Munich, Germany was relined with Type 316 stainless steel panels that were welded together. Photo courtesy of Martina Helzel

Bare Type 316 stainless steel has been used for pool linings, particularly in Europe.⁸ In relining applications, stainless steel has replaced plastic and ceramic tiles, while in new pools, self-supporting structures composed of stainless steel sheet and structural framing are typically used for water depths up to about 2 m (6.5 ft). Deeper pools typically require a secondary support structure or heavier wall panels due to water pressure loads. The stainless steel panels are welded together, producing a watertight structure, and the seams are pickled to restore corrosion resistance. Pool lane markings can be applied in advance using electrochemical coloring, which eliminates maintenance painting.

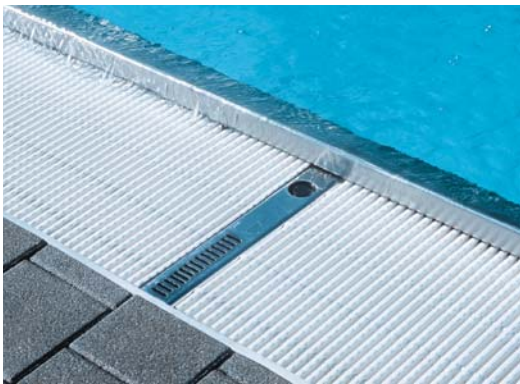
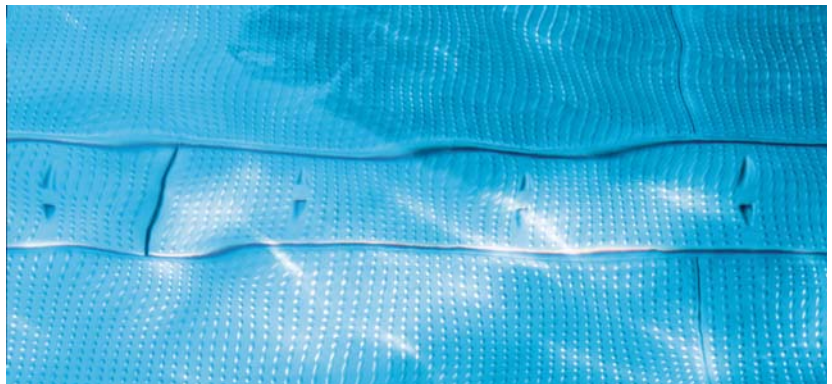
Figure 10 and 11: Type 316 pool gutters and water jet openings in the floor plates. Photos courtesy of Martina Helzel

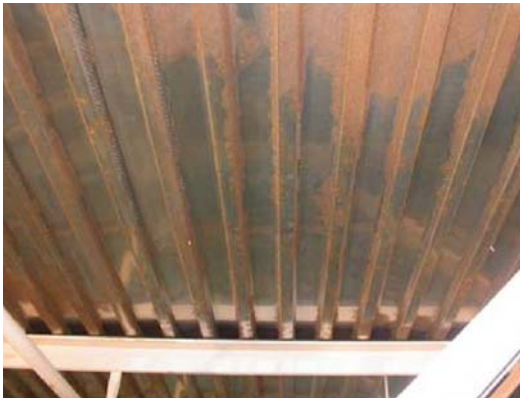
Figure 12: Corrosion of a Type 304 stainless steel roof deck above an indoor swimming pool.
Photo courtesy TMR Consulting

SCC is a concern in load-bearing applications that are not splashed with pool water or cleaned, such as ceiling hangers, fasteners, brackets, supports, bolts, wires, cables, and hooks. Figures 12 and 13 depict an example of SCC attack. This North American Type 304 stainless steel natatorium roof deck was never inspected or cleaned. After a decade of exposure, there was significant brown staining on the roof panels above the diving platforms. Samples were removed from the roof deck and close examination revealed shallow pitting and extensive cracking with some fissures penetrating 80 percent of the cross-section. This cracking resulted because of the following factors:

- The stainless steel was susceptible to SCC.
- There were relatively high residual stresses from the cold working the roof panels and high roof service stress loads, particularly with winter snow loads.
- There was no cleaning to remove the accumulation of aggressive chloride compounds.
- It was a poorly controlled pool environment.
