25th ANNUAL CONFERENCE OF METALLURGISTS - 1986

H₂O: Nickel's Contribution to Distilled Water, Dams, and Condensers

Arthur H. Tuthill, P.E.

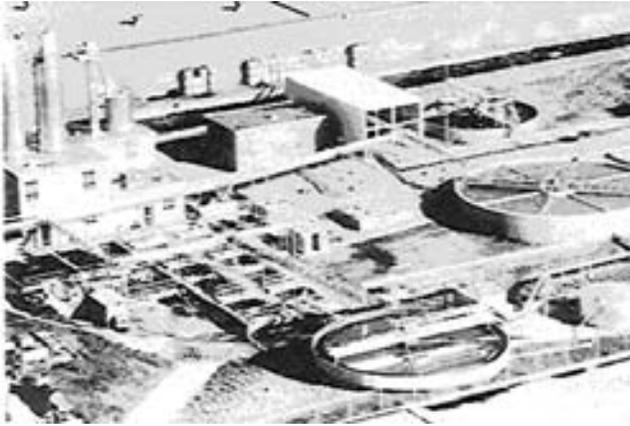
Figure 6: Municipal waste treatment plant

Figure 6 is an aerial view of a modern municipal waste treatment plant. About 1970, waste treatment plants upgraded from galvanized and coated carbon steel to stainless steel, especially in the extensive aeration piping systems these plants use.

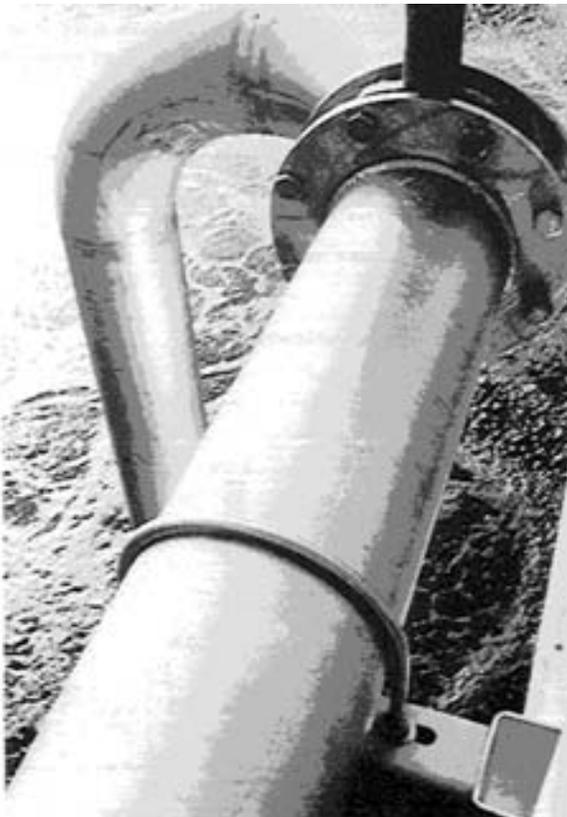
Figure 7: Type 304 aeration header

Figure 7 shows a Type 304 12-inch aeration pipe conducting air to the Type 304 distribution piping and nozzles shown in *Figure 8*.

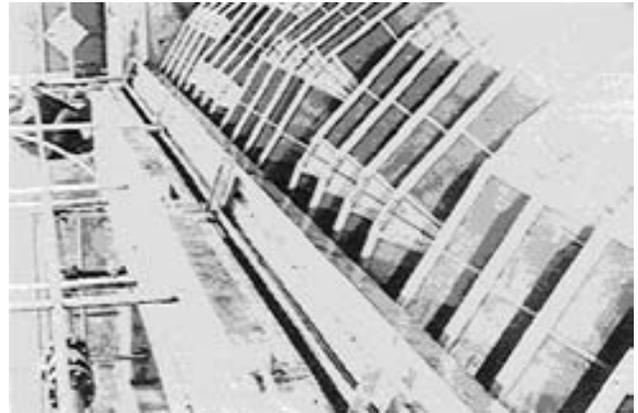
Figure 9 shows a Type 304 microstrainer built and installed in a Chicago area treatment plant.

Figure 9: Microstrainer 12 ft. x 30 ft., Type 304 with 0.002-inch Type 316 woven wire cloth

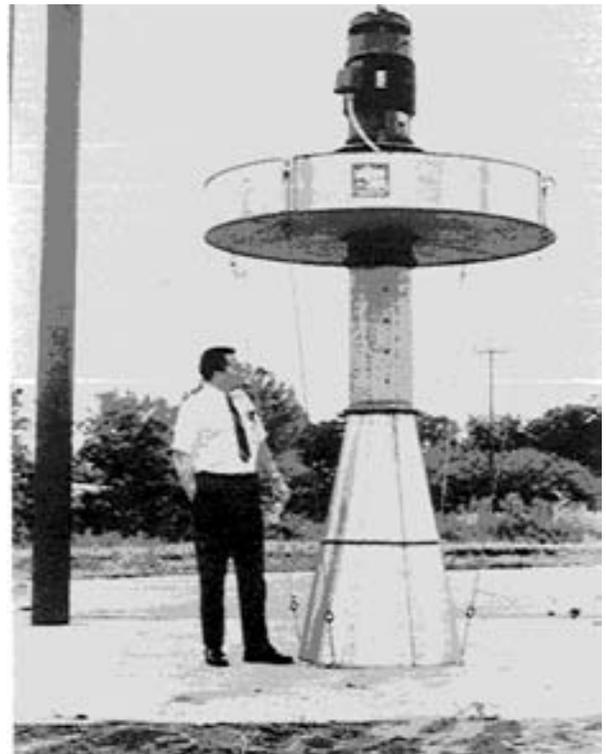
Figure 10: Type 304 floating aeration pump

Figure 10 is a Type 304 floating aeration pump for open basin aeration.

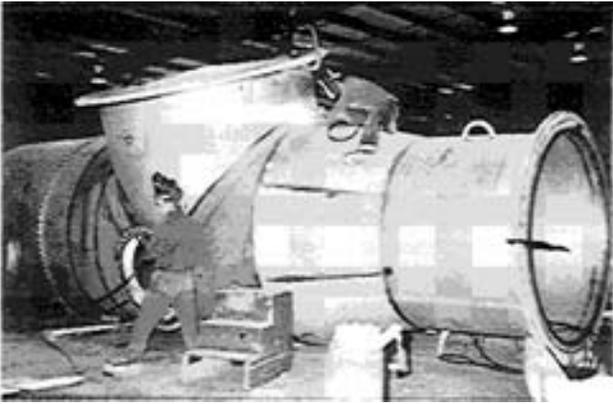
Figure 11: Type 304 water manifold waste water treatment plant.

Figure 11 is a large water manifold for a plant being fabricated in Brismet's Bristol, TN, shop. Since 1970, both Type 304 and Type 304L, as welded piping and tankage, have proved to be quite successful in the wide variety of waters in this kind of plant in the United States.
