The resistance of stainless steel, partly embedded in concrete, to corrosion by seawater

by G.N. Flint & R.N. Cox

NiDI Technical Series N° 10 022

Reprinted from:
Magazine of Concrete Research
Volume 40, Number 142, March 1988

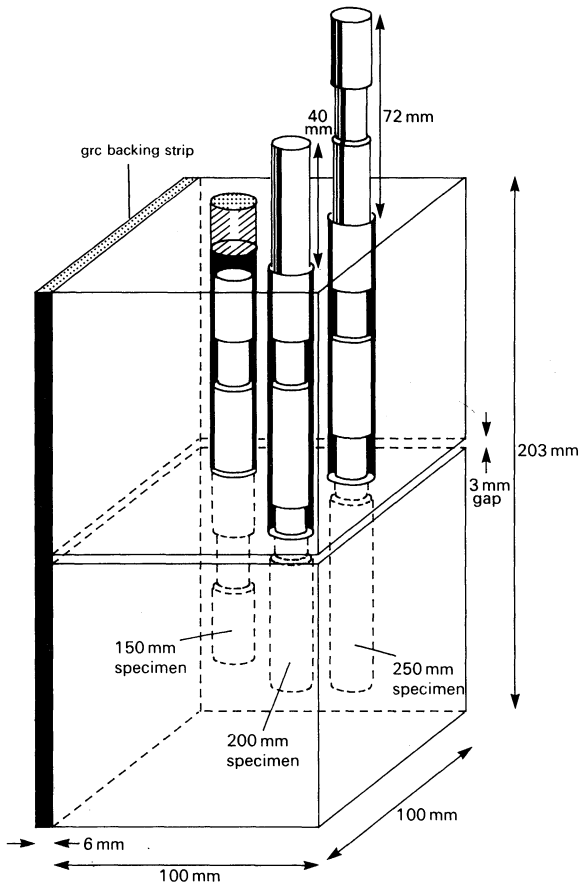
Figure 1: Schematic diagram of concrete blocks showing position of glass-fibre-reinforced cement backing strip and steel specimens.

sile test specimens were embedded in the lower cube and passed into or through the upper cube with a 1.5 mm gap around them, see Figures 1 and 2. The gap around the bars in the upper cube was formed by means of a steel sleeve which was withdrawn after casting.

The selected test specimen consisted of a dual concrete block composed of two 100 mm cubes, 3 mm apart, each supported along one face by a 6 mm thick sheet of glass-fibre-reinforced cement (grc). Three steel ten-

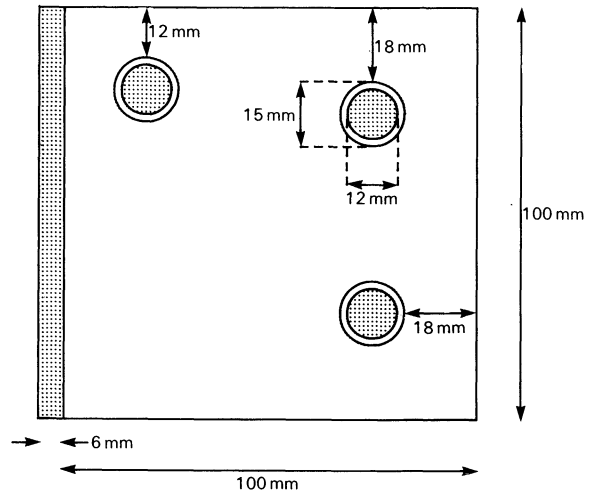
Figure 2: Horizontal section through upper concrete block.

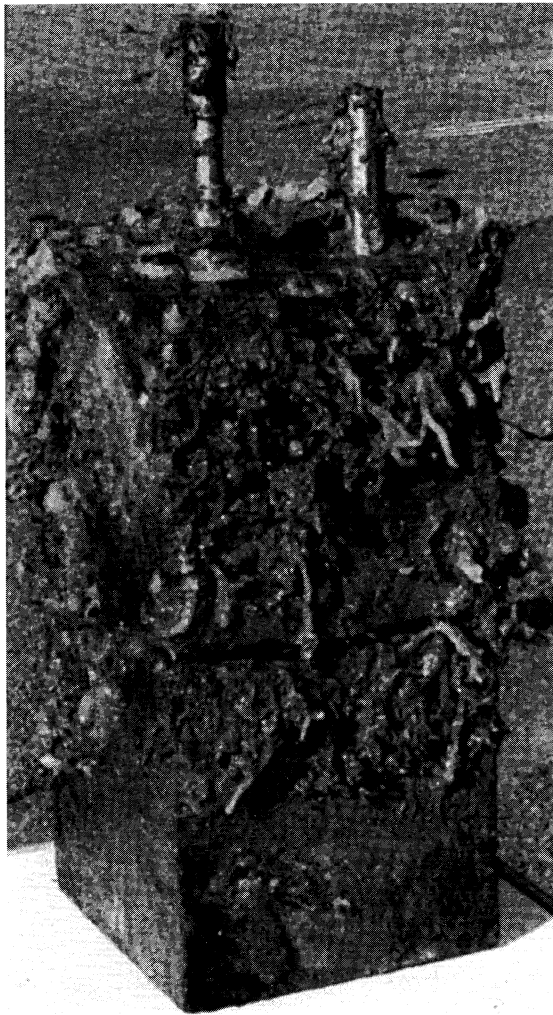
Figure 3: SRPC concrete blocks after 12½ years continuous exposure to seawater.

The appearance of the block made from SRPC concrete immediately after it was removed from the raft is shown in Figure 3. The OPC concrete block was similar. The appearance of the stainless steel specimens after removal from the upper block and cleaning in running water is shown in Figure 4. The specimens from both SRPC and OPC concrete showed rust staining but with one exception had suffered surprisingly little attack after over 12 years immersion in seawater, as is evident from their appearance after brushing and acid treatment (Figures 9 and 10).

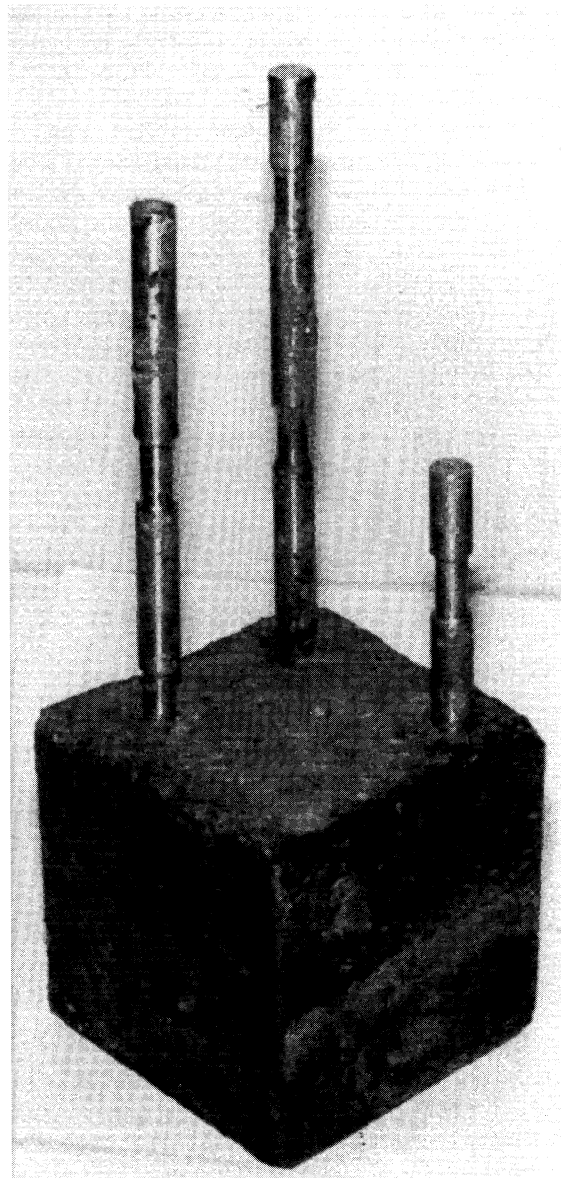
Figure 4: Type 316 stainless steel specimens after removal of upper block of SRPC concrete following 12½ years continuous exposure to seawater and cleaning in running tap water.

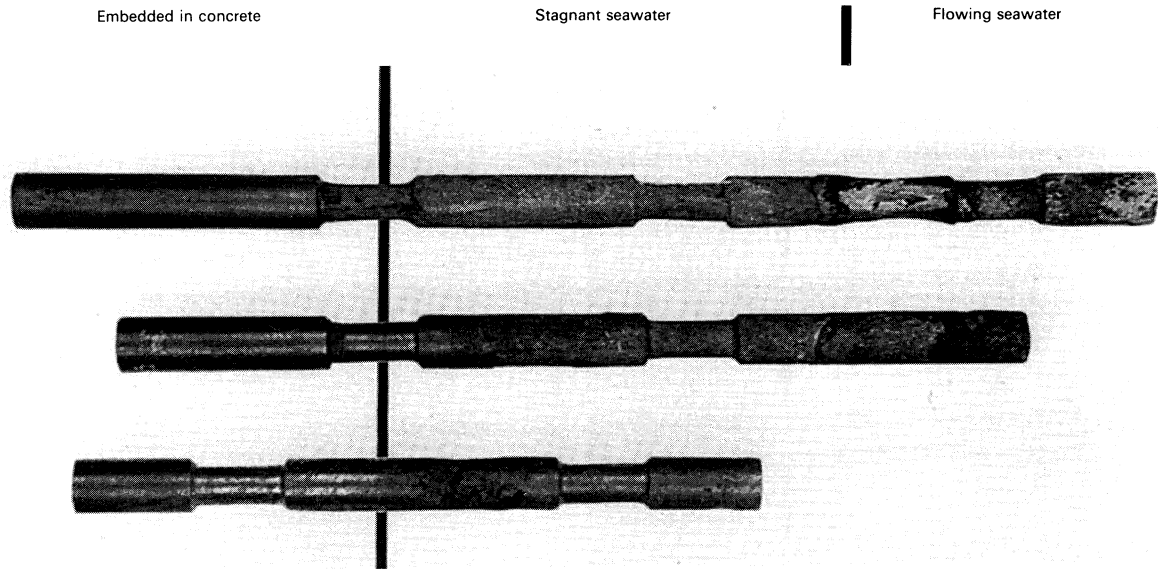
Figure 5: Mild steel specimens from SRPC concrete, 7 years intermittent immersion at tidal site, after mild cleaning.

A more detailed examination was made after exposure for approximately 7 years. The results of visual examination and measurements of the corroded area and depth of attack on the mild steel specimens are given in Tables 9 and 10. Their appearance is shown in Figures 5 and 6. The more severe corrosive attack on the 250 mm specimens is obvious, and so is the overall, more severe corrosion of the specimens at the tidal site. However, a locally intense attack on the 3 mm gap area on the 250 mm specimens at the raft site is evident in Figure 6 and is reflected in the tensile test results (Table 3).

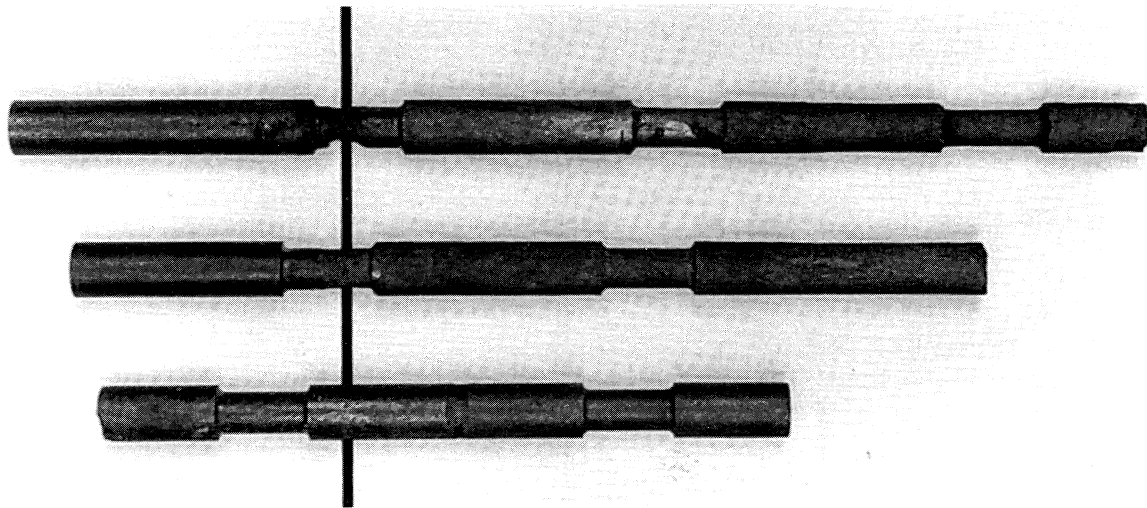
Figure 6: Mild steel specimens from SRPC concrete, 7 years continuous immersion at raft site, after mild cleaning.

Of all the mild steel specimens tested, this specimen had the greatest area and depth of corrosive attack in the section embedded in concrete.

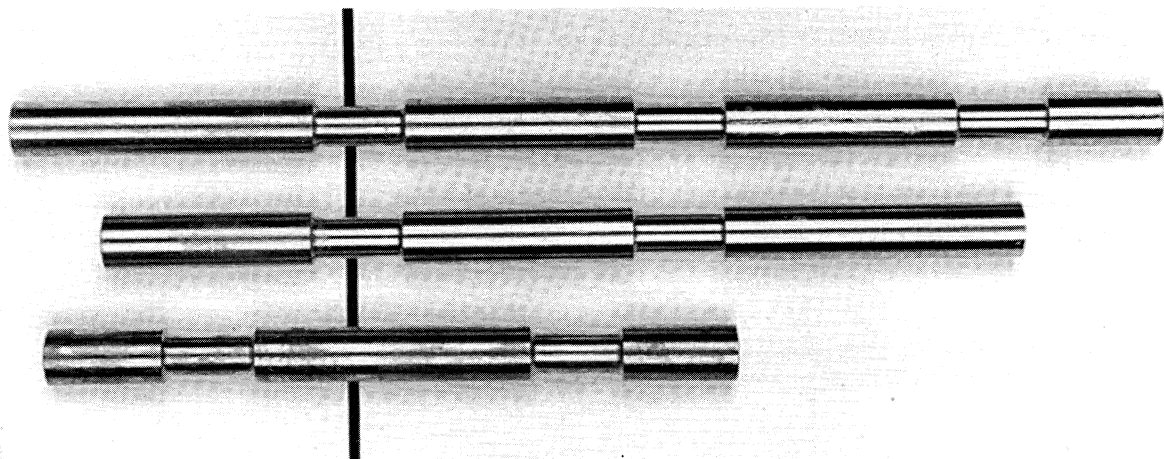
Figure 7: Stainless steel specimens from SRPC concrete, 7 years continuous immersion at raft site, after mild cleaning.

attack observed and its extent and depth are given in Tables 11 and 12. The appearance of the specimens is shown in Figure 7. There was no measurable effect on tensile strength and ductility (Tables 5 and 6). More severe attack occurred at the tidal site but nevertheless, after removal of rust staining, it was apparent that corrosion was superficial (Figure 8, Tables 13 and 14) and had negligible effect on strength and ductility (Tables 7 and 8).

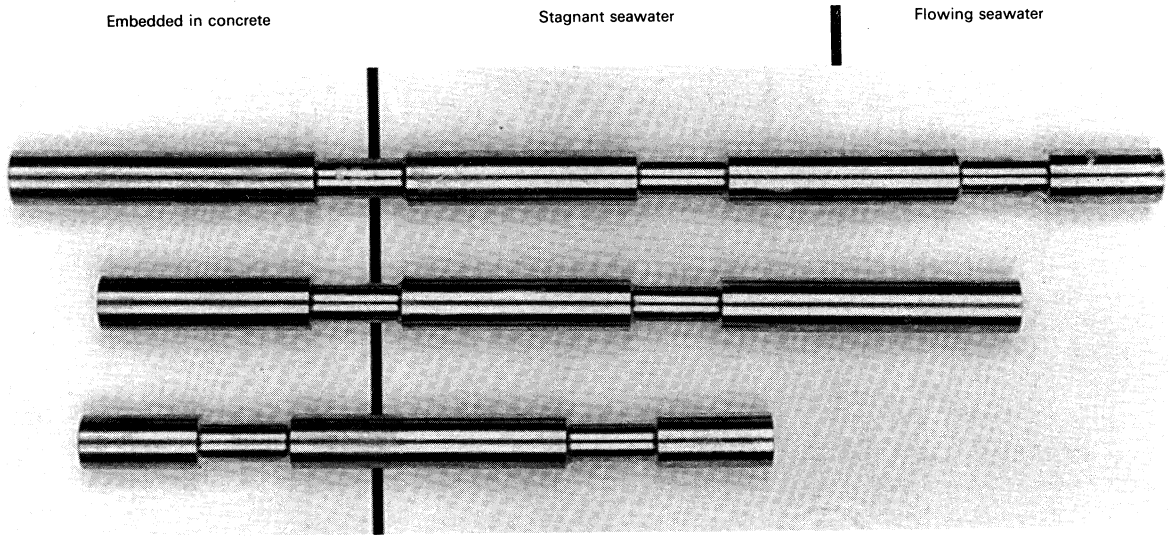
Figure 8: Stainless steel specimens from SRPC concrete, 7 years intermittent immersion at tidal site, after mild cleaning.

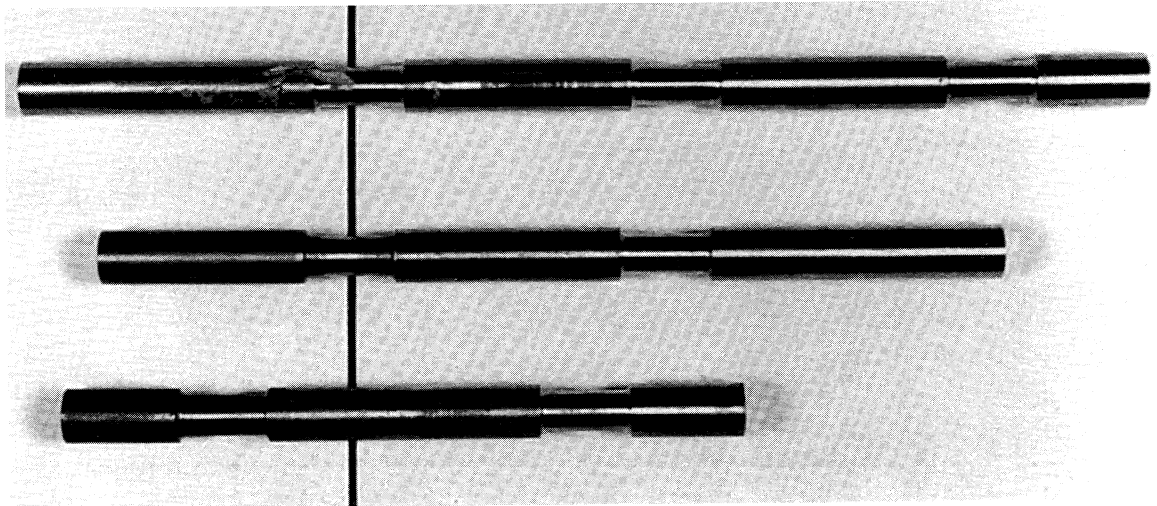
Figure 9: Stainless steel specimens from SRPC concrete, 12½ years continuous immersion at raft site, after mild cleaning.

Close inspection of Figures 9 and 10 reveals some of the few small areas of generally shallow local corrosion that had occurred.

The most seriously attacked was the 250 mm long specimen in the SRPC concrete block, which suffered severe crevice corrosion starting at its junction with the lower concrete block and progressing downwards into the concrete embedded portion as a result of the acidity developed in the crevice by the corrosion process⁽⁴⁾. Other patches of significant attack also occurred in the same region.

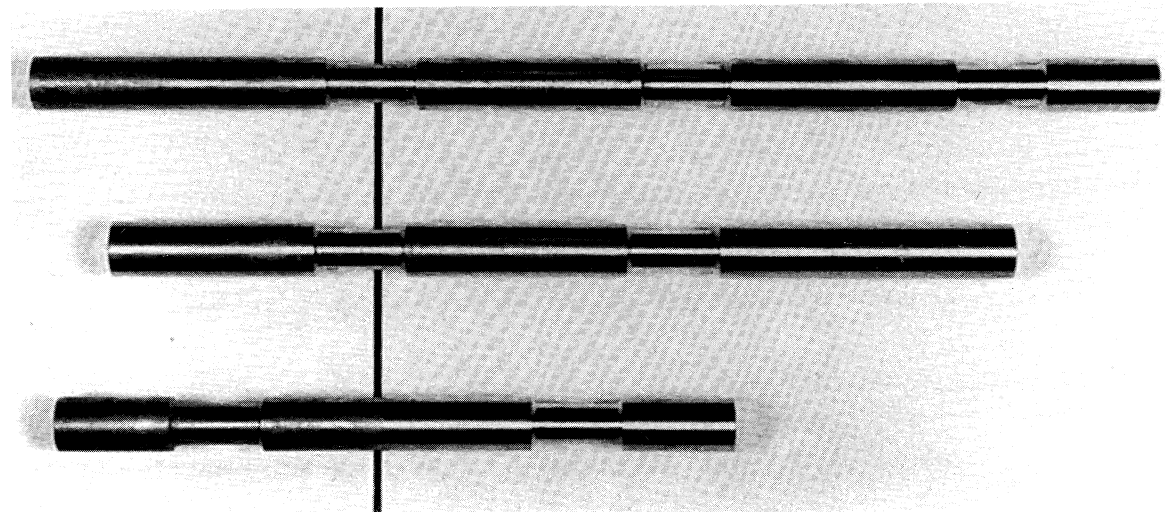
Figure 10: Stainless steel specimens from OPC concrete, 12½ years continuous immersion at raft site, after mild cleaning.
