The Pavilion, Regent's Place

The Pavilion marks the new western entrance into Regent's Place, a 13-acre development in the heart of London which features retail, leisure and public spaces. It is a structure made entirely of stainless steel in which a field of vertical columns supports a roof canopy 8 m above street level. The pavilion is 20 m by 5 m in plan, with 258 highly slender rectangular hollow sections supporting a roof plane, reflecting sunlight during the day and projecting light at night from lights integrated into the paving. The structure was opened to the public in 2009 and won a 2010 Royal Institute of British Architects (RIBA) Award for architectural excellence.

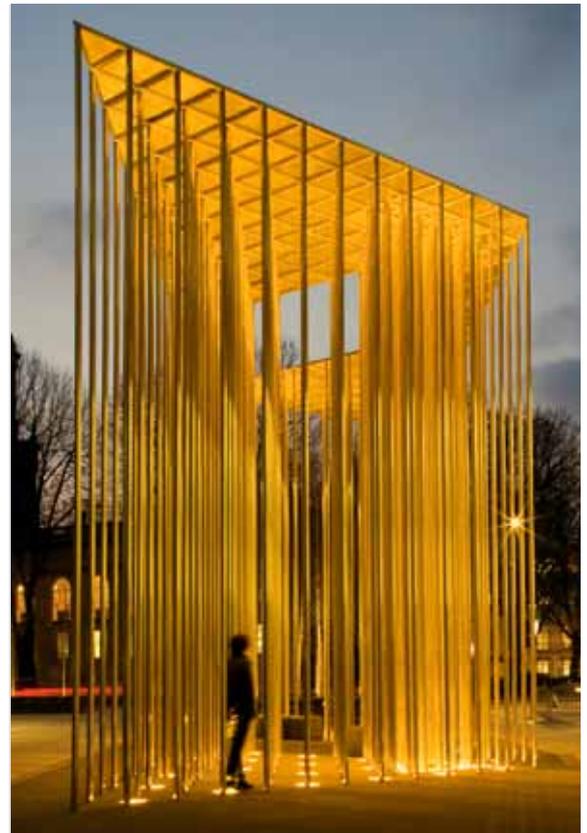
Figure 1: The Pavilion, Regent's Place, illuminated

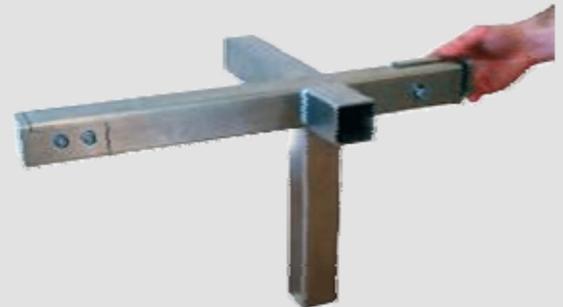
Figure 3: Mock-up of roof connection

Stainless steel is highly susceptible to weld distortion. To avoid issues arising from elements being out of tolerance, the whole superstructure was match fabricated with sections straightened after each welding procedure. To make the elements more manageable, the roof grillage was fabricated first with spigots (for attachment to the damper and the column section) prior to delivery on site.

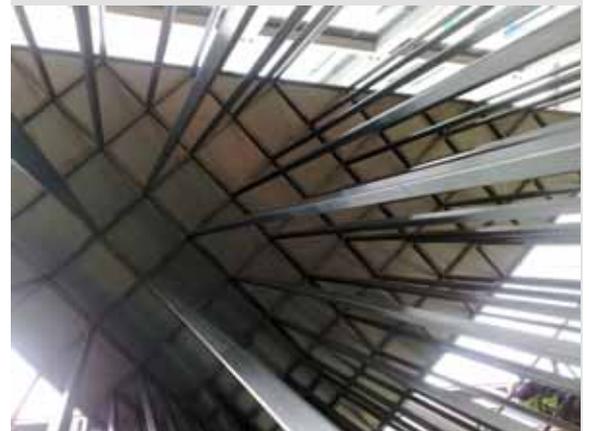
Figure 4: View of underside of roof

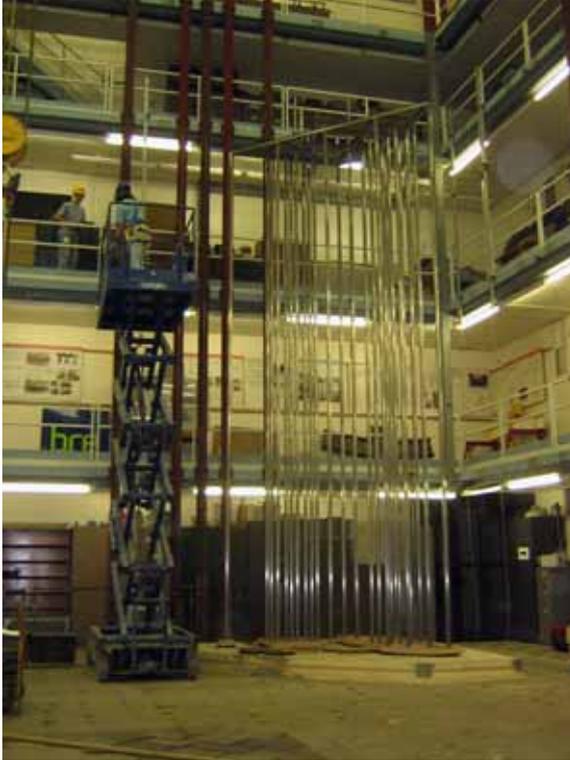
Figure 6: Bolt cage prior to concrete pour

1500 stainless steel holding down bolts were used to position the columns to very tight tolerances (± 1.5 mm). This was achieved by the use of a "bolt cage" (a network of carbon steel angles and flats) cast into the slab, which acted as reinforcement and held the bolts in position as the concrete was poured (Figure 6).

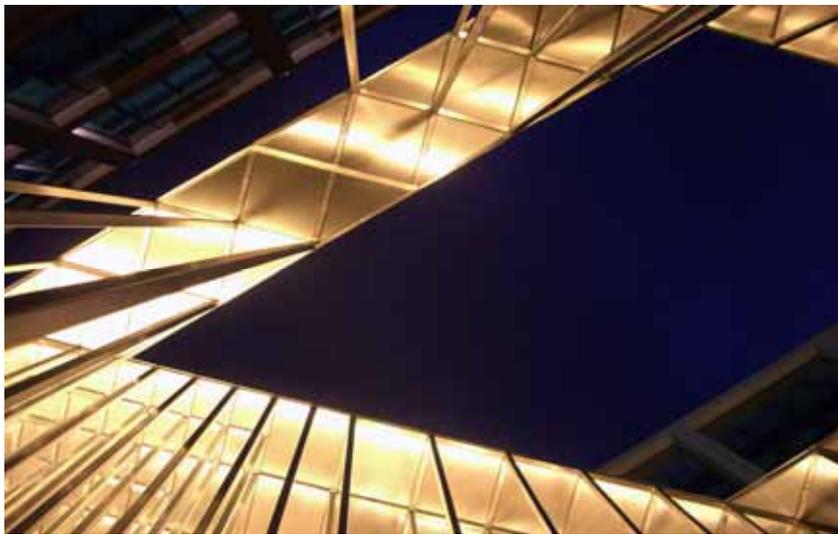
Figure 7: View of illuminated underside of roof

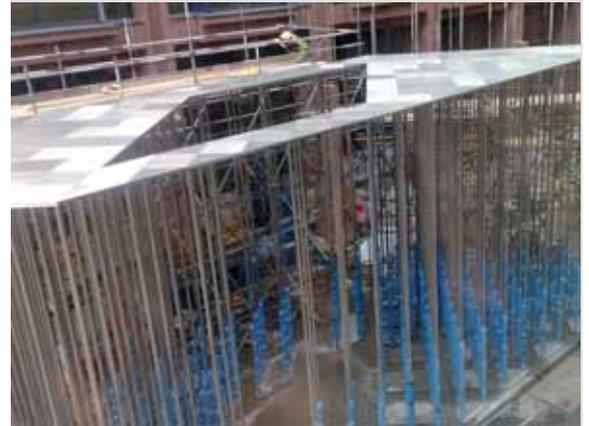
Figure 8: Pavilion under construction

The pavilion occupies a very constrained site and required a carefully planned programme with a very specific construction sequence and crane use. A method statement for the pavilion's erection was developed with the fabricator and 3D visualisations were produced to illustrate the erection procedure to the design team and client.

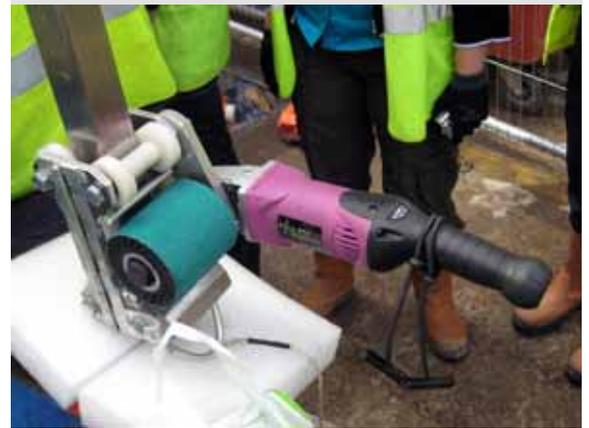
Figure 9: On-site polisher (“Rat up a drain-pipe”)

An adhesive plastic protective coating was applied along the length of the columns to protect them during transportation and erection [4]. Following completion of construction, a number of scratches to the column surface were evident at high level. A polisher was adapted such that it would automatically run up and down the height of the columns and remove any visible defects. This purpose-built machine was dubbed the “rat up a drain pipe” and ensured the full beauty of the elegant, impossibly slender columns was achieved.
