# Stainless Flexible Service Line

**Simply Fit and Forget!**

# Water leakage

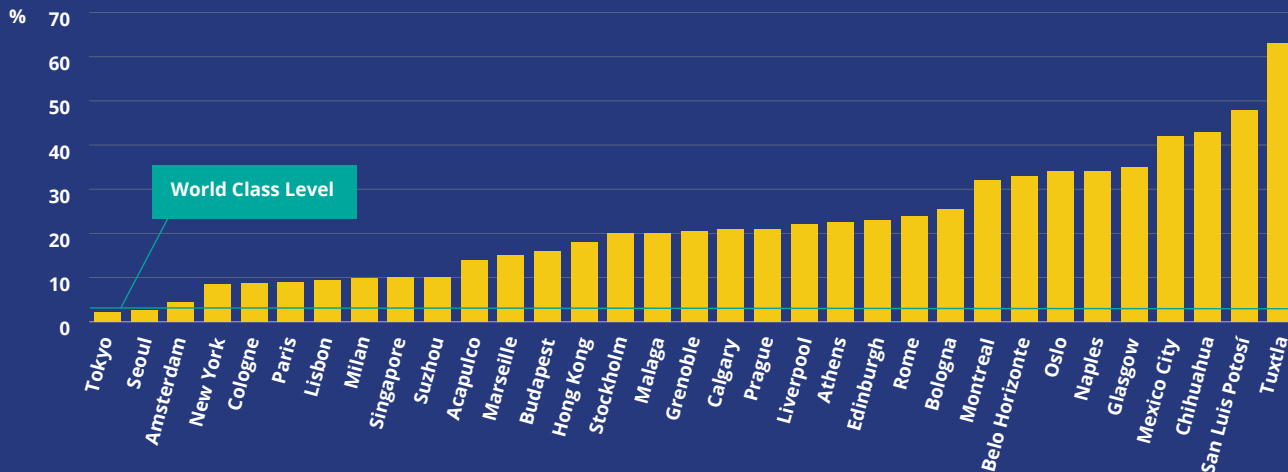
Leakage rate in major cities.  
Source: OECD (Water Governance in Cities, 2016)

Leaks in distribution systems are costly. Added to the direct cost of the lost water that cannot be sold are the financial and environmental costs of finding, treating and storing more water to compensate for the losses. This problem affects rich and poor cities alike, as shown in the graph below. Many utilities do not know the exact extent of the water loss in their system.

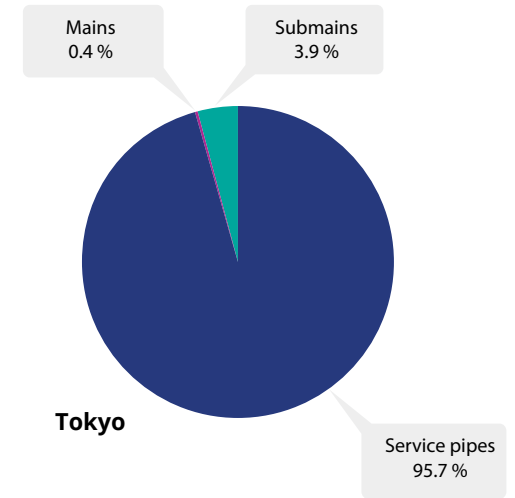
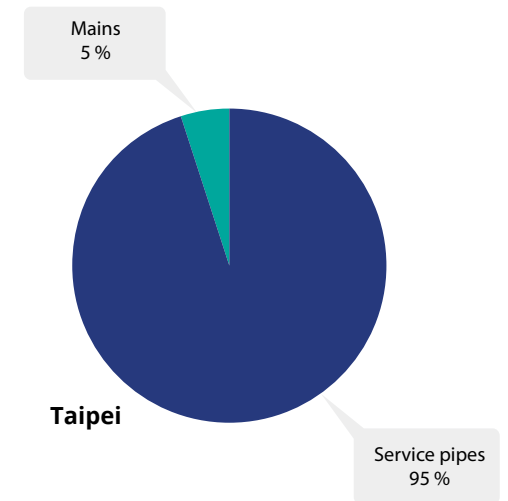
Most leakage cases are in service lines.  
Sources: Tokyo Bureau of Water Works;  
Taipei Water Department

Both Tokyo and Taipei have determined that some 95 % of leakage repairs affect their service pipes of 50 mm (2 inch) diameter or less. Historically, service lines in those cities had been constructed of lead, iron or plastics.

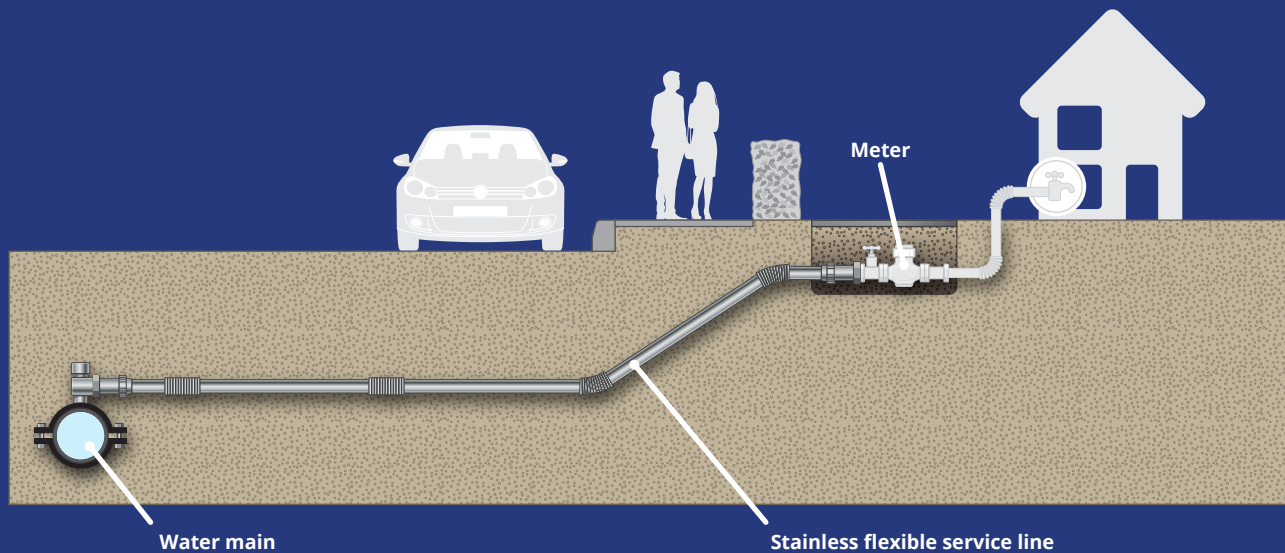
Schematic representation of the stainless flexible service line.  
Source: Team Stainless

In 1998, Type 316 stainless partially corrugated tube was introduced instead of straight tubes. The tube is corrugated at regular intervals so it can be easily bent during installation to accommodate changes in direction without additional joints. It also allows the tube to absorb the stresses from vibrations, subsidence and seismic events. The number of joints was also significantly reduced by using a single length of corrugated tube.

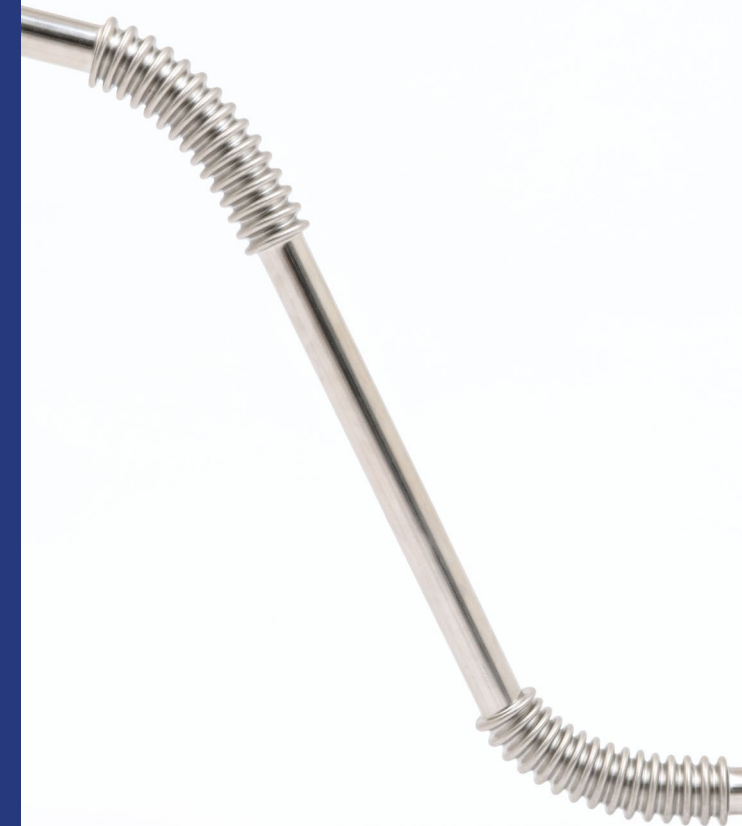
Stainless partially corrugated tube.  
Photograph: Ph. De Putter

Stainless partially corrugated tubes offer:

- Reduced leakage by minimizing the number of joints
- Improved workability
- Flexible and easy to install
- Resistant to seismic shocks and subsidence
- Matching fittings to connect to the water main and valves and meters

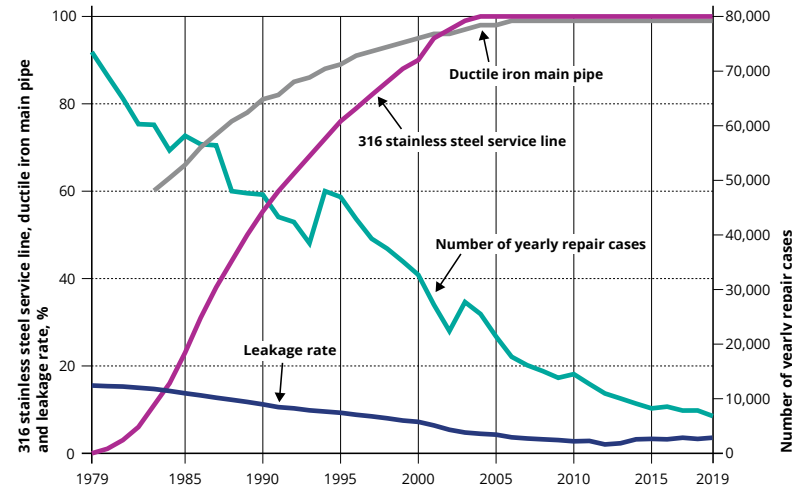
Gains made by using stainless steel in Tokyo.  
Source: Tokyo Bureau of Water Works

Tokyo's replacement program resulted in a water loss reduction from 260 million m<sup>3</sup> (15.4 %) in 1980 to 56 million m<sup>3</sup> (3.6 %) in 2019. At the same time, repair cases were reduced from 69,000 per year to 7,000 per year. The total savings amount to almost 500 million USD per year.

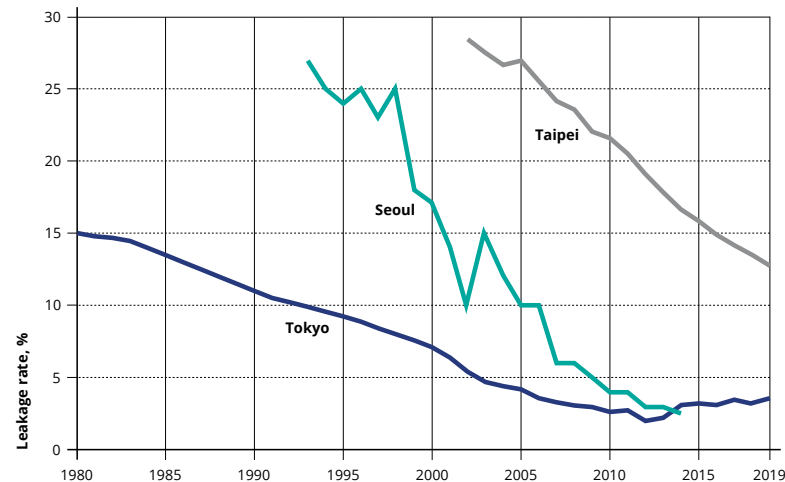
Leakage reduction in Asian cities through use of stainless steel service lines.  
Sources: Tokyo Bureau of Water Works; Ministry of Environment, Republic of Korea; Taipei Water Department

Tokyo's success at reducing leakage attracted the attention of Taipei and Seoul. Following a drought causing severe water shortages, Taipei began evaluating their program in 2002 and started their 20-year stainless flexible service line installation program in 2005. This resulted in a water loss reduction from 365 million m<sup>3</sup> (27 %) in 2005 to 109 million m<sup>3</sup> (12.7 %) in 2019, in just 12 years. At the same time, repair cases were reduced from 11,300 per year to 2,600 per year in 2019. When even more severe drought conditions returned in 2014, Taipei had no service disruption. In fact, it was able to maintain a surplus which was distributed to storage reservoirs and other utilities.

In Seoul, following the installation of stainless steel service lines, water leaks reduced from 27 % to 2.5 %. It has also enabled the city to reduce its total water production from 7.3 million m<sup>3</sup> to 4.5 million m<sup>3</sup> per day, leading to the closure of four of the original ten water treatment plants.
