THE SUCCESSFUL USE OF AUSTENITIC STAINLESS STEELS IN SEAWATER

A PRACTICAL GUIDE TO THE USE
OF NICKEL-CONTAINING ALLOYS
N° 1259

The Successful Use of Austenitic Stainless Steels in Sea Water

G. E. MOLLER

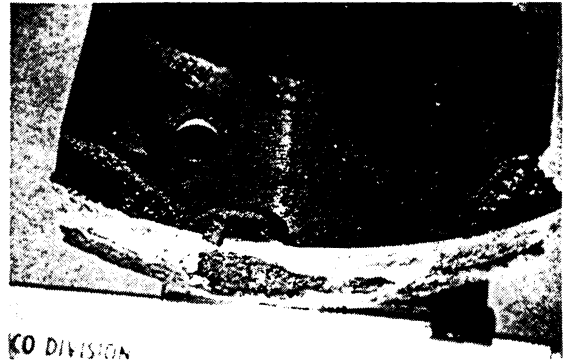
FIG. 3 — CAST TYPE 316 (ACI CF-8M) FLANGE — CREVICE CORROSION.

The chloride ion, if sufficiently concentrated, is capable of destroying the passivity of austenitic stainless steels under specific chemical or physical circumstances. In sea water with about 19,000 ppm of chloride, passivity can be destroyed and localized attack in crevices or under deposits can occur. Fig. 3 shows crevice corrosion in a segment taken out of a 316 flange assembly that was a component of a sea-water filter. Flange assemblies, by the nature of design, have deep crevices.

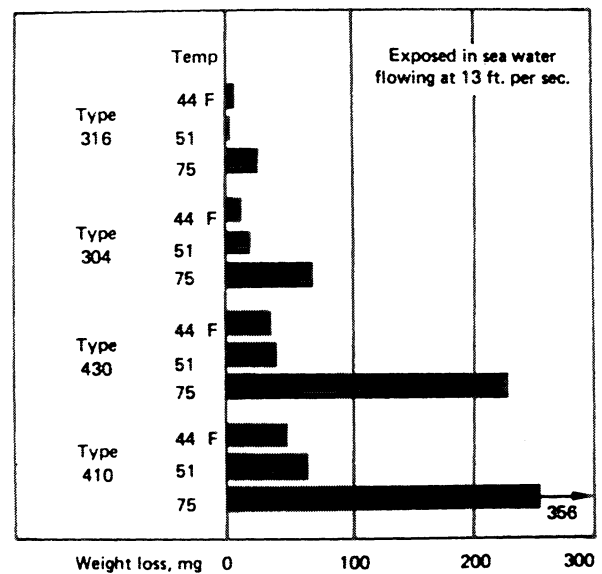
Corrosion-rate data for Types 316, 304, 430, and 410 stainless steels at 13 ft/sec with crevices present are displayed in Fig. 7, showing the effect of temperature.¹ The extreme acceleration of corrosion of Type 410 in 75 °F sea water is evident. The pump shaft in Fig. 5 was in a pump handling 72 °F sea water.

FIG. 7 — EFFECT OF SEA-WATER TEMPERATURE ON CORROSION OF STAINLESS STEEL.
