# STAINLESS STEEL FOR DURABILITY, FIRE-RESISTANCE AND SAFETY

Nº 10042

By G. Waller and David J. Cochrane, 1990.

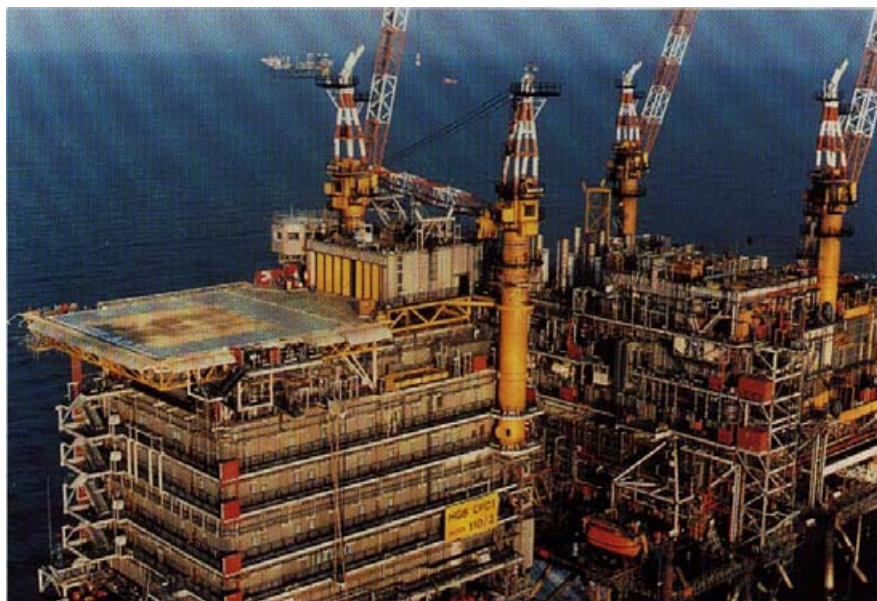
*Stainless steel cladding, as used for this British Gas platform in Morecambe Bay, ensures long trouble-free life, minimum maintenance and outstanding resistance to fire.*

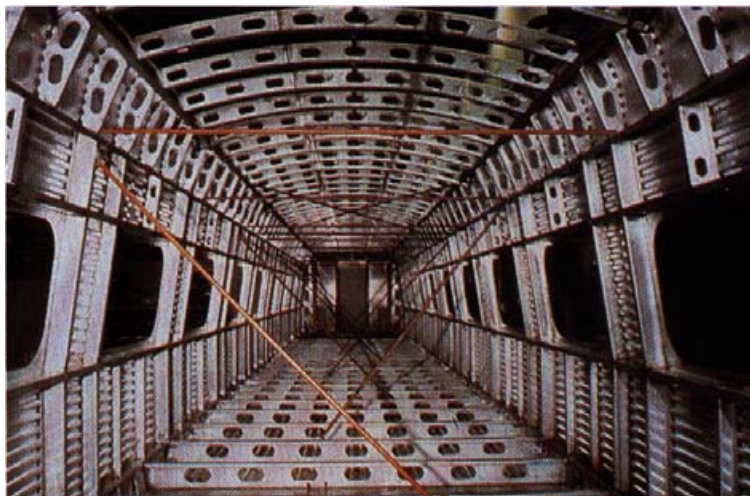
*Swedish railcar fabricated entirely from stainless steel (18% Cr 9% Ni). The body has a strong cross-section of arc-welded beams with longitudinal side-beams at floor and ceiling level. Roof and side panels are corrugated and the floor is pattern rolled for further strength.*

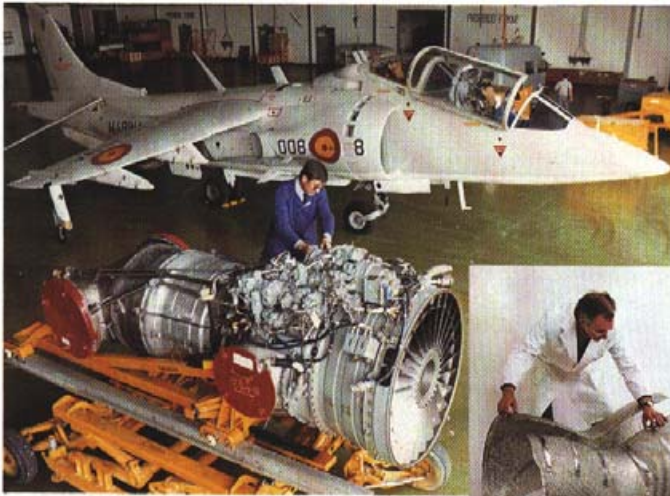
1. Lightweight all-stainless steel insulation encloses the bifurcated jet pipe of the vectored-thrust 'Pegasus' engine used in the 'Harrier' vertical take-off aircraft.  
Courtesy of Rolls-Royce plc

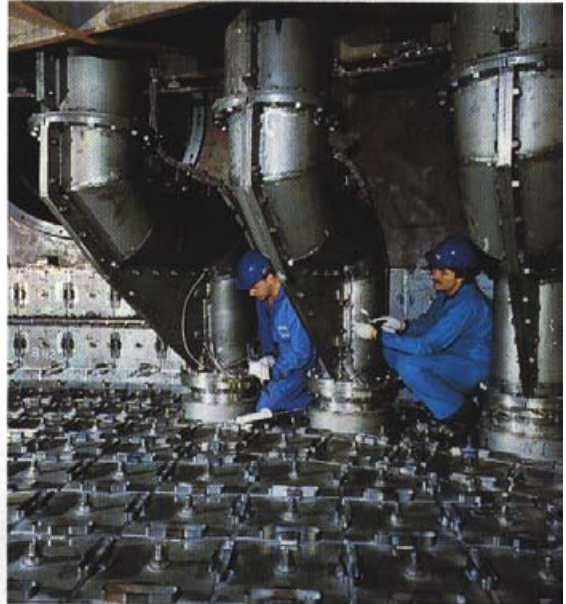
5. A stainless steel fire protection box for an emergency shut-down system at a chemical plant. In fire tests this type of enclosure was exposed to flame temperatures around 1000°C for over 15 minutes. The maximum inside face temperature reached only 170°C.  
Courtesy of Darchem Engineering Limited

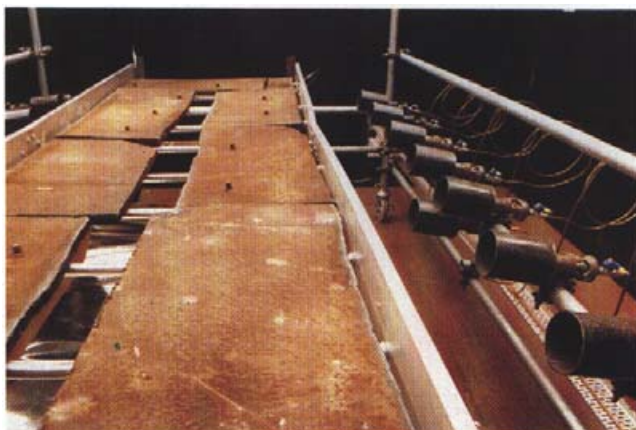
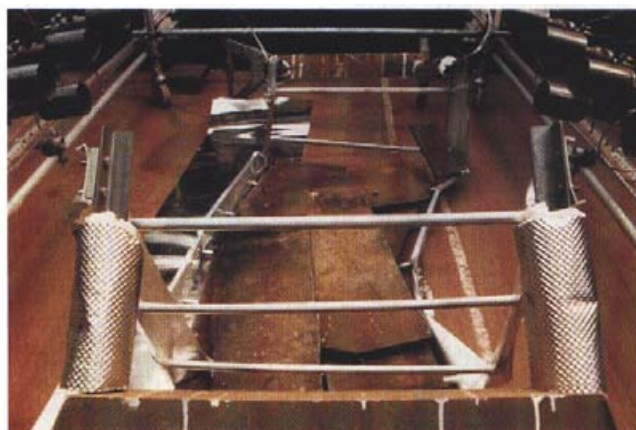
*Aluminium ladder before and after fire resistance test. The ladder collapsed 26 seconds after the burners were ignited.*

**Aluminium:** The aluminium ladder suffered total structural failure after 26 seconds, too short a time for meaningful temperature readings to be obtained. No molten metal was seen because the rapid collapse due to softening caused the ladder to fall outside the fire zone.

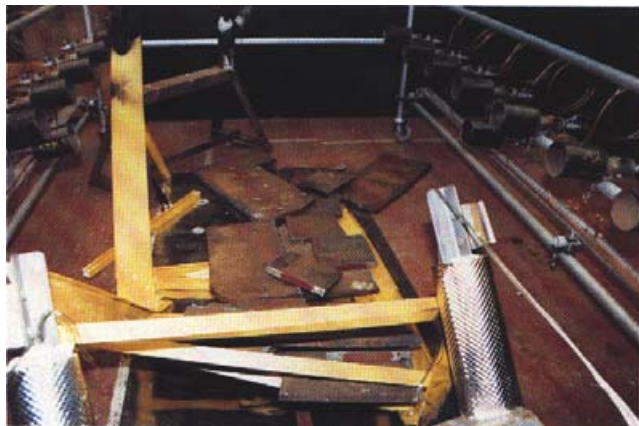
Top left: GRP ladder after fire resistance test. Total collapse occurred before all burners were alight. Smoke and fume emissions were noted.

**GRP:** The GRP ladder collapsed before all the burners were ignited and no meaningful temperature measurements were possible. Ignition of the ladder material was observed together with the emission of fumes.

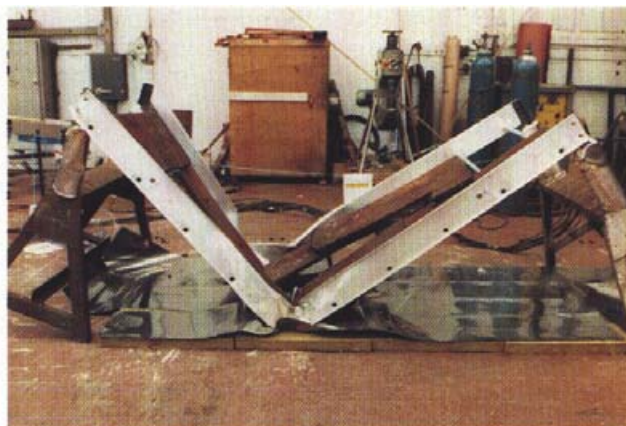
Top right: Aluminium ladder after radiation resistance test. Structural failure occurred after 12 minutes of radiant heating.

**Aluminium:** The aluminium ladder suffered total structural failure after 12 minutes. Average ladder temperature at failure was 238° C and the maximum individual temperature was 264° C.

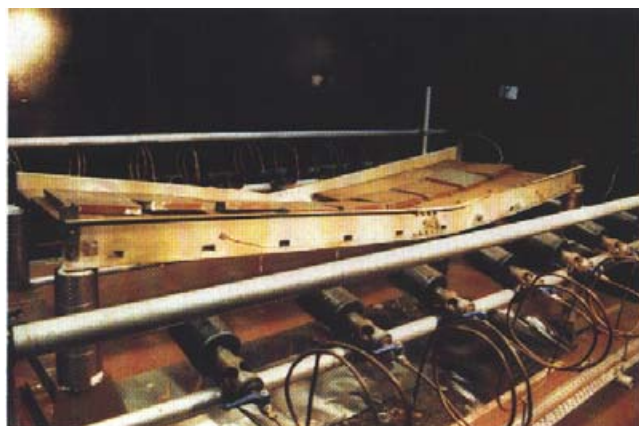
Bottom left: Galvanised mild steel ladder after fire resistance test. Structural integrity was maintained for the stipulated 5 minutes, at which time central deflection was 166.5 mm. Globules of molten zinc were seen falling during test.

**Galvanised Mild Steel:** The mild steel ladder maintained its integrity for the required 5 minutes. Large globules of molten zinc were seen to fall as the test proceeded. Maximum average temperature recorded was 642° C and the maximum individual ladder temperature was 811° C.

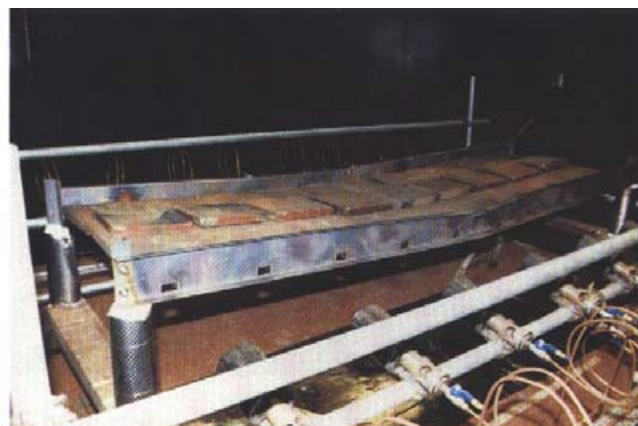
Bottom right: Stainless steel ladder after fire resistance test (extended to 45 minutes, see text). Structural integrity was maintained throughout test and central deflection was only 80.5 mm at conclusion.

**Stainless Steel:** The stainless steel ladder maintained its integrity for the required 5 minutes and, without shutting off the burners, it was decided to continue the test. After a further 40 minutes the test came to an end when the bottled gas supply ran out. Throughout the full 45 minutes the stainless steel ladder maintained its integrity. Maximum average ladder temperature reached was 705° C and maximum individual ladder temperature was 757° C. The average flame temperature exceeded the specified 1000° C for 14 minutes.

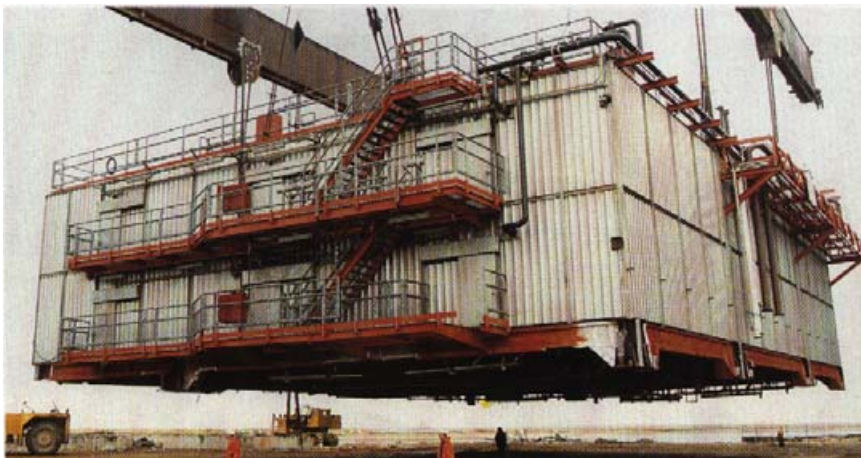
*Left: Accommodation module for the Hutton tension leg (TLP) platform, clad with stainless steel.  
Courtesy of Conoco (U.K.) Limited*

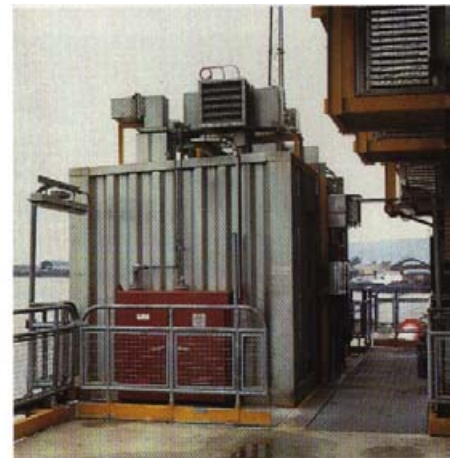
*Right: Firewall fabricated with stainless steel profiled cladding.  
Courtesy of Darchem Engineering Limited*

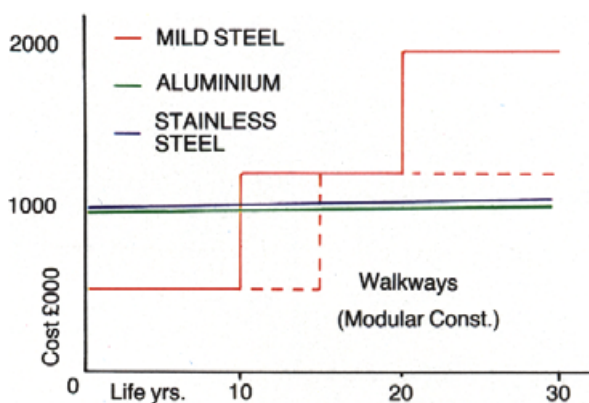
Estimated costs over a 30-year life cycle of walkways for a North Sea modular platform with a topside dry weight of 20,000 tonnes.

On the basis of direct costs alone, the study finds that the relatively low first-cost of mild steel structures is soon offset when the life-cycle maintenance and replacement costs are taken into account. The changeover point occurs at the time when the first replacement of mild steel becomes necessary. Aluminium structures, while significantly more expensive than mild steel, are shown to be somewhat cheaper than those of stainless steels at the materials costs obtaining in early 1989. Both aluminium and stainless steel are normally regarded as maintenance-free offshore apart from an infrequent wash-down.

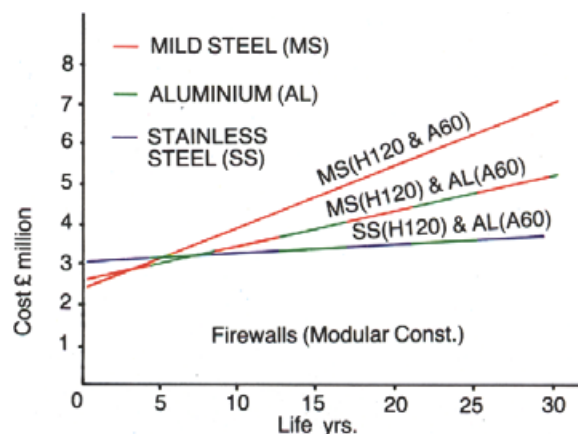
Estimated costs for the same platform of firewalls having fire ratings of H120 in process areas and A60 in accommodation areas.

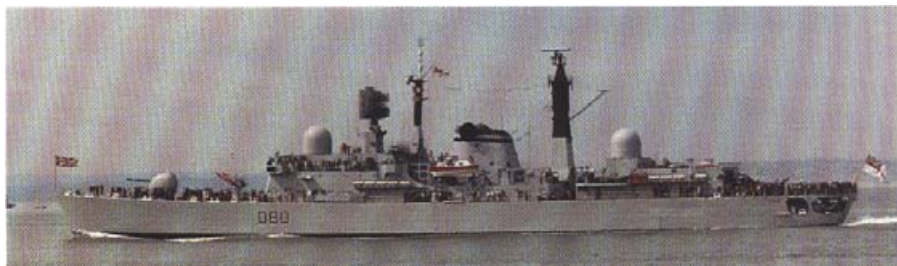
*The Royal Navy Type 22 frigate 'HMS Sheffield', commissioned in 1988, embodies four stainless steel stairways and numerous other functional and decorative components in the same material.*
