Water Loss **2022**

June 19-22, 2022

Proceedings

Alternative approach to assess SPCT benefits – LCC methodology

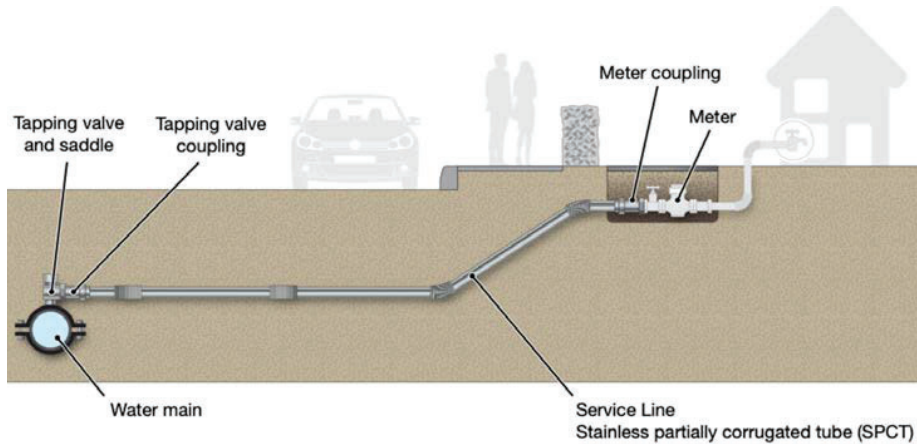
Figure 2: Stainless partially corrugated tube in a mains-to-meter configuration (source: Team Stainless).

In 1998, Type 316 stainless partially corrugated tube was introduced instead of straight tubes. The tube is corrugated at regular intervals so it can be easily bent during installation to accommodate changes in direction without additional joints. It also allows the tube to absorb the stresses from vibrations, subsidence and seismic events. The number of joints was also significantly reduced by using a single length of corrugated tube.

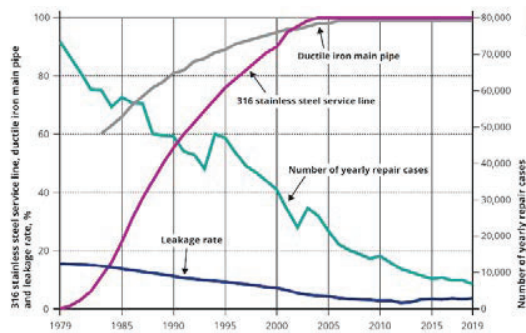
Figure 3: Gains made by using stainless steel in Tokyo (Source: Team Stainless, Tokyo Bureau of Water Works).

Tokyo's replacement program resulted in a water loss reduction from 260 million m³ (15.4 %) in 1980 to 56 million m³ (3.6 %) in 2019. At the same time, repair cases were reduced from 69,000 per year to 7,000 per year. The total savings from both these effects (compared to the initial situation) amount to almost 500 million USD per year. A similar sum was already documented earlier by Tokyo Waterworks Bureau (4).

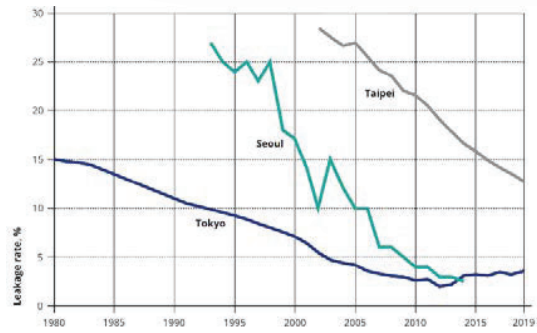
Figure 4: Leakage reduction in Asian cities through use of stainless steel service lines. (Sources: Tokyo Bureau of Water Works; Ministry of Environment, Republic of Korea; Taipei Water Department).

Tokyo's success at reducing leakage attracted the attention of Taipei and Seoul. Following a drought causing severe water shortages, Taipei began evaluating their program in 2002 and started their 20-year stainless flexible service line installation program in 2005. This resulted in a water loss reduction from 365 million m³ (27 %) in 2005 to 109 million m³ (12.7 %) in 2019, in just 14 years. At the same time, repair cases were reduced from 11,300 per year to 2,600 per year in 2019. When even more severe drought conditions returned in 2014, Taipei had no service disruption. In fact, it was able to maintain a surplus which was distributed to storage reservoirs and other utilities.

In Seoul, following the installation of stainless steel service lines, water leaks reduced from 27 % to 2.5 %. It has also enabled the city to reduce its total water production from 7.3 million m³ to 4.5 million m³ per day, leading to the closure of four of the original ten water treatment plants.

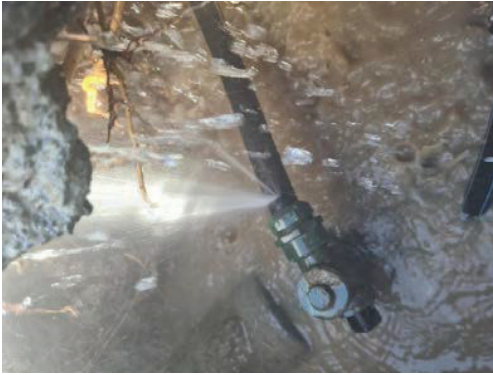
Image 1: typical failure of the Australian utility's PE-pipe.

The Australian utility stated that vast majority of the leaks are occurring at the Ferrule, or in other words in that (final) section of the PE-pipe where flexible PE meets the rigid ferrule. The image shows a typical failure. We therefore chose to attribute the amount of failures entirely to the pipe (near the connection of the PE Pipe at Mains Valve) and thus **setting the PE-pipe failure rate at 1/1000 connections or a likelihood of 0.10 %**.

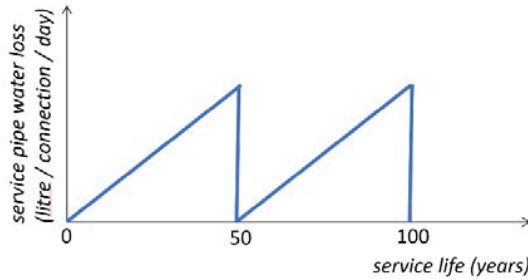
In the 100-year running cumulative calculation, we made the mathematical assumption of loss increasing linearly (until the maximum of 70 litre : connection / day) between year one and year 50, when the PE-pipe would be scheduled to be replaced.

Figure 5: assumed water loss – time dependency.

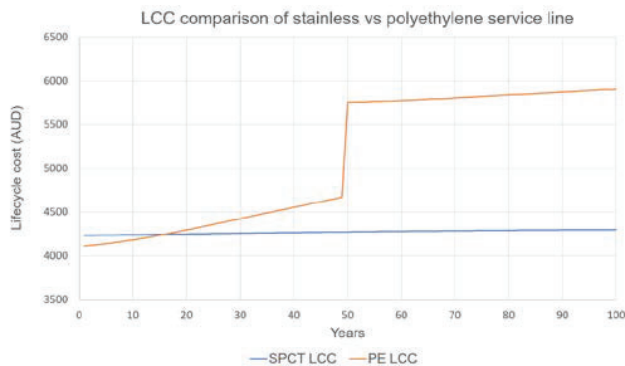
Figure 6: graphical representation of stainless 316 (SPCT) versus polyethylene service line life cycle cost.

- 316 stainless steel service line pipe is clearly cheaper than polyethylene over the entire worry-free service life of 100 years, as the diagram below shows.
- More importantly, 316 SPCT becomes less expensive after only 15 years already.
- In the next section about sensitivity analysis, it will be demonstrated that the point at which stainless steel becomes less expensive can be reached sooner.

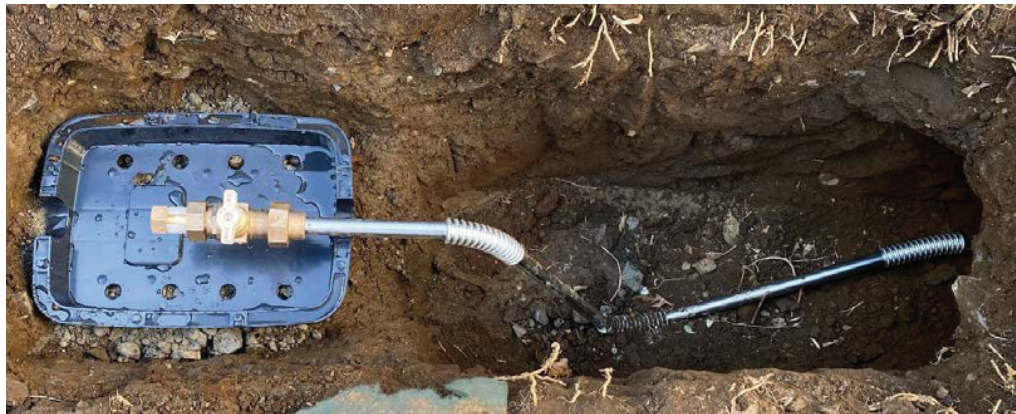
Image 2: Installation of SPCT in Tokyo / photo Nicole KINSMAN.
