Evaluation of bleach plant piping materials

NICKEL DEVELOPMENT INSTITUTE
NiDI Reprint Series Nº 14 007

Arthur H. Tuthill and A. Garner

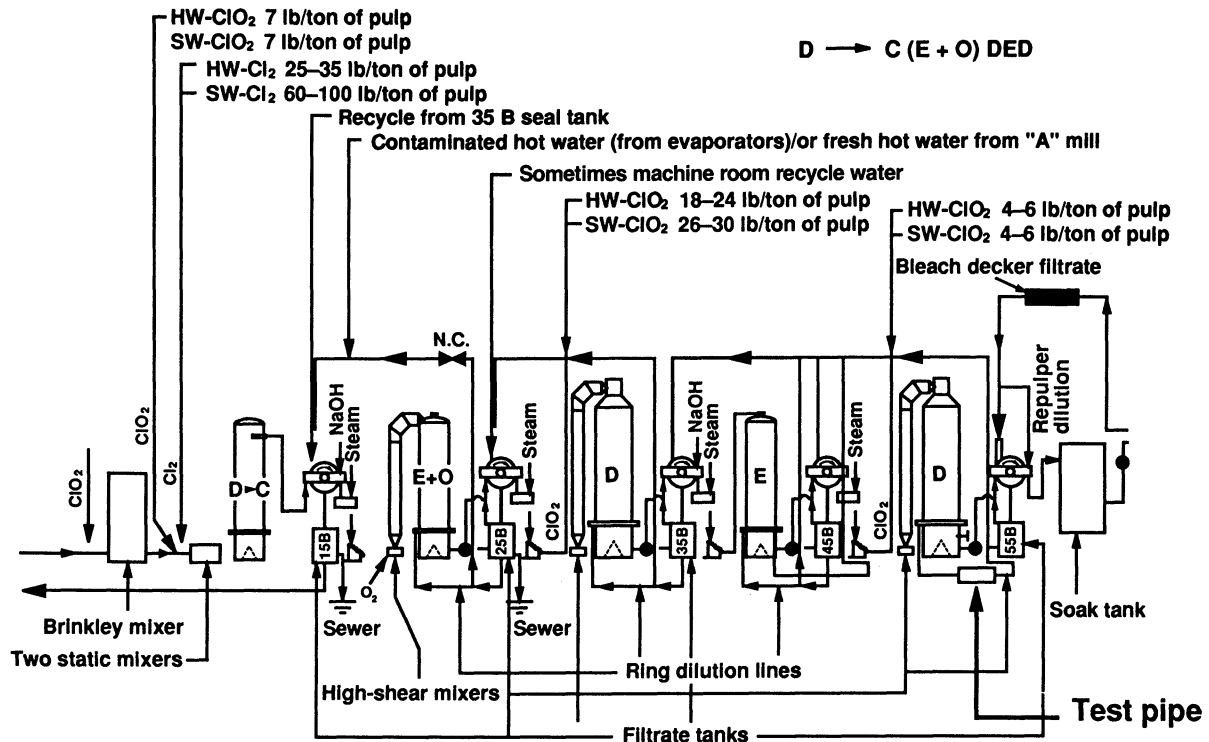
1. Bleach plant flow diagram showing position of test pipe

indicated in Fig. 1. It was installed and put into service on April 17, 1987, and removed on June 5, 1988. Visual inspection from the ends indicated that the surfaces were clean and free of pulp, except in the vicinity of localized corrosion sites near the welds of some—but not all—sections. Mill practice was to flush and drain lines on shutdown. No other cleaning was done on the test assembly.

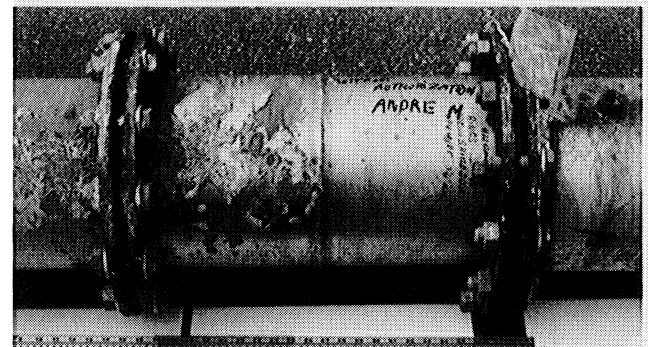
At the laboratory, the assembly was photographed (Fig. 2), unbolted, flanges removed, and each length was cut in half longitudinally for visual inspection. One half of each length was cleaned by sand blasting. Samples were cut for metallography and for immersion testing in ferric chloride solution. Critical pitting temperatures were determined on the upper face of duplicate samples of uncorroded base metal in 10% FeCl₃ at a constant temperature, which was increased by 2.5°C each working day.

2. A section of the pipe spool before disassembly
