PROTECTING PUBLIC ART AGAINST CORROSION

L. H. Boulton¹ and E. Yuda²

¹Les Boulton & Associates Ltd, ²Artefacts Conservation Ltd

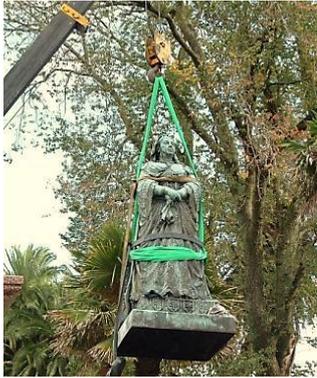
Figure 3. Bronze statue of Queen Victoria being removed by crane at Albert Park.

1) *Remedial conservation treatment.* Once the statue had been removed to an indoor location (*Figures 3 and 4*) all of the bronze surfaces were closely inspected. It was necessary to assess the extent of remedial treatment and repairs required to address the disfiguring corrosion as well as any material losses and structural damage. Fortunately, inspection revealed that reconstruction of parts of the statue was not necessary other than minor brazing repairs around the neck area (*Figure 5*).

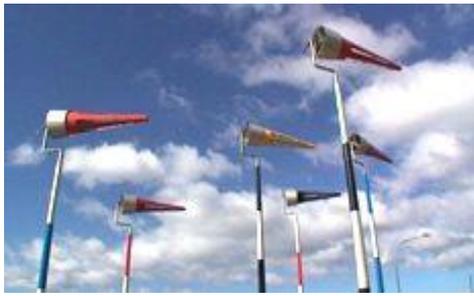
Not long after installation cracking occurred in a weld on the grade 316L stainless steel support arm for the pivoting wind sock on one of the kinetic sculptures. The sculptures were subjected to wind velocities of 100 km/hour or higher and vibrate vigorously in the wind. The stainless steel pipe cracked at a weld adjacent to a pipe elbow on the U-shape support arm. The weld at the other end of the elbow on the support arm also showed cracking (*Figure 8*).

The kinetic sculptures were also exposed to a severe marine environment as well as high wind loadings. Chlorides from windborne sea salt (i.e. marine aerosol) gained access inside the support arm pipe during service. The pipe weld showed some lack of penetration across the throat of the weld and there was heat tint present on the stainless steel around the internal root of the weld. Heat tinting on stainless steel welds is undesirable as it encourages corrosion to occur on welds exposed to a corrosive environment. The cracking in the pipe weld was found to be due to a mechanism called chloride-stress corrosion cracking (SCC). Residual tensile stresses from fit-up and welding had contributed to the SCC.

Figure 7. Pole mounted wind sculptures located next to a harbour.

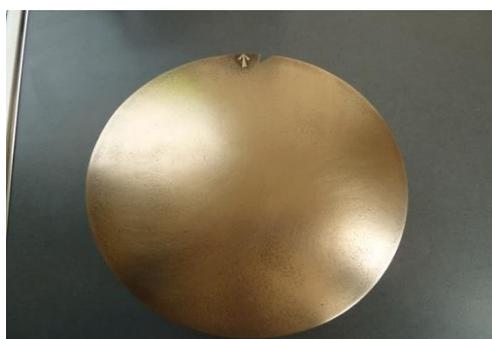
Figure 10 shows the honey-gold colour on a cast test piece of the silicon bronze. For a various reasons, the polished surface of the bronze sculpture had not been cleaned and coated with wax annually, as part of a maintenance plan. Wax is applied onto the bronze surfaces to stop the metal from coming into contact with an aggressive *marine aerosol* that prevails over the Auckland isthmus.

Figure 10. The honey-gold colour of a polished silicon bronze casting similar to the pieces comprising the sculpture.

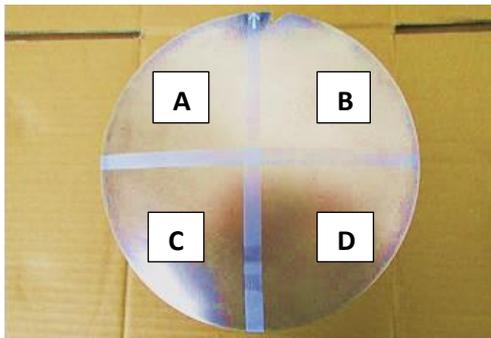
The four segments on the bronze sample are shown in *Figure 12*. The identification marks, A, B, C and D, were chosen to identify each of the four coating systems that were subsequently applied. The quadrants on the bronze disc were treated as follows:

Figure 12. The silicon bronze cast disc after polishing, cleaning and masking into four segments.

C: Cold application of *Fishoilene* corrosion prevention compound.

D: Hot application of microcrystalline wax with BTA incorporated into the wax. A second coat of wax was cold-applied.

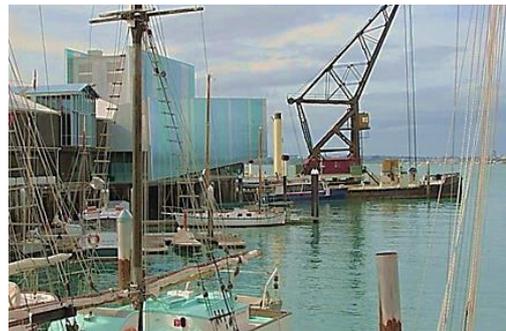
Figure 13. The old dredge *MV Rapaki* moored (right) at the National Maritime Museum wharf on Auckland harbour.

The bronze disc was exposed in a vertical orientation to the prevailing marine environment, attached to the cabin of an old dredge moored by a wharf at the National Maritime Museum in Auckland. The dredge was situated on the edge of Auckland harbour (*Figure 13*). The bronze disc was installed facing north-east and the sample was rain washed during the exposure period. The exposure time in the marine environment on the dredge was approximately three months. The bronze disc was removed and swabs of visible corrosion products were taken off each quadrant. The swab samples were subjected to microscopic examination and to X-ray analysis (EDS) of the corrosion products in a scanning electron microscope.

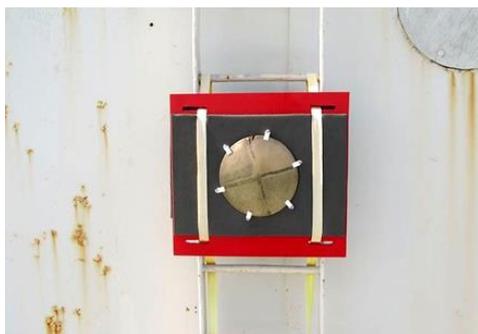
Figure 14. The bronze disc mounted vertically on the dredge cabin.
