**Nickel  
Institute**

Reference Book  
Series No 11 023

# Timeless Stainless Architecture

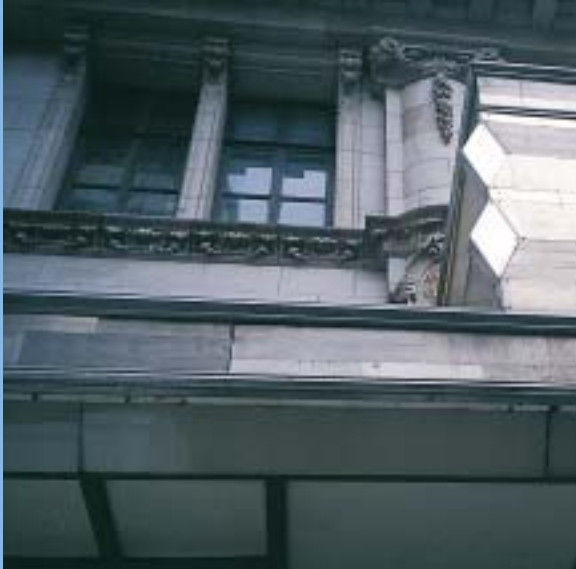
The Savoy canopy in 1999

LOCATION	1 Savoy Hill, London WC2 0BP, United Kingdom
DESCRIPTION	Stainless steel sign and sidewalk canopy for the Savoy Hotel which is in the Strand area of central London.
ENVIRONMENT	Near the coast, urban, and heavily polluted with coal fire smoke (sulphur compounds and high levels of particulate) until the late 1950's.
COMPLETED	1929
ARCHITECT	Sir Howard Robertson
OWNERS	Blackstone Group
ENTRANCE CANOPY	Single-story stainless steel marquee over the pavement (or sidewalk) with panels that are riveted in place.
Stainless steel	Type 302 stainless steel, 0.06 inch (1.5 mm) thick with a 'Staybrite' (buffed 2B) finish.
Maintenance	There is no routine maintenance schedule and it is cleaned infrequently. It was professionally chemically cleaned in 1989. The cleaning solution is unknown.
Condition	The famous 'Savoy' sign is in excellent condition. The marquee's alternating horizontally and vertically fluted panels trap dirt and are difficult to clean. Although discolouration occurs, there is no perforation of the stainless steel even at the junction with the adjacent building wall, which is one story higher and subject to rainwater run off.

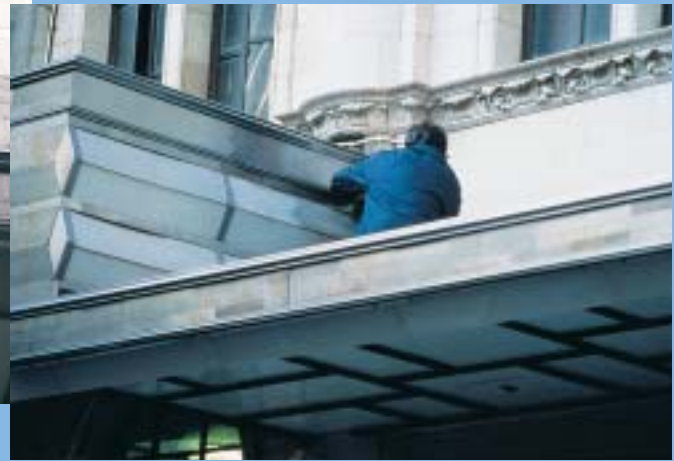
A worker hand-cleaning the canopy

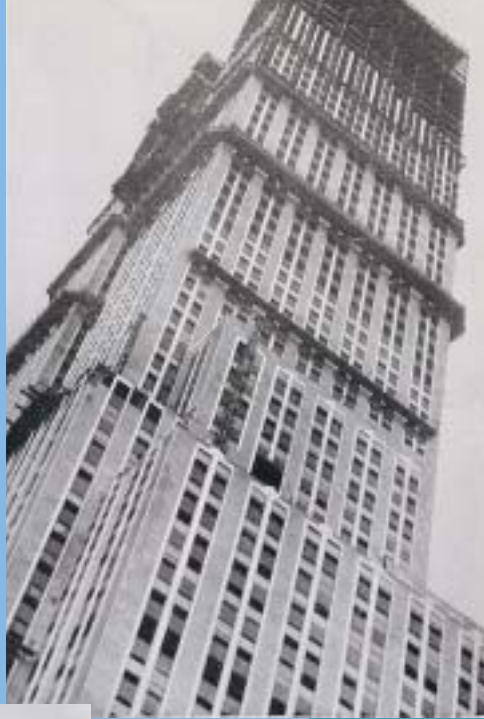
Topping out the steel framing and completing exterior panel installation, September, 1930

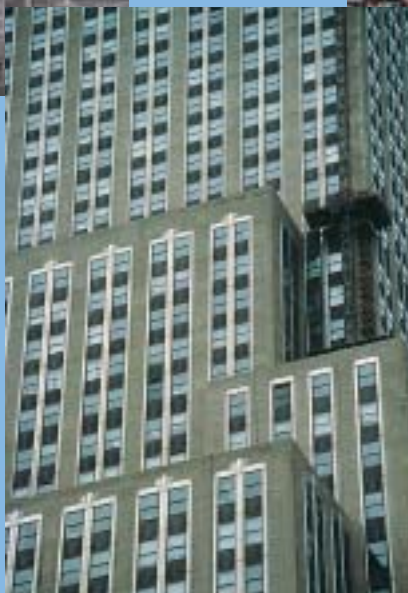
The spandrel panels and sunbursts in 1996

LOCATION	350 Fifth Avenue, New York, New York
DESCRIPTION	This Historic Landmark building is 1,252 feet (382 m) tall with 85 stories of office space. It was the world's tallest building for 41 years. The 200 foot (61 m) dirigible mooring mast and five stories of office space were late design additions to surpass the Chrysler Building's height. The exterior is stainless steel, gray limestone, and dark gray aluminum.
ENVIRONMENT	Coastal, urban and heavily polluted for most of the building life.
COMPLETED	April, 1931
ARCHITECTS	Shreve, Lamb, and Harmon
OWNER	Helmsley-Spear, Inc.
STRUCTURAL ENGINEERS	Homer G. Balcom
GENERAL CONTRACTORS	Starrett Brothers and Eken
FABRICATOR	United Metal Products Co.
INSTALLER	C. E. Halback and Company and William H. Jackson Company.
SPANDREL PANELS	Vertical Type 302 stainless steel, 10 inch (254 mm) wide spandrel panels start on the sixth floor and extend upward outside each window group to form a sunburst at the top of each tier. There are 22 inch wide (559 mm) stainless steel mullions between each window. The stainless steel panels are bolted to brackets in the masonry wall and reinforced with Type 302 stainless steel channels every 2 feet (610 mm). The longest is 151.56 inches (3,849.6 mm). The dark panels underneath each window are cast aluminum.

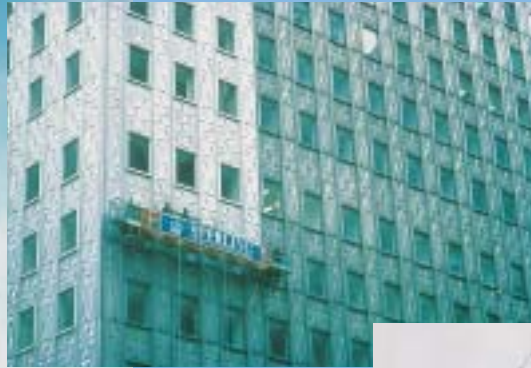
Workers cleaning 150 East 42nd Street in 1995

LOCATION	150 East 42nd Street, New York, New York
DESCRIPTION	This 42-story office building was the world's largest metal clad building in 1954.
ENVIRONMENT	Coastal, urban environment with moderate to high pollution levels during the building life.
COMPLETED	1954
ARCHITECTS	Harrison, Abramovitz & Harris
OWNER	Hiro Real Estate Co.
CURTAIN WALL	The 4th through 42nd floors have pressed stainless steel panels joined with continuous vertical stainless steel battens that allow movement. Overlapping panels form the horizontal joints. The stainless steel frames for the enamelled panels at the base of the building have a No. 4 polish.
Stainless steel	340 metric tons of 0.038 inch thick (0.97 mm), Type 302 stainless steel, 2B finish, surface roughness of $R_a$ 12 micro inches or 0.3 microns
Fabricator/installer	Truscon Division, Republic Steel Corporation
Maintenance	Cleaned for the first time in 1995 with a proprietary neutral detergent, degreaser, and water solution.

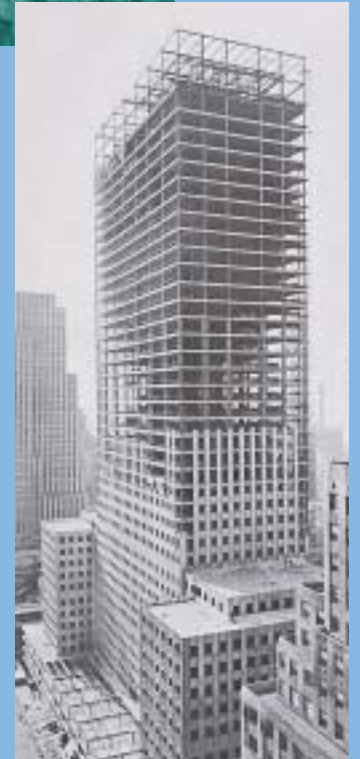
Erecting the wall panels

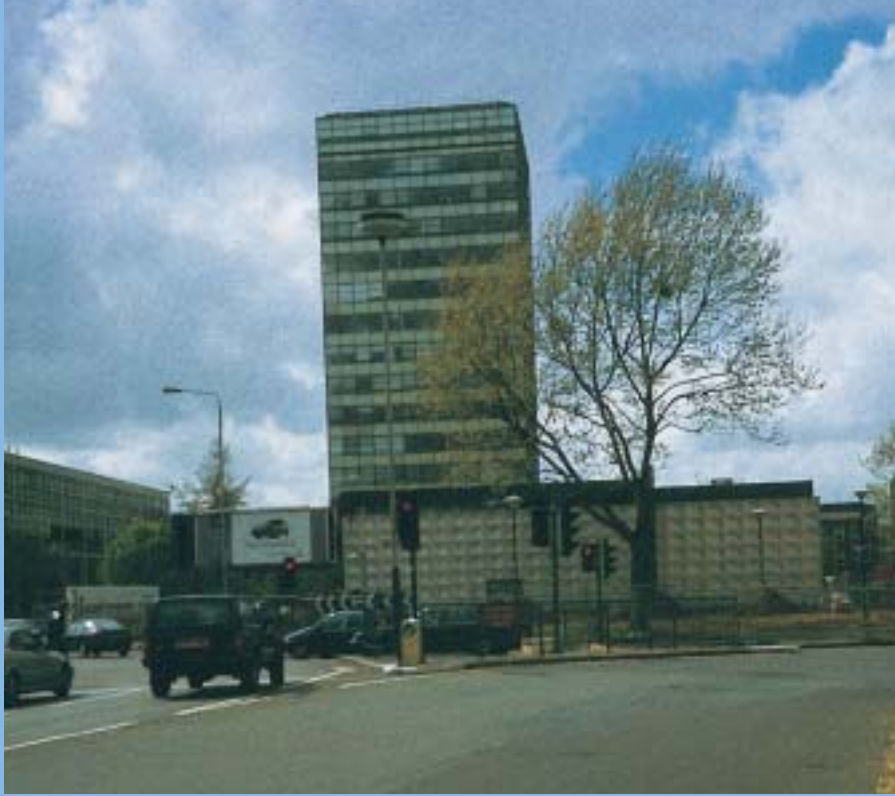
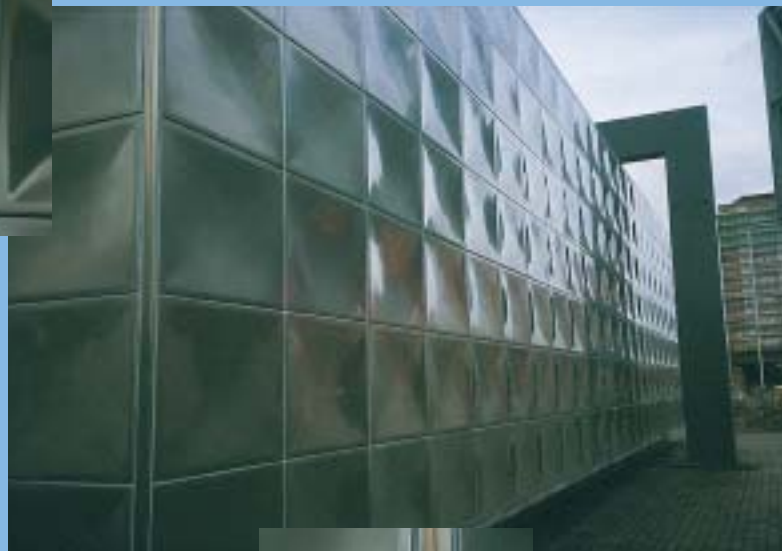
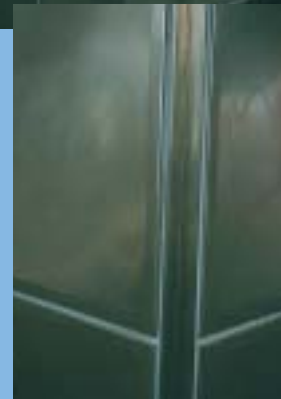
These 1999 photos of the Elephant & Castle Sub-Station illustrate that industrial buildings can remain attractive and relatively clean if an appropriate stainless steel and a smooth surface finish are specified. The design encourages natural rain cleaning and there is plentiful rain.

LOCATION	Newington Causeway, London, United Kingdom
DESCRIPTION	This single-story listed building is protected from modification. It is in central London on the southern side of the Thames River and houses an electrical sub-station.
ENVIRONMENT	Near the coast in an urban location that is exposed to dust and high levels of vehicle emissions.
COMPLETED	1962
ARCHITECT	London County Council
CONTRACTOR	Morris Singer (now Crittal Construction Ltd.)
OWNERS	London Transport
CURTAIN WALL	Stainless steel exterior wall panels with a pressed pattern
Stainless steel	Type 316 stainless steel, 0.028 inch (0.711mm) thick with a 'Staybrite' (buffed 2B) finish produced by Firth Vickers (surface roughness R <sub>a</sub> 12 micro inches or 0.3 microns)
Maintenance	No cleaning was planned and none has been done.
Condition	Excellent. The stainless steel is shiny and stain-free with some minor dents. Natural rainwater washing has prevented accumulations of airborne contaminants.

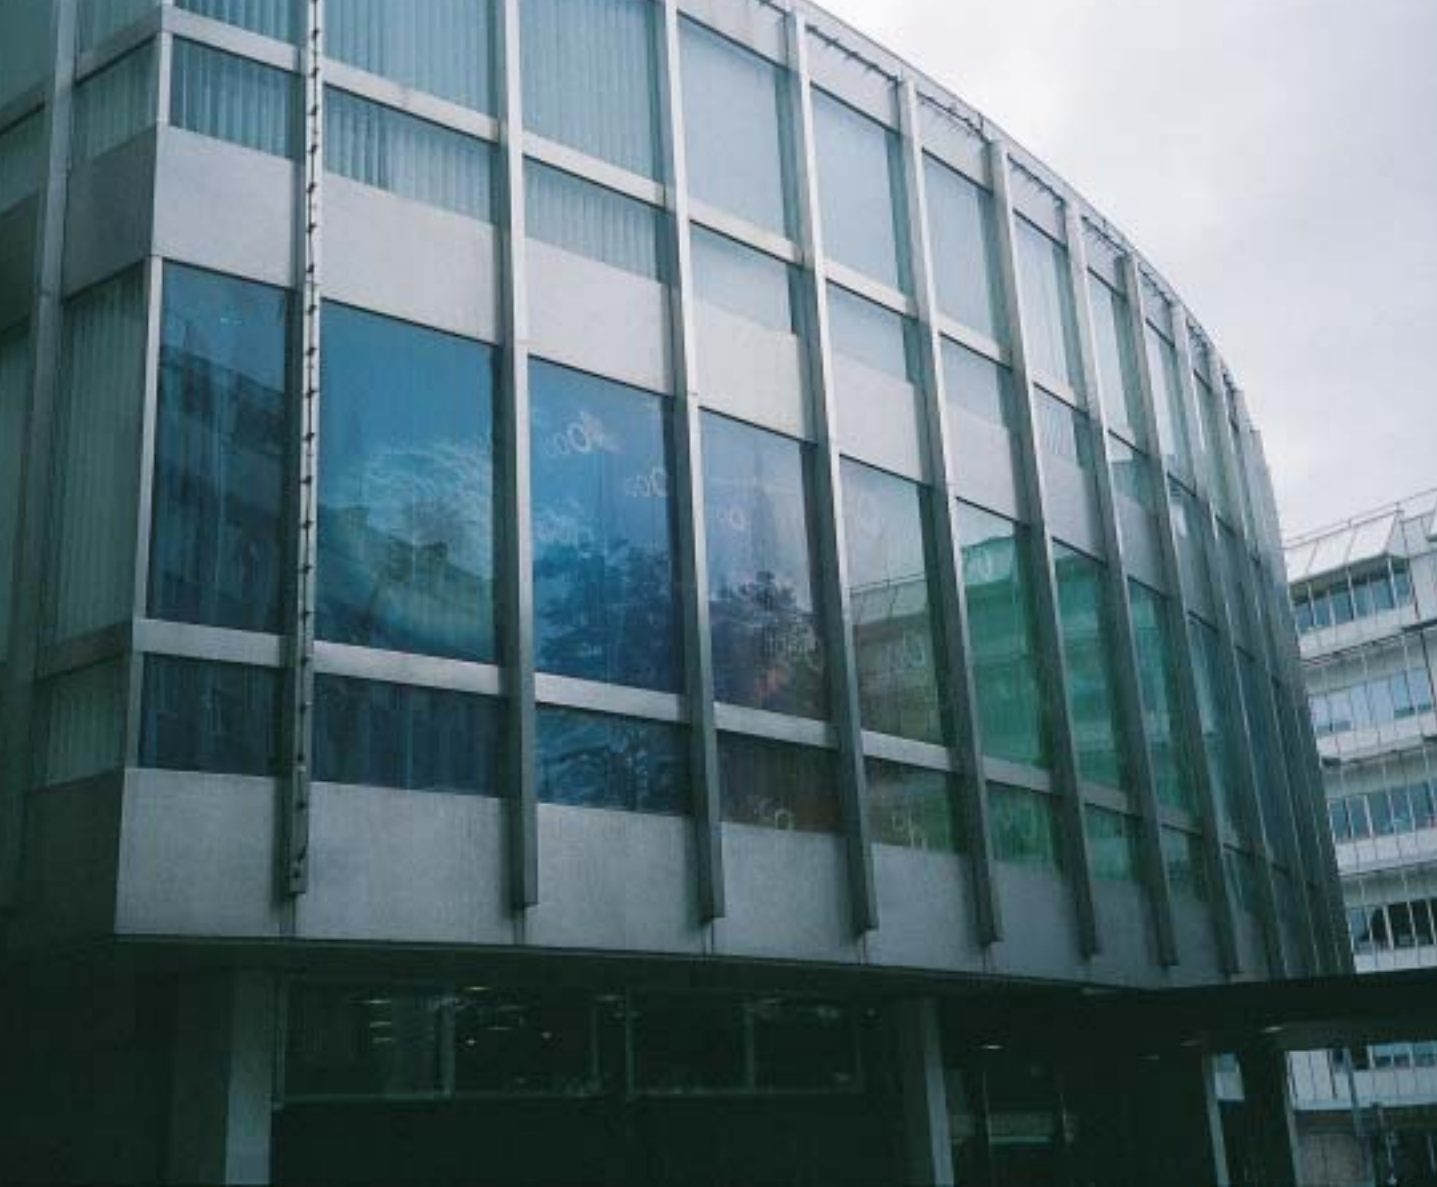
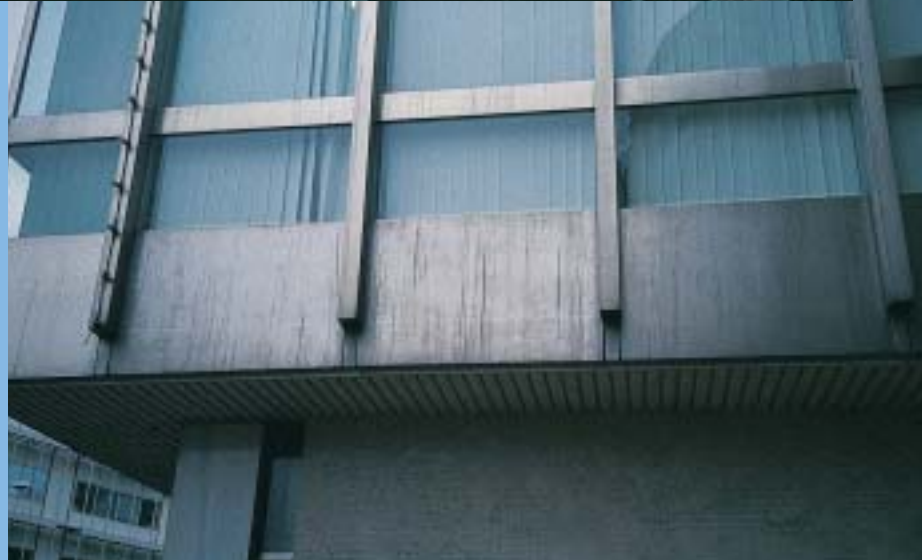
The Lewisham Civic Centre has never been cleaned and dirt accumulation is evident in these 1999 photos. No corrosion is visible and cleaning would restore the building to its original appearance.

LOCATION	Catford Road, Lewisham, London SE6, United Kingdom
DESCRIPTION	Three-story local government office building
ENVIRONMENT	Near the coast in an urban location that is exposed to heavy automotive pollution and dust.
COMPLETED	1971
ARCHITECT	Lewisham Borough Architects
CONTRACTOR	Culford Metal Industries
OWNERS	Lewisham Borough Council
CURTAIN WALL	The second and third floors have stainless steel mullions, rails and spandrel panels.
Stainless steel	Type 316 stainless steel
Maintenance	The maintenance department has no record of ever cleaning the building.
Condition	The stainless steel is quite dull in appearance. There is some visible discolouration, which appears to be dirt accumulation that could be removed by cleaning. There is no visible corrosion.

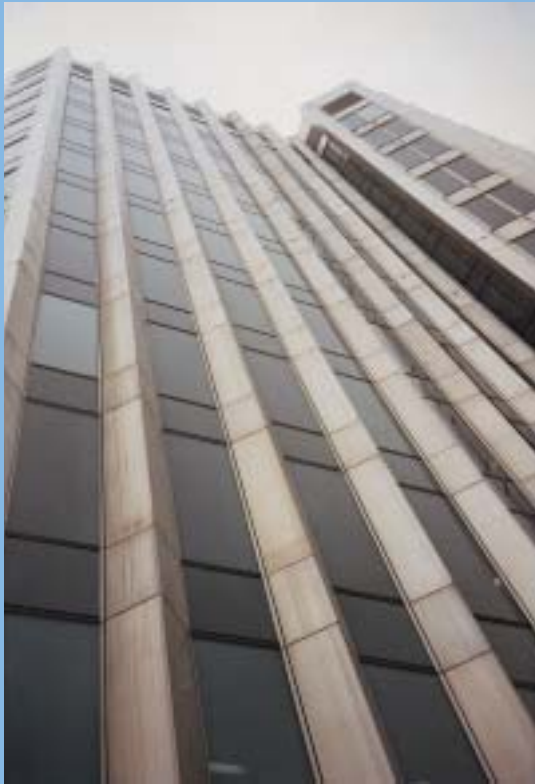
The Enfield Civic Centre has never been cleaned. Although some dirt accumulation is visible in this 1999 photo, the building is still attractive. Cleaning would restore the panels to their original appearance.

LOCATION	Enfield, Middlesex, United Kingdom, which is on the northeast outskirts of London, approximately one mile inside the M25 motorway.
DESCRIPTION	Twelve-story local government office building
ENVIRONMENT	Near the coast in a moderate, urban location set back from a busy street.
COMPLETED	1973
ARCHITECT	Enfield Borough
OWNERS	Enfield Borough Council
CURTAIN WALL	The bright annealed and embossed stainless steel exterior cladding is held in place by screws stud-welded to the back of the panels.
Stainless steel	100 metric tons of 0.06 inch (1.5 mm) thick Type 316 stainless steel with either a bright annealed (BA) or an embossed (Rimex 6WL) finish.
Maintenance	None
Condition	The stainless steel has a dull appearance. There is superficial staining on the lower panels. Despite the lack of recommended maintenance, it is in good condition. Cleaning would restore it to its original appearance.

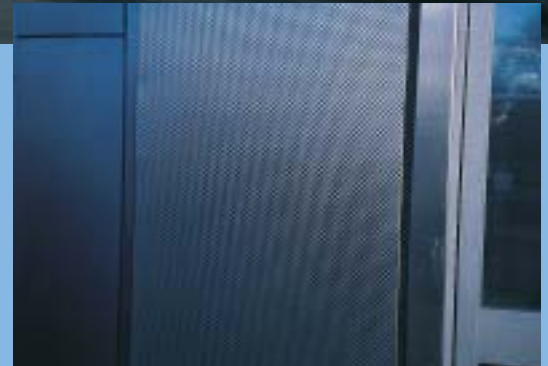
The wall panels have an embossed finish and the window frames have a bright annealed finish.

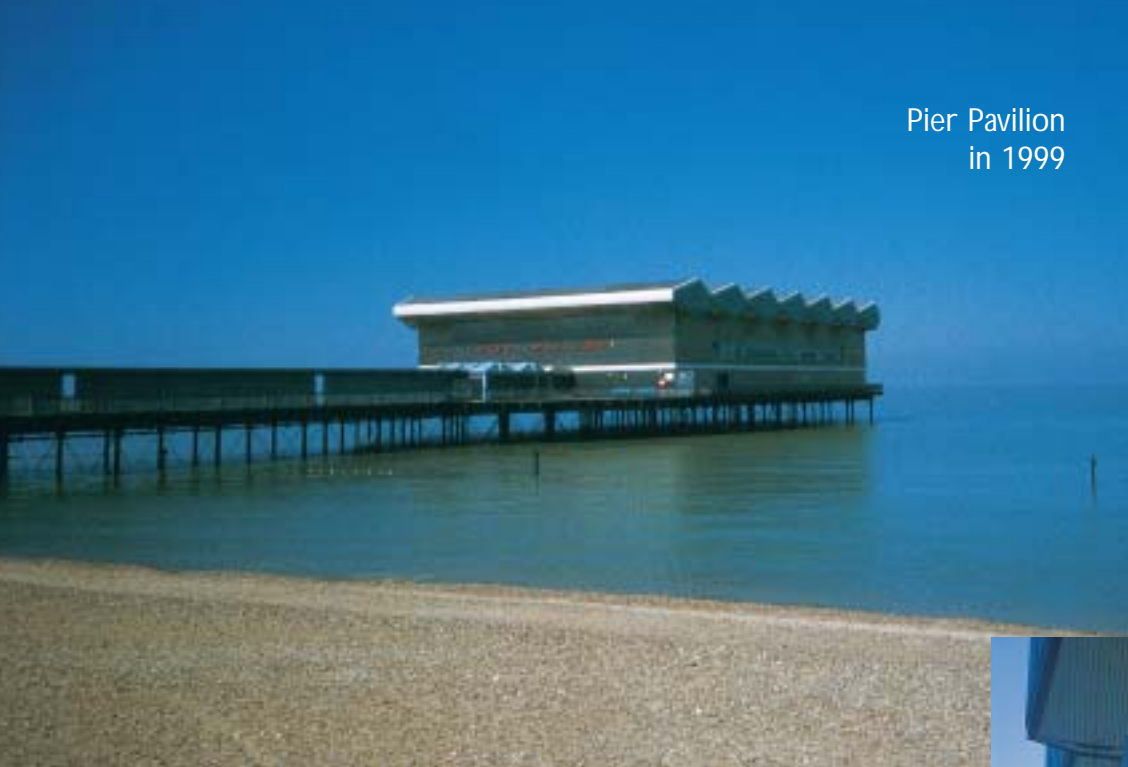
The Pier Pavilion has never been cleaned and it is splashed with seawater spray. There is some superficial corrosion staining, particularly in sheltered areas that are not washed by rainwater. Regular cleaning would remove the stains and prevent recurrence.

LOCATION	Herne Bay, Kent, United Kingdom
DESCRIPTION	A two to three-story sports centre on the end of an ocean pier.
ENVIRONMENT	A low-pollution, severe marine environment with seawater spray exposure.
COMPLETED	1976
ARCHITECT	John C. Clague
CONTRACTOR	H. H. Robertson Ltd.
OWNERS	Herne Bay County Council
CURTAIN WALL	The external corrugated or profiled stainless steel cladding has a trapezoidal cross section and is held in place with stainless steel rivets.
Stainless steel	Type 316 stainless steel with a 2B finish (surface roughness of $R_a$ 14 micro inches or 0.35 microns)
Maintenance	No cleaning was intended and none has been carried out.
Repair/replacement	Some stainless steel panels were replaced due to accidental damage when equipment was lifted into the building by crane. The newer stainless steel panels are visibly cleaner than the older panels.
Condition	Despite the lack of recommended maintenance and the direct exposure to seawater spray which deposits salt on the stainless steel, it is in very good condition. There is some superficial staining. Although this is clearly visible at close range, it is not obvious from the shore end of the pier. The staining could be removed by cleaning. There is staining around some but not all of the rivets. Different rivet materials may have been used. The building has a mixture of exposed and roof-overhang-sheltered stainless steel cladding. The sheltered areas are not washed by the rain and have more dirt and salt deposits.

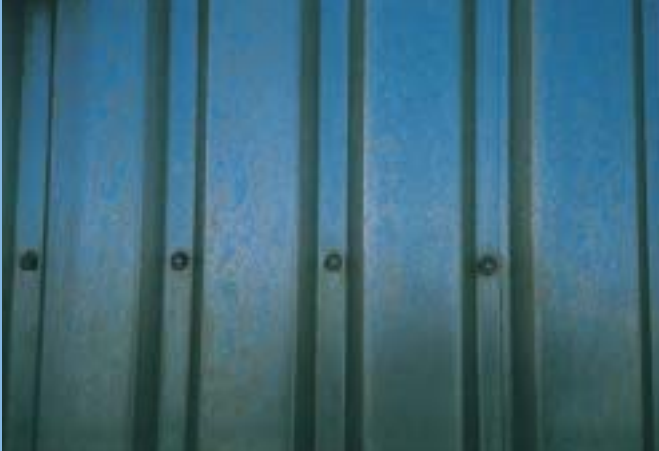
Salt deposits  
are visible on  
the wall panels

Pier Pavilion has large eaves  
that limit rainwater washing.

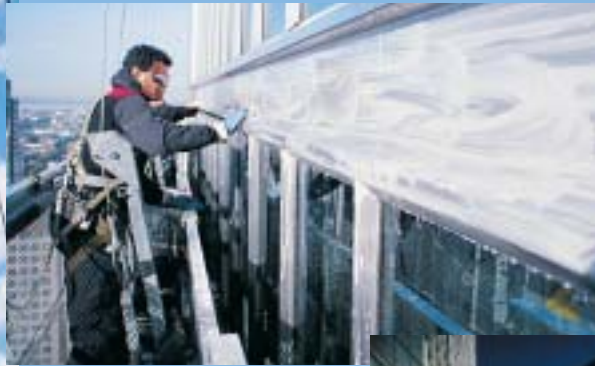
The stainless steel is cleaned three to four times per year when the windows are cleaned
