CAPABILITIES AND LIMITATIONS OF ARCHITECTURAL METALS AND METALS FOR CORROSION RESISTANCE PART 2

Metals for Corrosion Resistance: *Part II*

by Catherine Houska

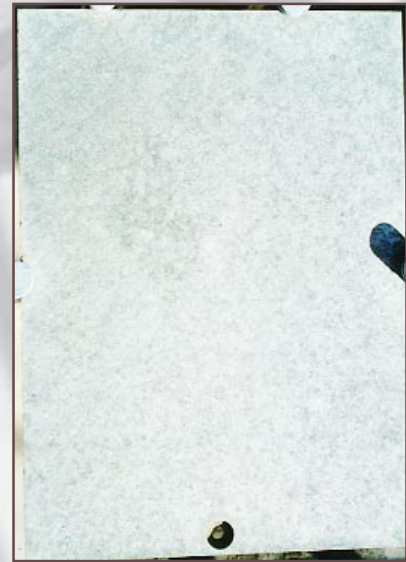
Aluminum alloy 6061 exposed since 1982 about 25 m (82 ft) from the mean high tide.

The atmospheric corrosion test samples shown in the photos are at the LaQue Center for Corrosion Technology, Inc., an internationally respected corrosion research facility in Kure Beach, North Carolina. The samples have been exposed to the elements and are only cleaned by rain. Except where noted, the samples are 250 m (820 ft) from the ocean's mean high tide.

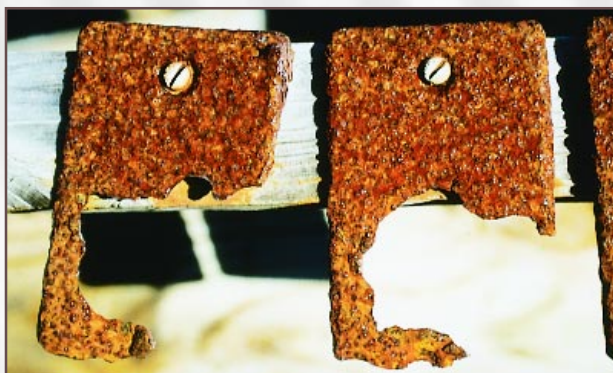
Coated (60 Zn, 20 Al, 20 Mg) carbon steel exposed since 1952.

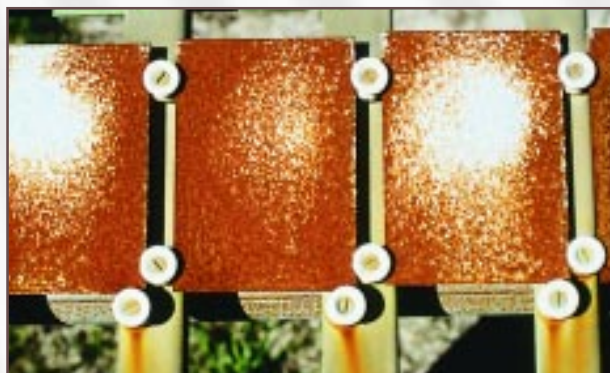
Bare G-90 galvanized steel exposed since 1981.

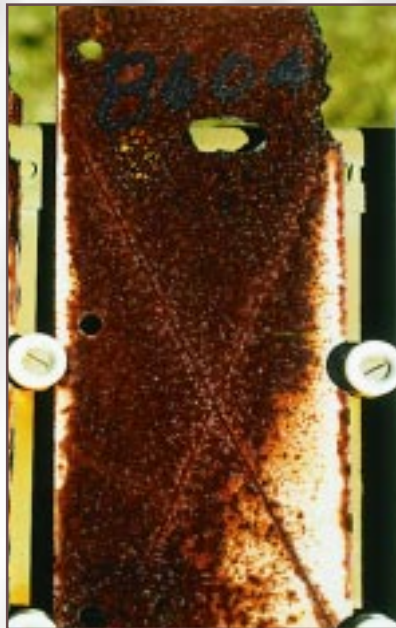
Painted cold rolled steel exposed since 1988.

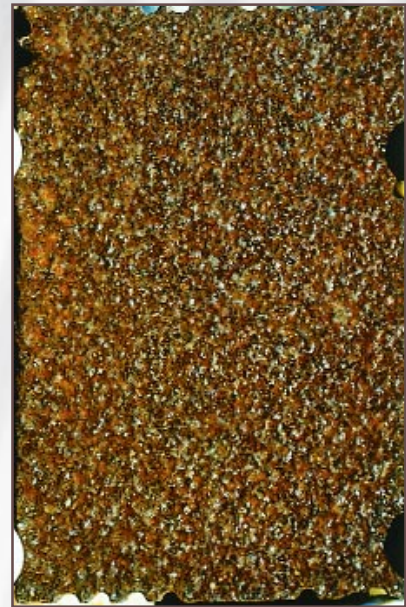
High strength low alloy weathering steel exposed since 1968.

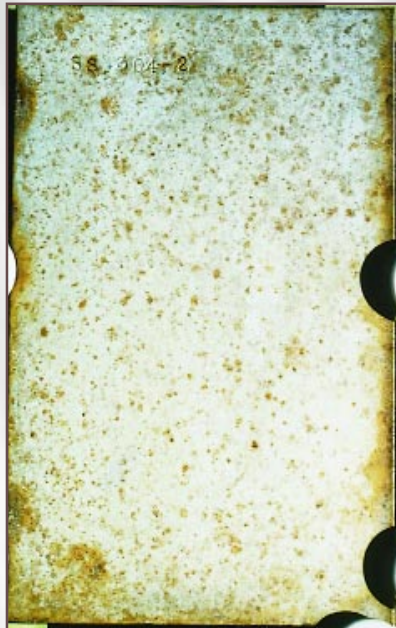
Type 304 exposed since 1941.

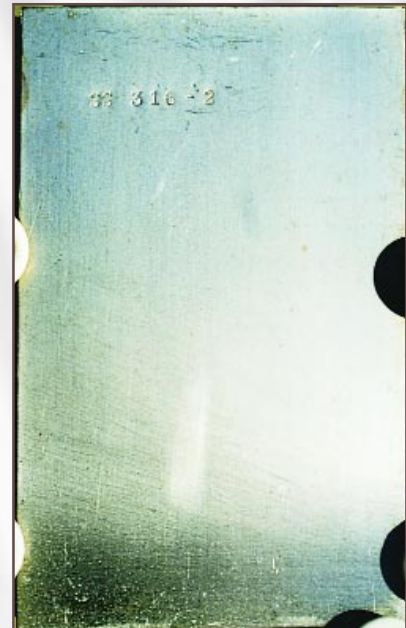
Type 316 exposed since 1941.

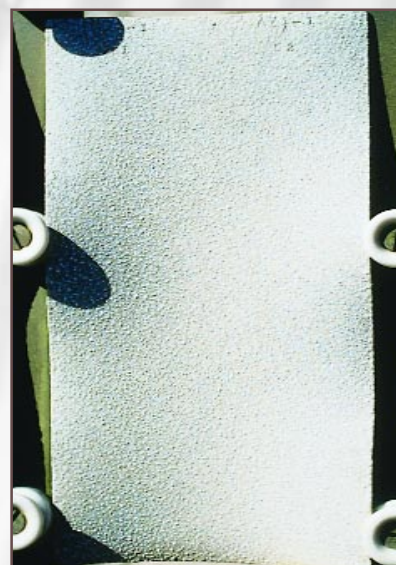
Pure zinc exposed since 1960 about 25 m (82 ft) from the mean high tide.
